## Technical Service Bulletin

| GROUP<br><b>CAMPAIGN</b> | NUMBER<br><b>19-01-004H</b> |

**SUBJECT:** TUCSON (TL) & IONIQ PLUG-IN HYBRID (AE PHEV) D-AUDIO LITE SOFTWARE UPDATE: BLANK HOME SCREEN (SERVICE CAMPAIGN T3R)

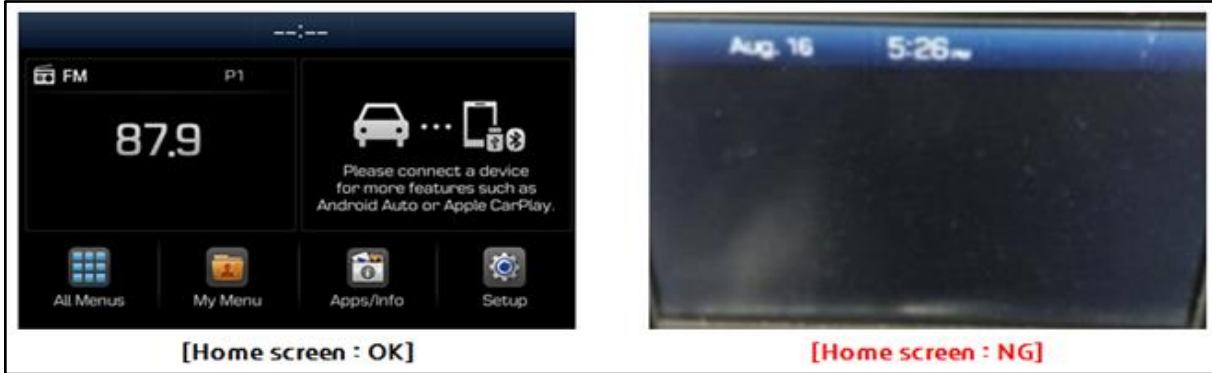
**Symptom**

**Description:** This bulletin describes the procedure to update the D-Audio lite head unit on certain Tucson (TL) and Ioniq Plug-in Hybrid (AE PHEV) to correct the home screen remaining blank.
