HYUNDAI Technical Service Bulletin	GROUP AUTOMATIC TRANSMISSION	NUMBER 19-AT-002H
	DATE FEBRUARY, 2019	MODEL ELANTRA SPORT (AD) 1.6T, TUCSON (TL) 1.6T, VELOSTER (FS) 1.6T
SUBJECT: DUAL CLUTCH TRANSMISSION CLUTCH REPLACEMENT AND TCU SOFTWARE UPDATE

Description: Certain vehicles (listed below) equipped with 7-speed Dual Clutch Transmission (DCT) may exhibit an abnormal vibration at low speeds. This bulletin outlines the procedures for diagnosing and replacing the Double Clutch, including a Transmission Control Unit (TCU) software update.

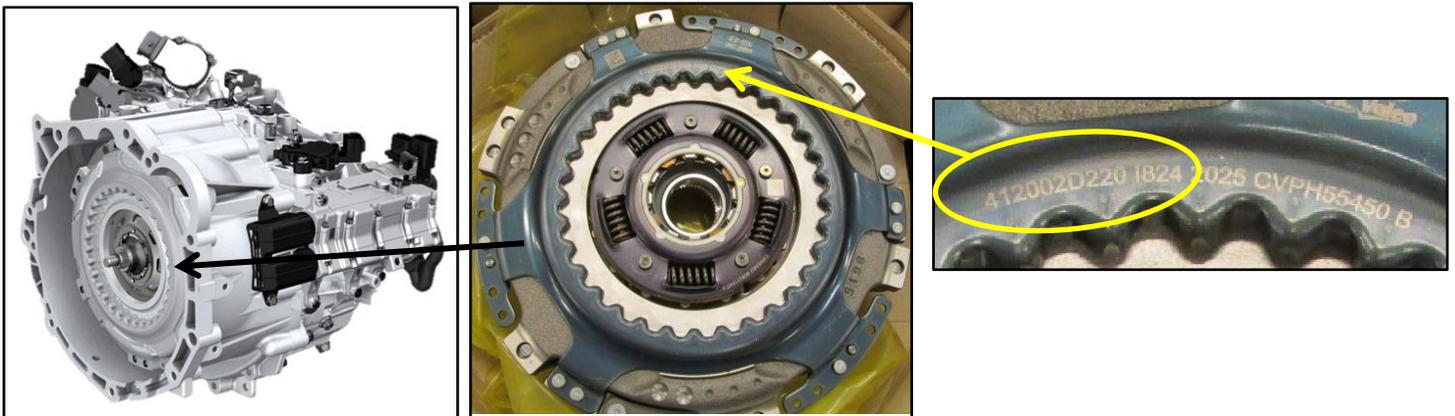
Updated F850 clutch material identification:

MODEL	PREVIOUS CLUTCH PART NUMBER (F833DS)	NEW CLUTCH PART NUMBER (F850)
2017~2018 Elantra Sport (AD) 1.6L Turbo 2016-2017 Tucson (TL) 1.6L Turbo 2016-2017 Veloster (FS) 1.6L Turbo	41200-2D101	41200-2D220

- When replacing the Double Clutch, refer to the table on page 3 of this TSB to identify if the originally clutch material was the older F833DS or newer F850 clutch material.
- Only if the Dual Clutch Transmission was originally equipped with the old F833DS clutch and the replacement Double Clutch is the new F850 material should the software update be performed.

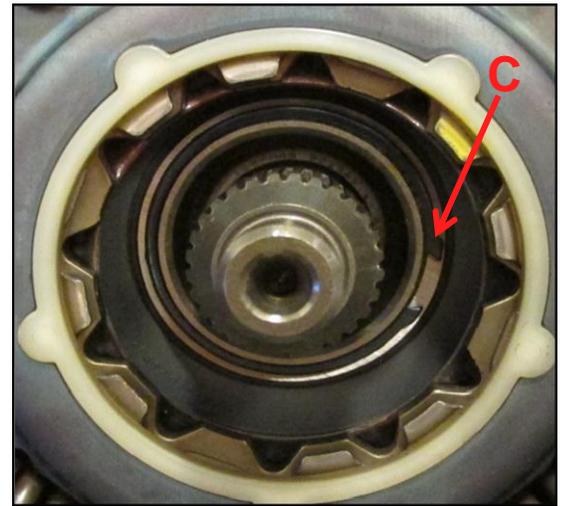
The snap ring can become deformed in the removal process. Do not reuse the existing snap rings when reinstalling the Double Clutch into the transmission.

3. Remove snap ring (C) (41068-2D000).

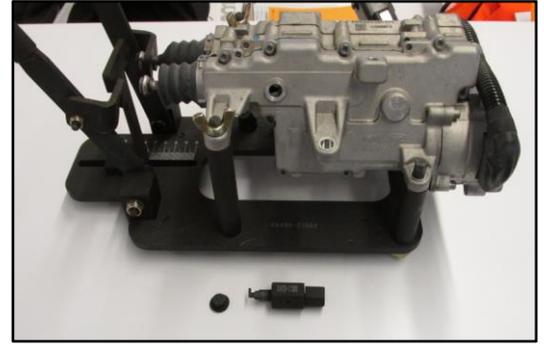
When installing a new Double-Clutch, the clutch actuator rod length has to be reset back to the factory zero. If the rod length is not adjusted correctly, the GDS DCT relearn procedure will not complete.

7. Follow the service shop manual procedure to initialize the rod length for both odd and even clutch actuator rods.

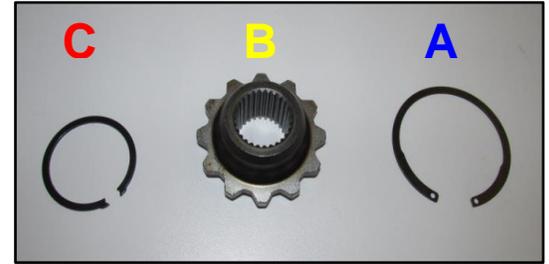
When installing the new snap ring, make sure it is fully seated and can be easily rotated left and right.

12. Install new snap ring (C), splined hub (B) and retaining ring (A).
