**HYUNDAI**  
**Technical Service Bulletin**

| GROUP<br><b>CAMPAIGN</b> | NUMBER<br><b>19-01-006H</b> |

**SUBJECT:** THETA GDI ENGINE DTC P1326 - WIRING INSPECTION /  
 INSTALLATION AND ENGINE REPLACEMENT  
 (SERVICE CAMPAIGN T3G)

**This TSB supersedes TSB# 18-01-032-2 and modifies the list of applicable vehicles to add 11-14MY and 16-18MY Sonata, 13-14MY and 16-18MY Santa Fe Sport, 14-15MY and 18MY Tucson.**

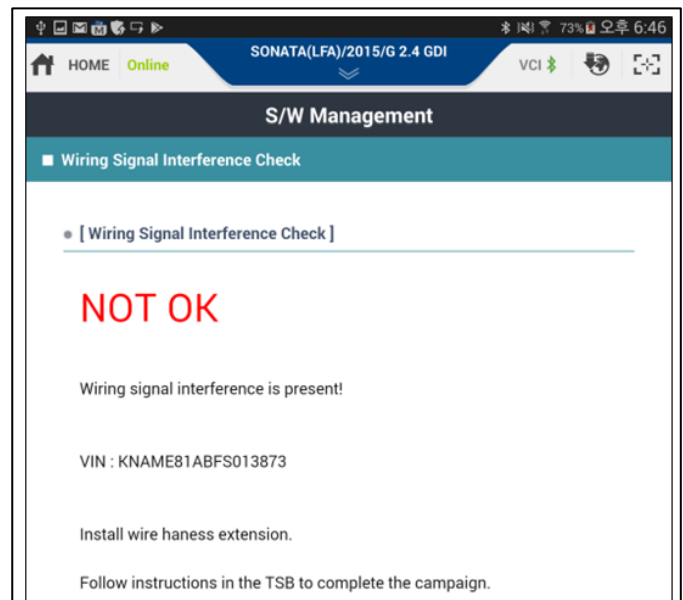
**If the inspection result is NOT OK:**

- Install the new wire harness extension kit.
