GROUP ENG	MODEL 2018MY Stinger (CK) 2.0T
	NUMBER 191 (Rev 2, 02/20/2019)	DATE November 2018
TECHNICAL SERVICE BULLETIN		
SUBJECT: SERVICE ACTION: 2.0T ECU REPLACEMENT FOR DTC P053F AND/OR P0087 (SA352)

SUBJECT: SERVICE ACTION: 2.0T ECU REPLACEMENT FOR DTC P053F AND/OR P0087 (SA352)

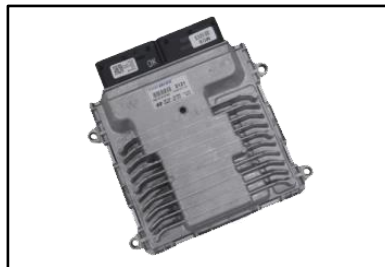
This bulletin provides the procedure to replace the Electronic Control Unit (ECU) on ALL 2018MY Stinger (CK) 2.0T vehicles, produced from September 29, 2017 through March 27, 2018, which may exhibit engine hesitation and/or a Malfunction Indicator Light (MIL) ON with DTCs P053F and/or P0087 as the engine is warming up to operating temperature. Follow the procedure below to replace the ECU. Before conducting the procedure, verify that the vehicle is included in the list of affected VINs.

P053F: Cold Start Fuel Pressure Performance
P0087: Fuel Rail/System Pressure – Too Low
