GROUP <b>Product Improvement</b>	MODEL <b>See Model List on Page 1</b>
	NUMBER <b>PI1802W/X (Rev 2, 02/11/2019)</b>	DATE <b>October 2018</b>
<b>PRODUCT IMPROVEMENT CAMPAIGN</b>		
SUBJECT: <b>ENGINE REPLACEMENT INSTRUCTIONS FOR DTC P1326 (PI1802W/X)</b>

This bulletin provides information related to the Technical Service Bulletin previously published in July 2018 ([PI1802](#), Rev 6, 01/31/2019) titled “Knock Sensor Detection System - ECU Logic Improvement”. Specifically, this bulletin provides instructions on which procedures to follow if, after installation of the KSDS, any one of the subject vehicles below returns to the dealer with Diagnostic Trouble Code (“DTC”), P1326.

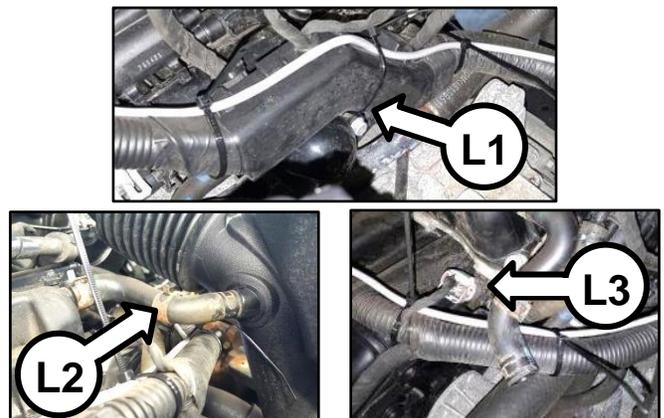
The harness (B) must be routed above and secured to the harness protector (L1) and **UNDER** the Breather Hose (L2) and Camshaft Position Sensor (L3).

- Route the extension harness (B) along the existing harness (A) leading by the intake manifold (C) to the knock sensor (D), as shown.

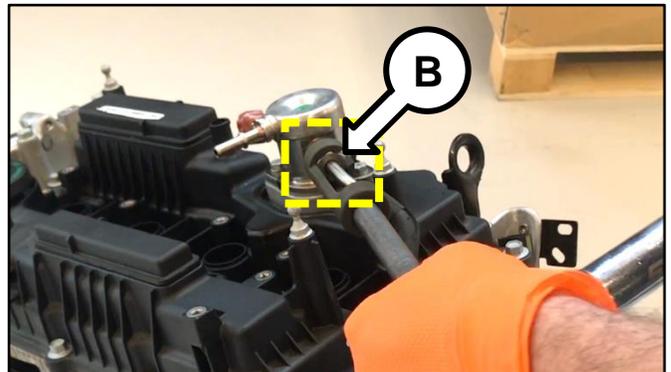
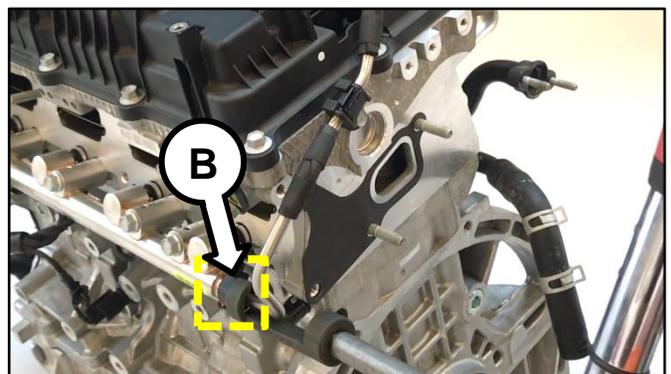
The high pressure fuel pipe bracket and bolt must be installed and properly torqued prior to torquing the high pressure fuel pipe flare nuts.

3. Using a click-type/electronic torque wrench and SST 09314-3Q100, torque both flare nuts (B) to specifications.

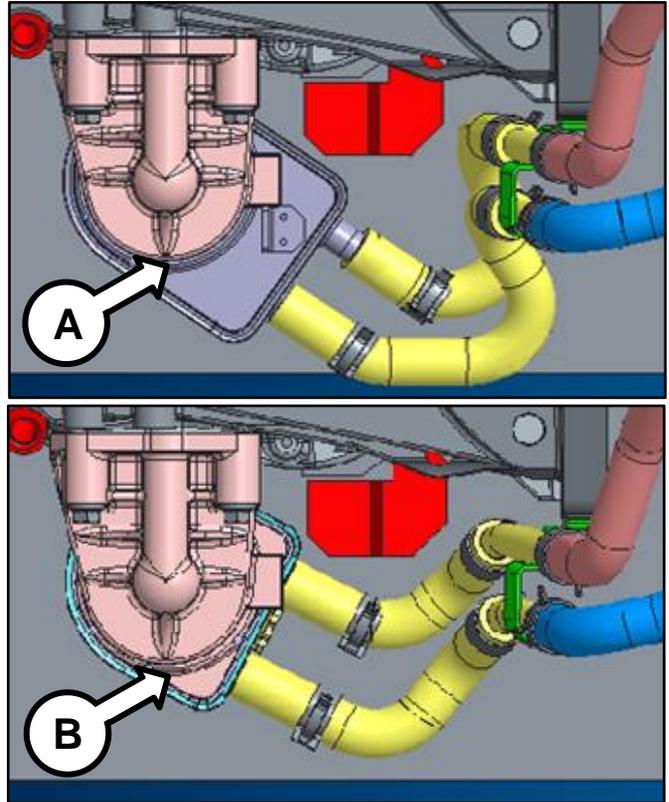
New engines may be supplied with a different oil cooler. Use steps below to determine the need for a replacement oil cooler tube assembly.

- If the new engine's (bigger) oil cooler (A) does not match the old engine's (smaller) oil cooler (B), replace the oil cooler tube assembly with the improved part. See parts table on page 17.
- If the new engine's (bigger) oil cooler (A) matches the old engine's (bigger) oil cooler (A), reuse the old engine's oil cooler tube assembly.
- If the new engine's (smaller) oil cooler (B) matches the old engine's (smaller) oil cooler (B), reuse the old engine's oil cooler tube assembly.

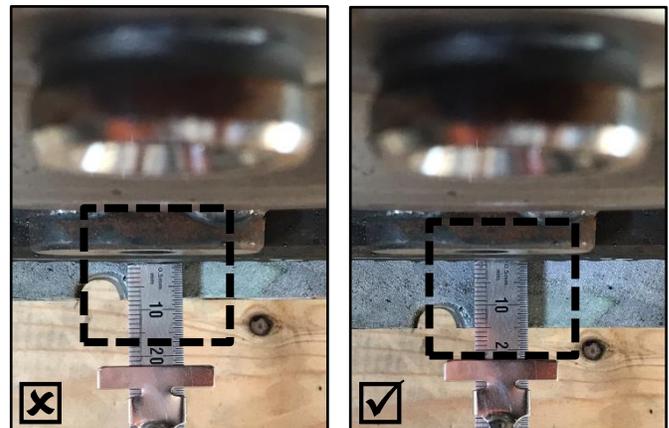
Not Fully Inserted

Fully Inserted

- If the torque converter has moved from the fully inserted position, carefully push inward while rotating the torque converter until it is recessed approximately 9/16 – 5/8" (14 – 16mm) (☑) into the transaxle case when reinstalling the automatic transaxle.
