MODEL  
2011-2014MY  
Optima (QF/TF)  
2012-2014MY  
Sorento (XMa)  
2011-2013MY  
Sportage (SL)

NUMBER  
PI1803W/X (Rev 2, 02/11/2019)

## PRODUCT IMPROVEMENT CAMPAIGN

SUBJECT: ENGINE REPLACEMENT INSTRUCTIONS  
FOR DTC P1326 (PI1803W/X)

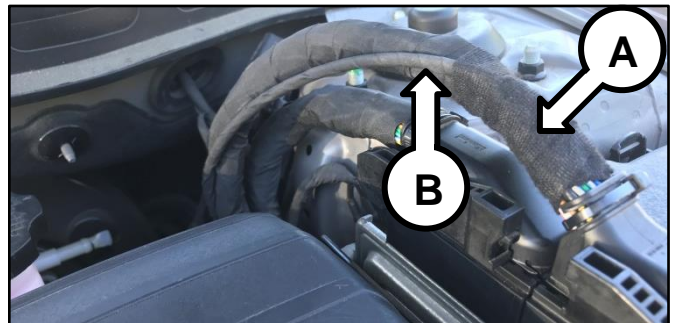
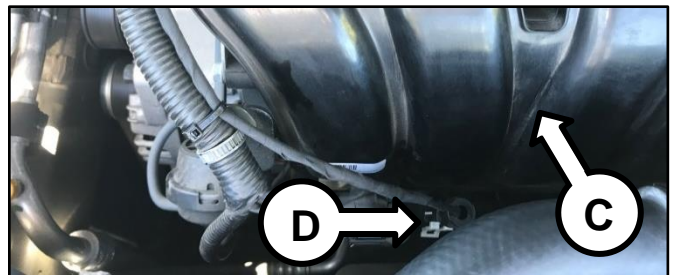
1. Inspect the ECU harness (A) and verify if the Knock Sensor wiring extension harness (B) has previously been installed.

**NOTE:** To identify the extension harness (B), look for an external harness (B) which should be cable-tied to the existing wiring harness (A) leading by the intake manifold (C) to the knock sensor (D), as shown.

- If the extension harness (B) has been installed, open a Techline case online.
- If the extension harness (B) has not been installed, proceed to the next step.

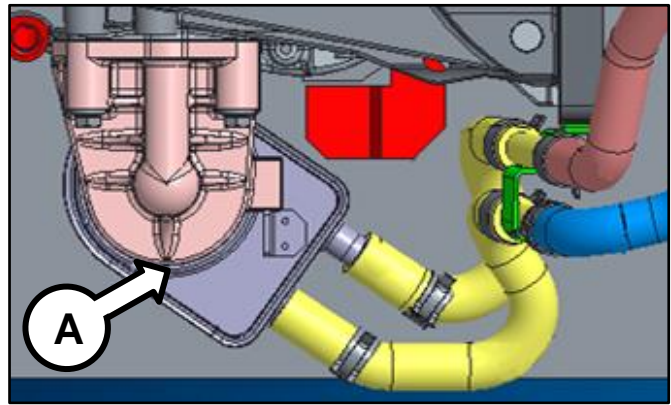
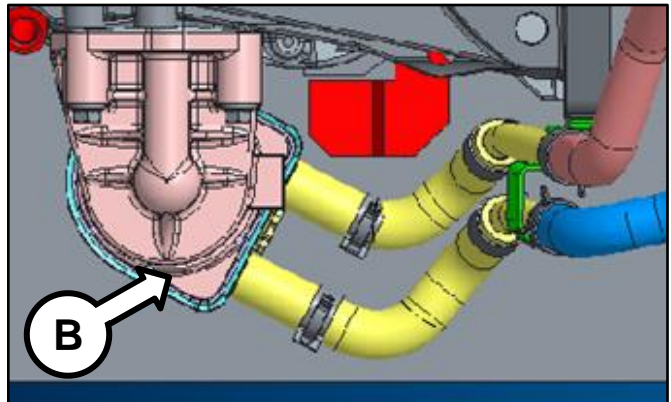
New engines may be supplied with a different oil cooler. Use steps below to determine the need for a replacement oil cooler tube assembly.

- If the new engine's (bigger) oil cooler (A) does not match the old engine's (smaller) oil cooler (B), replace the oil cooler tube assembly with the improved part. See parts table on page 15.
- If the new engine's (bigger) oil cooler (A) matches the old engine's (bigger) oil cooler (A), reuse the old engine's oil cooler tube assembly.
- If the new engine's (smaller) oil cooler (B) matches the old engine's (smaller) oil cooler (B), reuse the old engine's oil cooler tube assembly.
