| SUBJECT: | | | No: | TSB-19-27-001 |
| CORRECTIONS TO AWD REAR AXLE HUB ASSEMBLY REMOVAL & INSTALLATION | | | DATE: | February 2019 |
| PROCEDURE - SMR | | | MODEL: | 2017 Outlander |

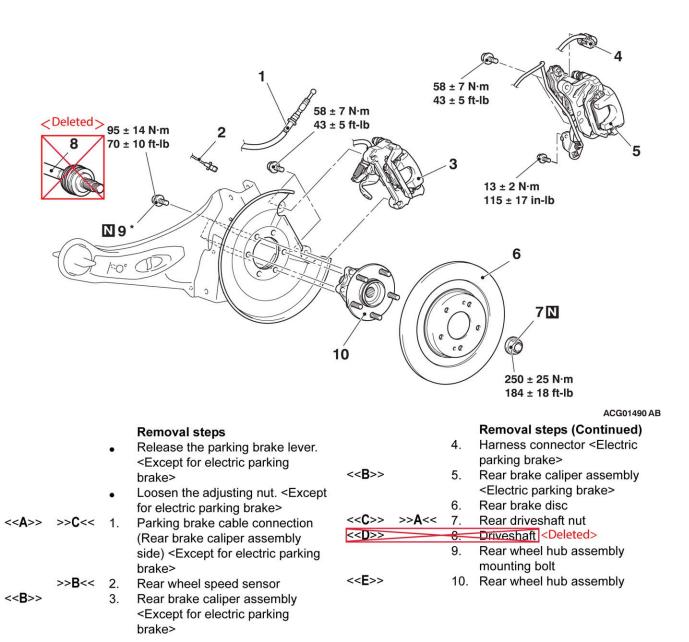
Please make the indicated changes below to the 2017 Outlander Service Manual, Group 27-Rear Axle -> 27B-Rear Axle (AWD) - .Rear Axle Hub Assembly -> Removal and Installation:

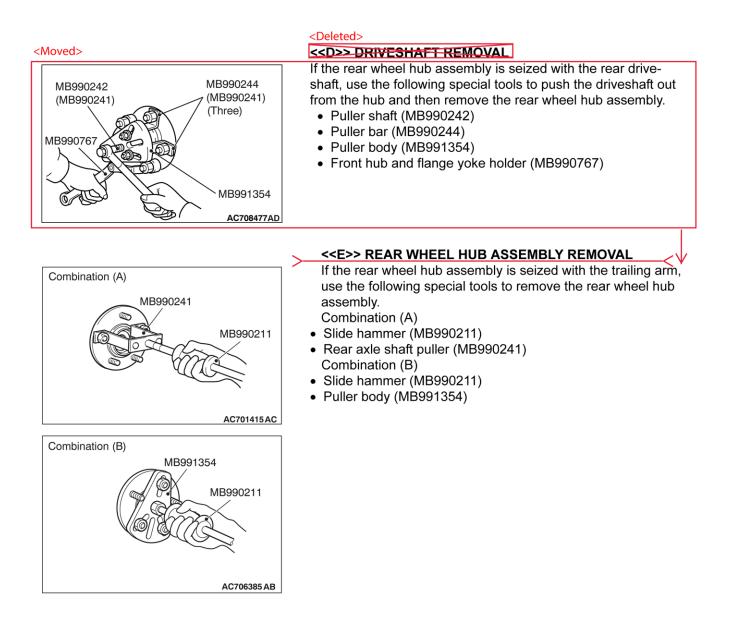
Please make the indicated changes below to the 2017 Outlander Service Manual, Group 27-Rear Axle -> 27B-Rear Axle (AWD) - .Rear Axle Hub Assembly -> Removal and Installation -> Removal Service Points:
