CAMPAIGN BULLETIN Fuel Tank Dealer Inventory

Reference: PC681
Date: February 13, 2019

Affected Models/Years:	Affected Population:	Dealer Inventory:	SERVICE COMM Activation date:	Stop Sale In Effect
MY2019 Altima (L34) AWD	NA	80	February 13, 2019	NO

PC681 - 2019 – ALTIMA (AWD ONLY) FUEL TANK INSPECTION

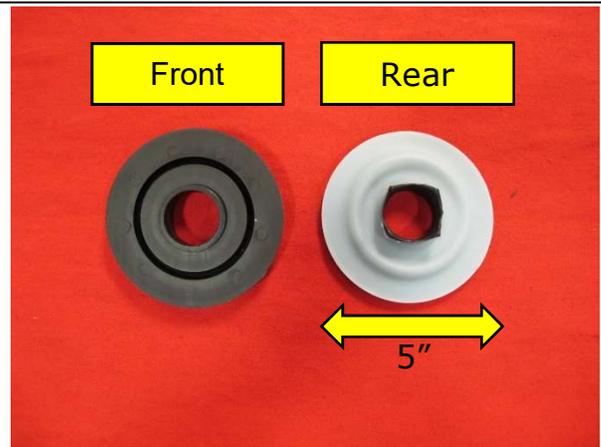
Figure 11

10. Inspect the fuel tank for the plastic slug shown in Figure 11.

NOTE: The plastic slug is white on one side and black on the other. (Figure 11)

NOTE: The plastic slug does **NOT** float.

- Remove the plastic slug from the fuel tank using a clean suitable tool
- Email a clear picture of the plastic slug to: nafgasupport@nissan-usa.com
 - Make sure to include the below information:
 - E-Mail Subject Line: PC681 AWD Altima fuel tank inspection
 - Attach Clear Picture referenced above
 - Dealer Name:
 - Dealer Code:
 - Dealer Address:
 - VIN:
 - Contact Person Name:
 - Contact Person Phone Number:
- Continue to Step 13 for reassembly

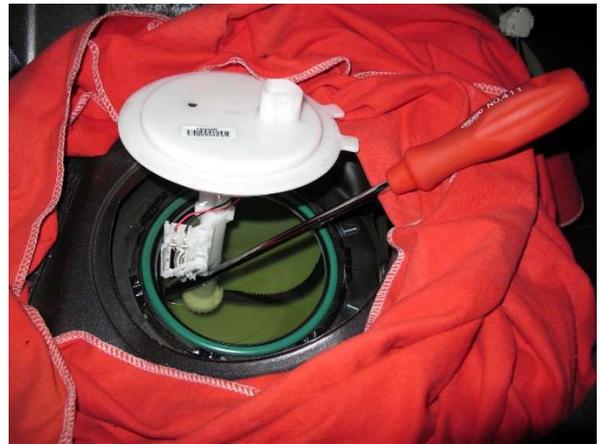
Figure 12

- Using flashlight inspect the fuel tank for a large plastic slug
- When inspecting, be sure to check the rear of the fuel tank as plastic slug can be difficult to see
- Use a long suitable tool to gently probe the rear of the fuel tank (Figure 12)
- Continue to next step
