## SERVICE BULLETIN

NTB18-058b

### 2013-2017 SENTRA; ENHANCED DIAGNOSTIC LOGIC FOR CVT

**APPLIED VEHICLES:** 2013-2017 Sentra (B17)

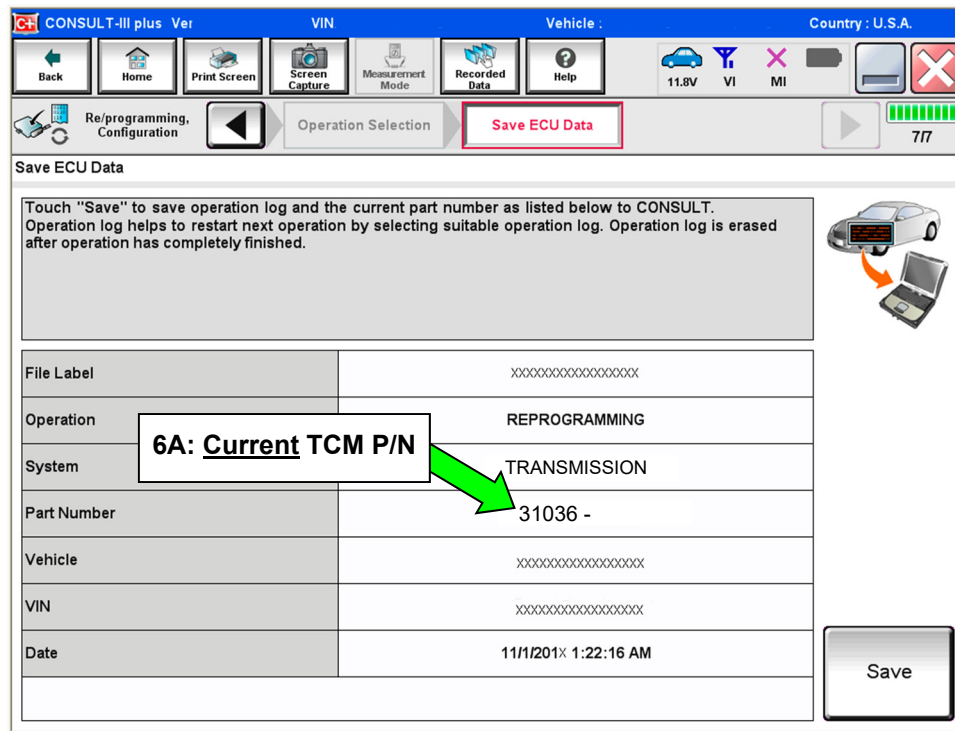
Figure 2

A. Find the TCM **Part Number** and write it on the repair order.

B. Compare the P/N you wrote down to the numbers in the **Current TCM Part Number** column in **Table A** below.

- If there is a match, this bulletin applies. Continue with the reprogramming procedure.
- If there is not a match, this bulletin does not apply. Refer to ASIST for further diagnostic and repair information.

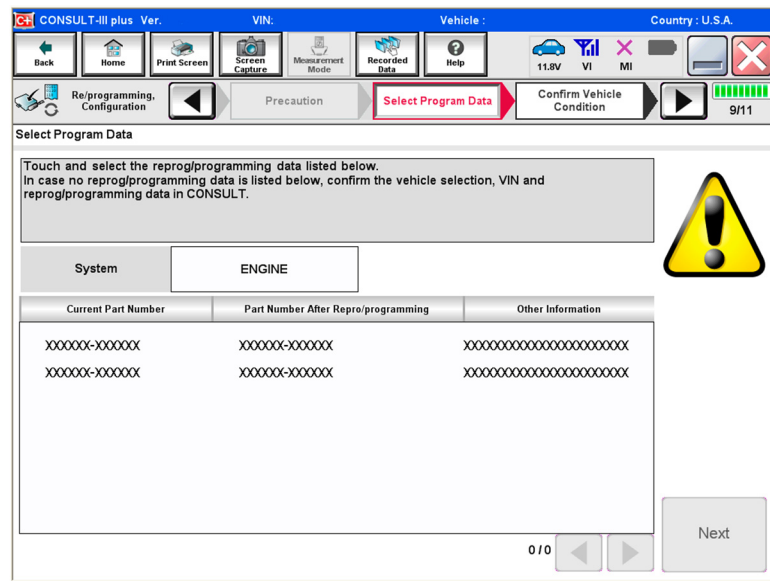
- In some cases, more than one new P/N for reprogramming is available.
  - If there is more than one new P/N, the screen in Figure 3 displays.
  - Select and use the reprogramming option that **does not** have the message “Caution! Use ONLY with NTBXX-XXX”.
- If you get this screen and it is blank (no reprogramming listed), it means there is no reprogramming available for this vehicle.

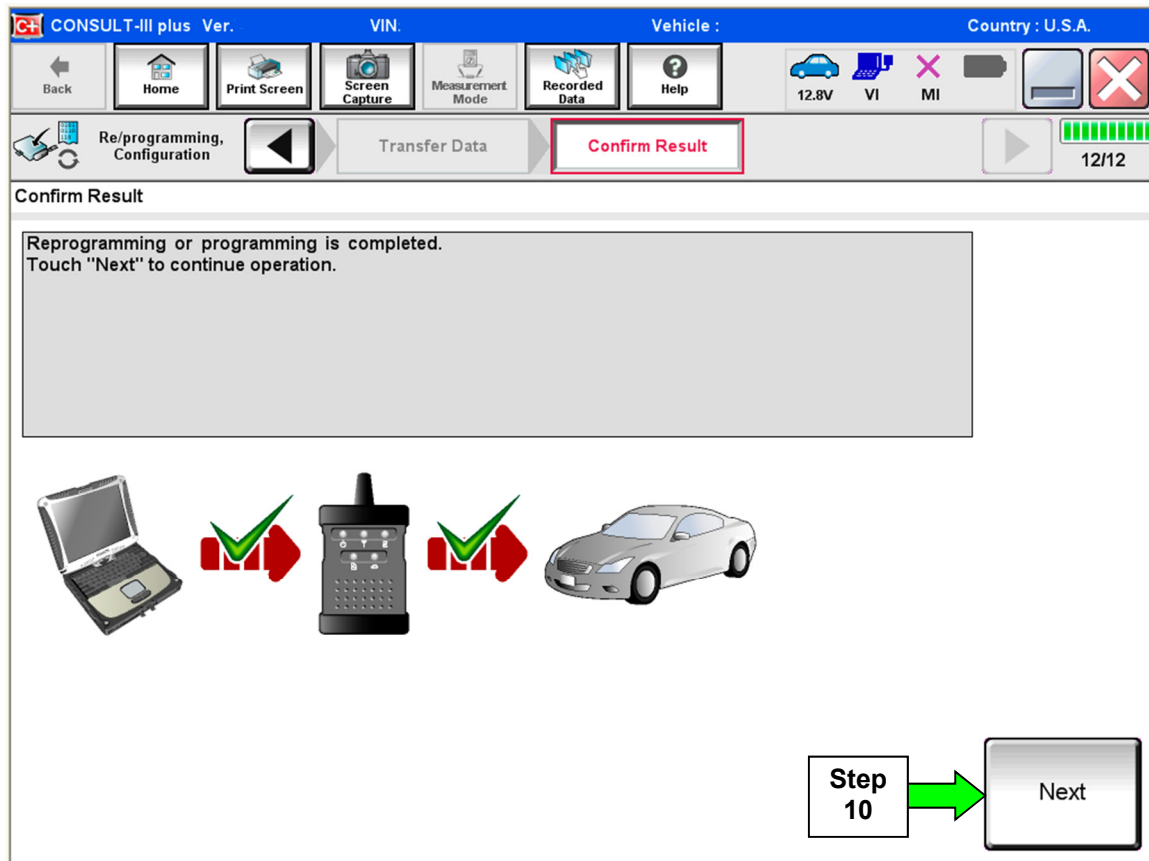
8. When the screen in Figure 5 displays, reprogramming is complete.

**NOTE:** If the screen in Figure 5 does not display (indicating that reprogramming did not complete), refer to the information on the next page.

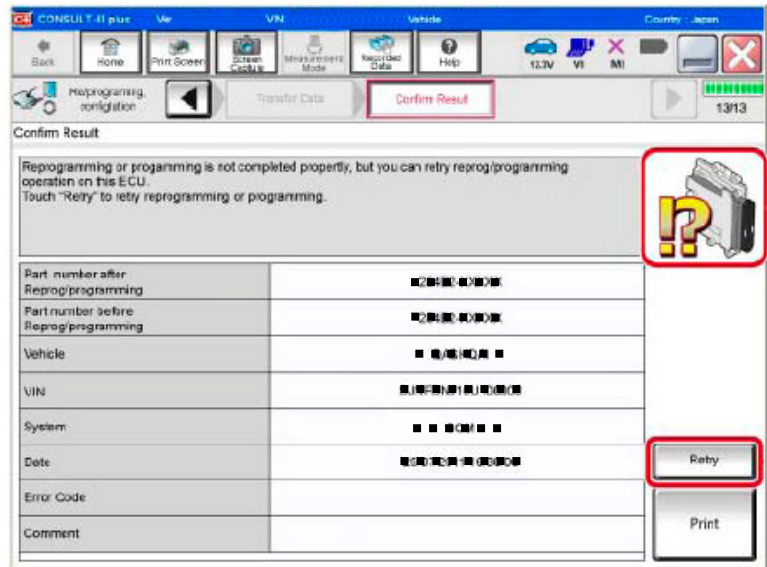
Figure 6

If reprogramming does not complete and the “!?” icon displays as shown in Figure 6:

- Check battery voltage (12.0–15.5 V).
- Ignition is ON, engine OFF.
- External Bluetooth® devices are OFF.
- All electrical loads are OFF.
- **Select retry and follow the on screen instructions.**
- “Retry” may not go through on first attempt and can be selected more than once.

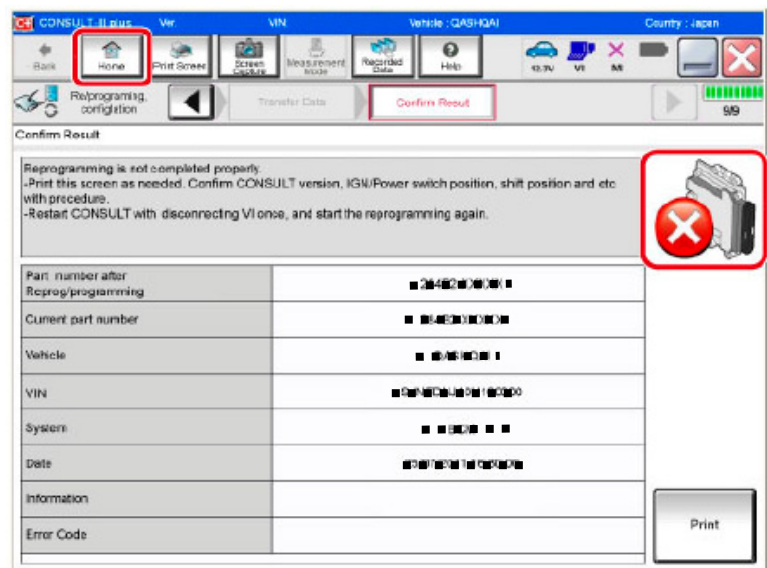
Figure 7

If reprogramming does not complete and the “X” icon displays as shown in Figure 7:

- Check battery voltage (12.0 – 15.5 V).
- CONSULT A/C adapter is plugged in.
- Ignition is ON, engine OFF.
- Transmission is in Park.
- All C-III plus / plus VI cables are securely connected.
- All C-III plus updates are installed.
- **Select Home, and restart the reprogram procedure from the beginning.**

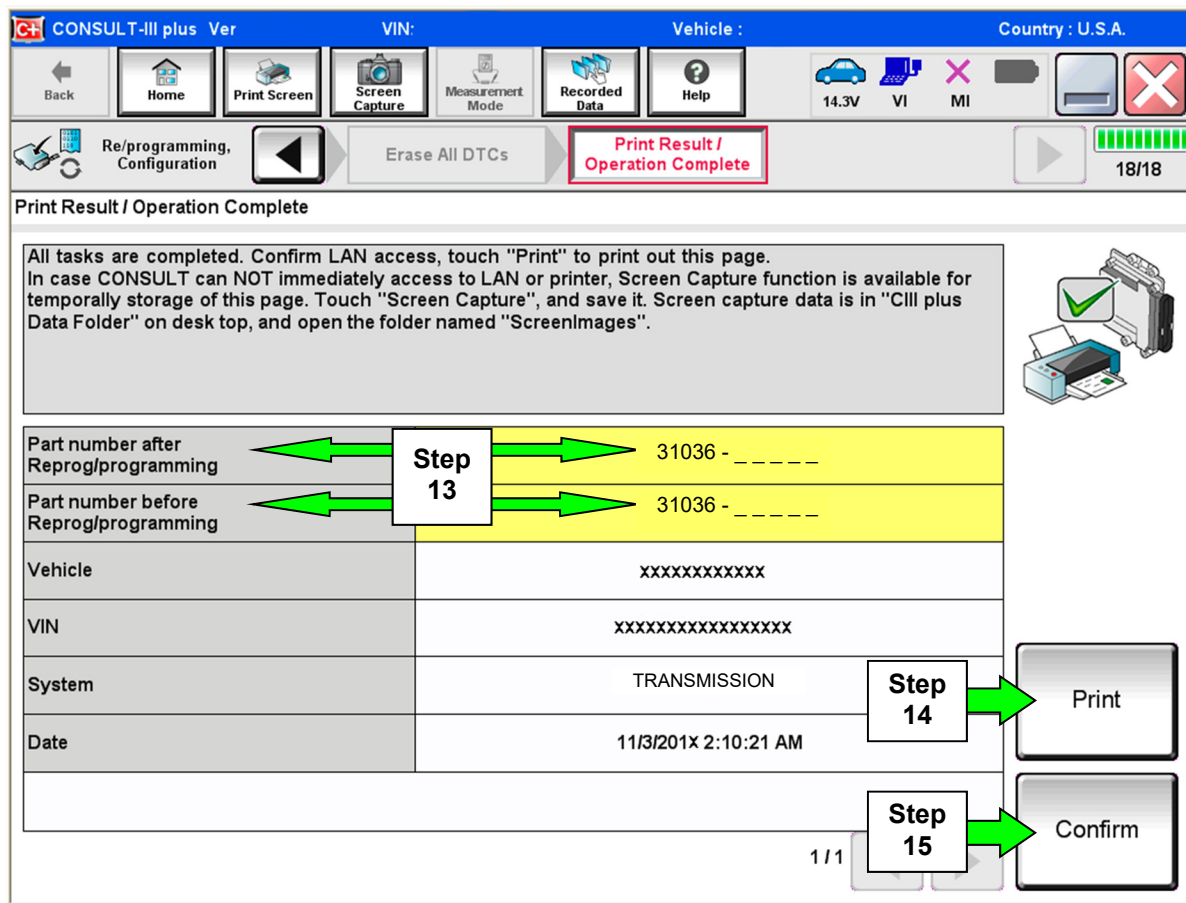
11. Follow the on-screen instructions to **Erase All DTCs**.
12. When the entire reprogramming process is complete, the screen in Figure 8 will display.
13. Verify the before and after part numbers are different.
14. Print a copy of this screen (Figure 8) and attach it to the repair order for warranty documentation.
15. Select **Confirm**.
