SERVICE BULLETIN

Classification:	Reference:	Date:
EC19-005	NTB19-011	February 28, 2019

2016 – 2018 TITAN XD; MIL ON WITH DTC P2048 STORED

APPLIED VEHICLES: 2016 – 2018 Titan XD (A61)
APPLIED ENGINE: Cummins 5.0L Diesel

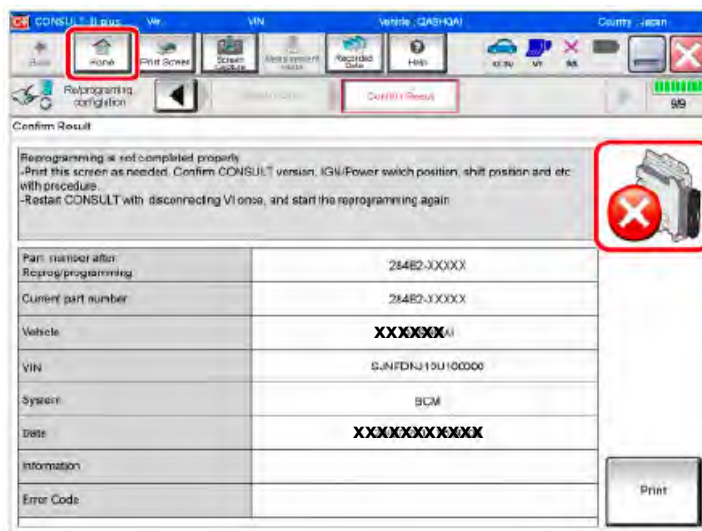
Figure 6

If reprogramming does not complete and the “X” icon displays as shown in Figure 6:

- Check battery voltage (12.0 - 15.5 V).
- CONSULT A/C adapter is plugged in.
- Ignition is ON, engine OFF.
- Transmission is in Park.
- All C-III plus / VI cables are securely connected.
- All C-III plus updates are installed.
- **Select Home, and restart the reprogram procedure from the beginning.**
