US 54380454-08

Rattling Noise from Timing Gear

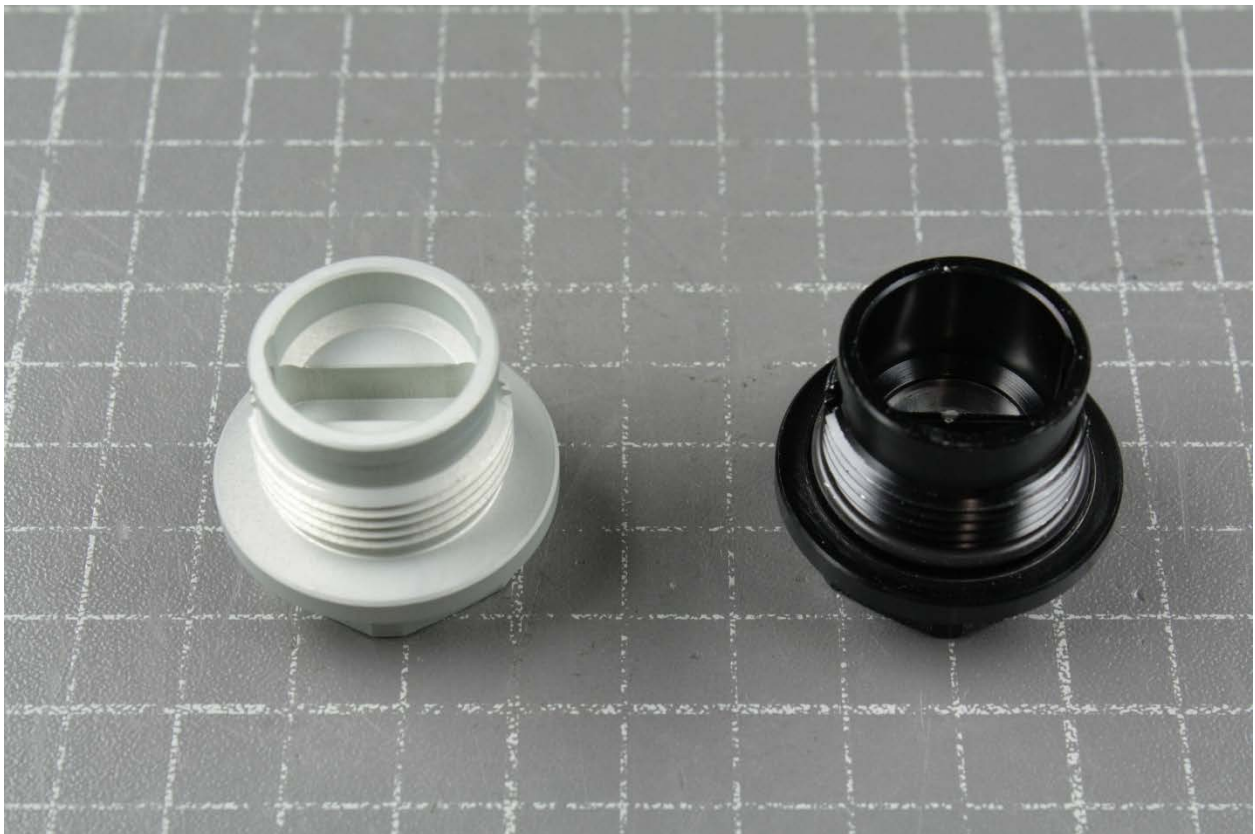
Rattling / chattering engine noise from the timing gear.

After approximately 9,000 mi, the timing chain (7 713 828) may wear to the point that the chain tensioners range of adjustment is no longer sufficient to accommodate the change in length.

In the event of a verified customer complaint;
 remove the black screw plug (11 31 7 718 69) and replace it with a silver screw plug
 (11 31 8 534 849).

See attached photos.

Note: The silver screw plug has a longer range of adjustment for the chain tensioner
 and installing it in conjunction with a new timing chain or one that does not exhibit signs
 of wear is not permitted.
