Technical Repair Guide

ADHESION LOSS

Example Model: RiverStone 39RKFB

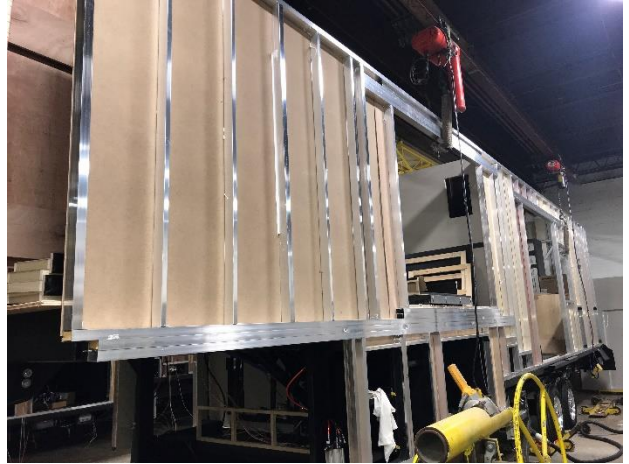
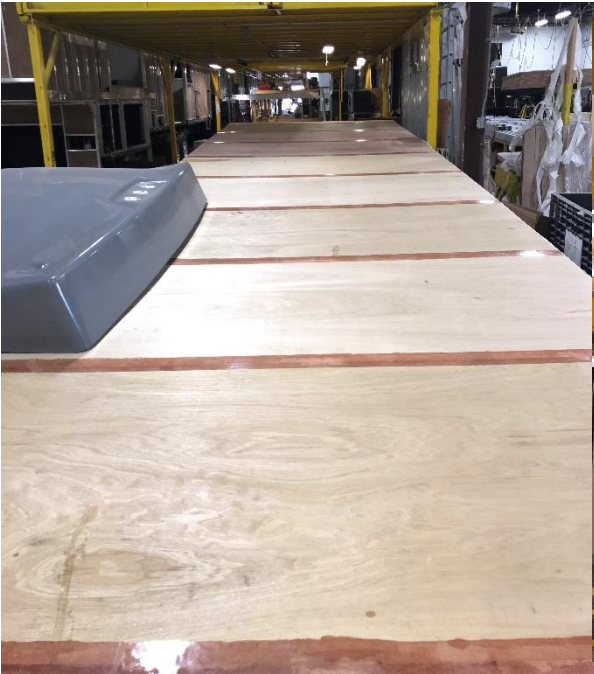
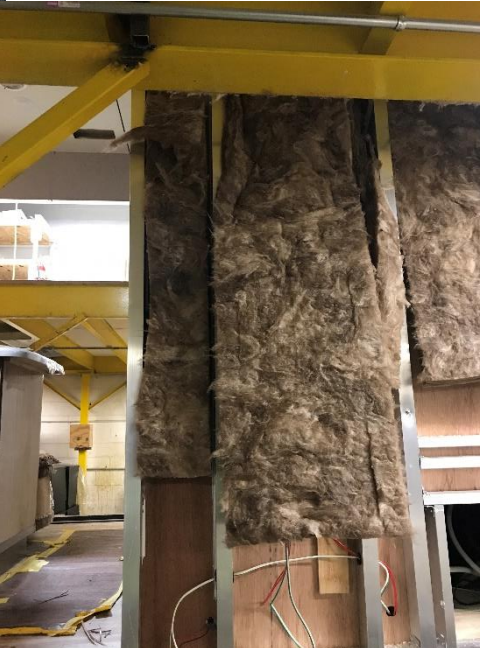
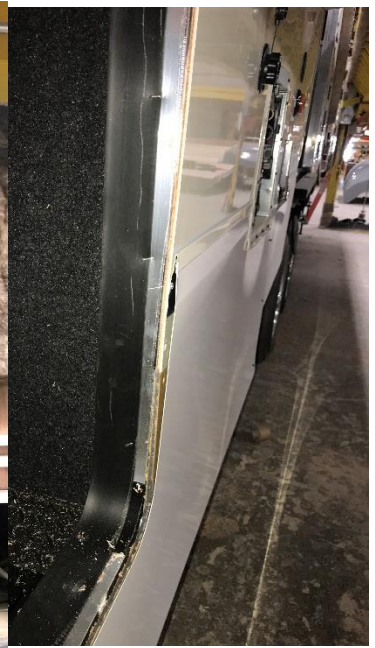
Keep in mind, RiverStone units have a hung wall construction, so none of our walls are laminated. What you are seeing in this bubble is an area where one of two things happened in production. Either the residential wool insulation overlapped the glue between the fiberglass and the aluminum stud, or there was an air bubble in the tube of glue and the amount of glue applied to the stud appeared to be thicker than it actually was.

One advantage to the hung wall constructions vs lamination; they aren't laminated, so delamination is not possible. If you see a bubble in the gel coat, which looks very similar to the bubble, which would indicate a delamination in a laminated wall, it is actually just an area where the sheet of gel coat did not adhere to the aluminum stud. That being said, we can remove the interior wall panel to access the inside of the wall and re-glue it in lieu of being required to replace the wall, as would be required in the case of a laminated wall's delamination.
