TECHNICAL SERVICE BULLETIN

Technical Service Bulletin: 47-0961

R. POD & SURVEYOR SEALANT - REMEDY INSTRUCTIONS

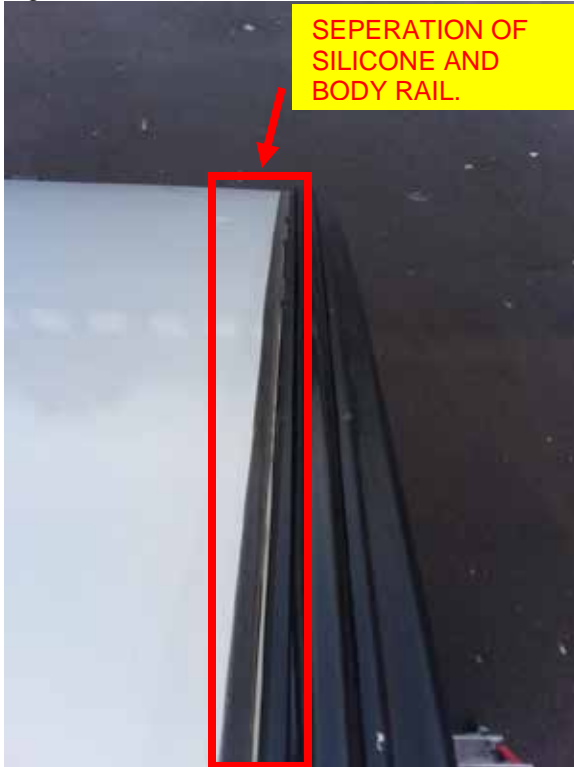
Figure 1

The silicone sealant used to seal the vehicle may not adhere to all surfaces as intended. This may allow water to leak into the vehicle.

STEP 4: Clean off the silicone seal;

STEP 5: Prepare and clean debris and apply Isopropyl Alcohol along the path/area;

STEP 6: Apply new silicone seal along the path/area and allow for proper curing time;
