Clicking Noise From Front Wheel Area During Slow Speed Turns (F Sport 2WD)

Service Category Brake

Section Brake (front)

The information contained in this bulletin supersedes Service Bulletin No. L-SB-0100-16.

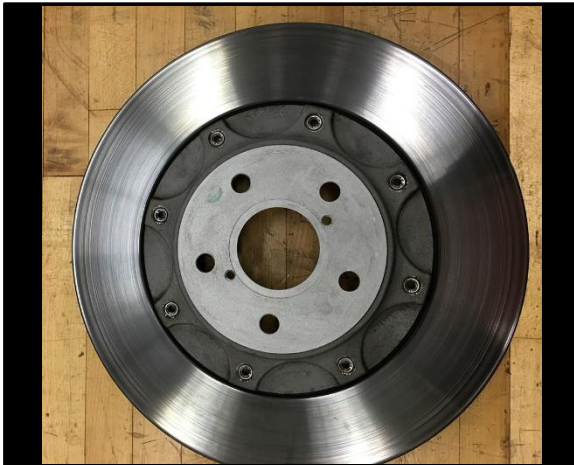
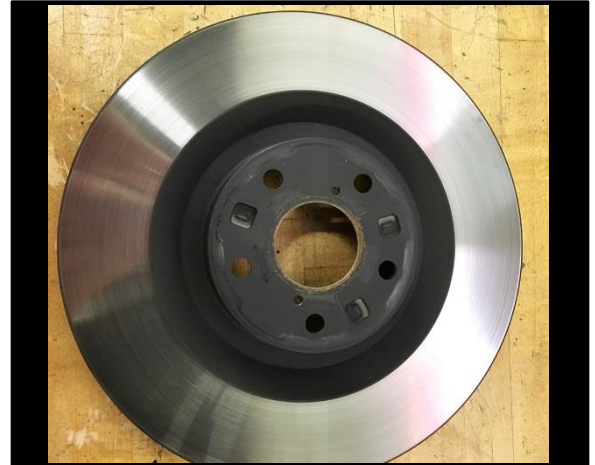
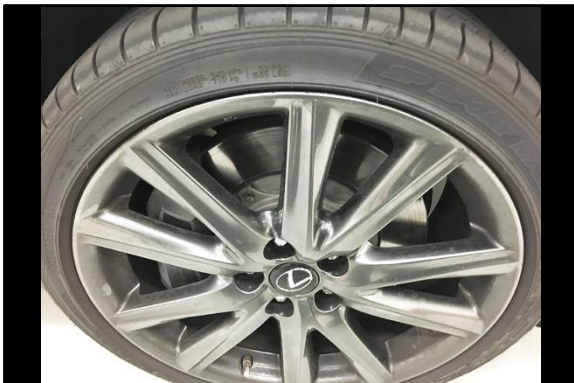
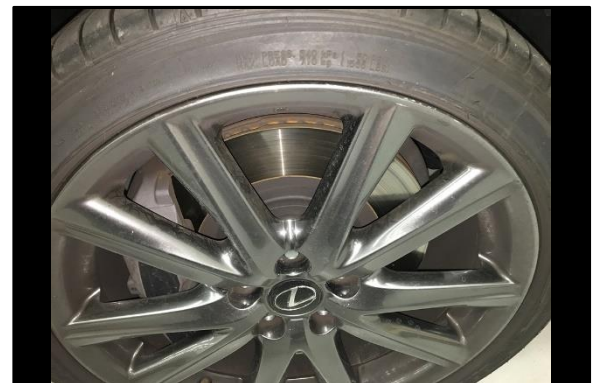
These vehicles are originally equipped with a lightweight two-piece aluminum rotor assembly. The clicking noise that can be heard during sharp turns is a normal condition. For customers who find this objectionable, an alternative steel rotor is available. Before performing this repair, it is recommended to review the visual differences of the steel rotor with the customer.

Figure 1. Before (Aluminum)

Figure 2. After (Steel)

Figure 3. Before* (Aluminum)

Figure 4. After* (Steel)

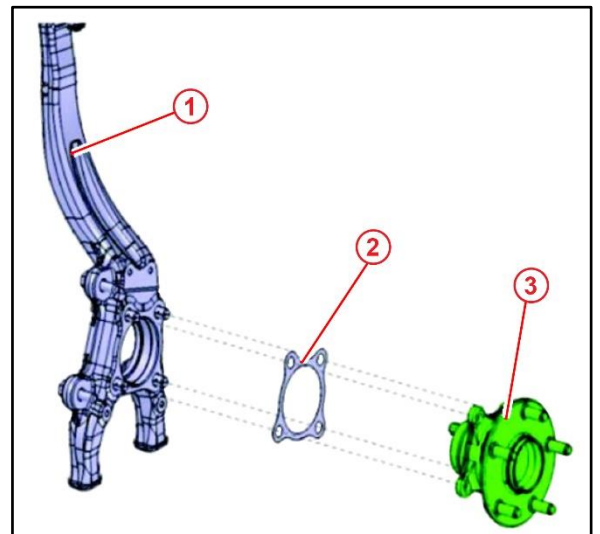
Figure 5.

1	Knuckle
2	Shim
3	Hub Bearing

B. Install the painted brake shim between the hub bearing and knuckle as shown.

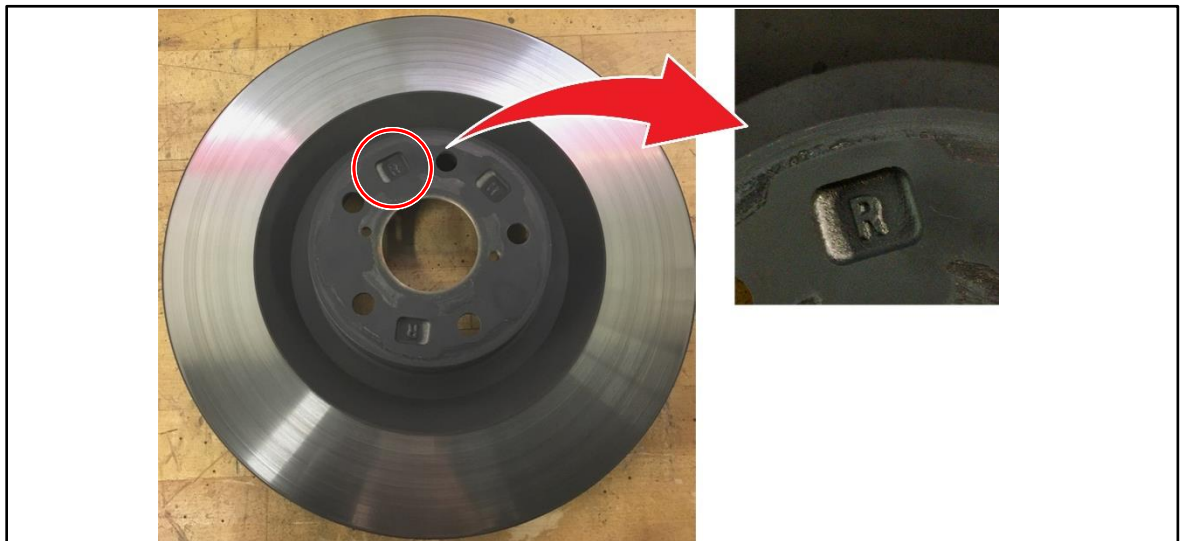
Figure 6.

NEW steel one-piece rotors do NOT have paint marks as shown in the Repair Manual. They are marked with an “L” or an “R” to show which location to install.

C. Reinstall the hub bearing, NEW rotors, and NEW brake pads.
