Paint Stains Under Rappard

Service Category Vehicle Exterior

Section Paint/Coatings

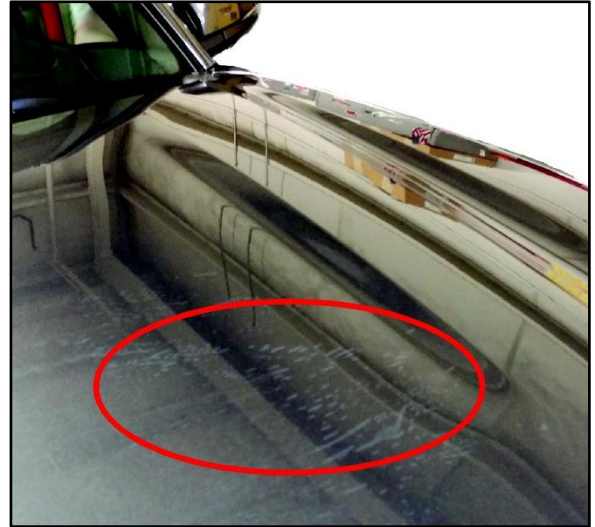
Figure 1.

Some 2010 – 2019 model year Toyota vehicles may exhibit paint stains after the removal of Rappgard™. The paint stains may appear to be under the clear coat but are usually under wrinkles in the Rappgard™. The wrinkles may trap water and cause the paint to stain from the trapped moisture, especially on horizontal surfaces, such as the hood, roof, and trunk. Follow the Repair Procedure in this bulletin to address this condition.

1. Confirm the condition exists.
 AFTER Rappgard™ removal, does the vehicle exhibit paint stains as shown?
 - **YES** — Continue to step 2.
 - **NO** — This bulletin does NOT apply. Continue diagnosis using the applicable Repair Manual.

It is NOT necessary to repaint the stained area.

2. Using aluminum foil or a damp cloth, cover ANY plastic and/or rubber parts located near the stain.
3. With an infrared lamp or heat gun, apply heat to the stain for 5 – 10 minutes at 158°F – 176°F (70°C – 80°C).

Do NOT allow the surface to become hotter than 176°F (80°C). Measure the temperature with a thermometer.

4. Wait AT LEAST 5 minutes AFTER heat application, then examine the area and determine if the stain has been removed.
