ADDRESSEES	: Owners and operators ABC Customer Care and Parts Source
VEHICLE MODEL	: CX45 and TX45 with DD13 EPA16 engine
MANUAL SECTION	: 14.10 Electricity – wiring
BULLETIN TYPE	: Field Change Program
DATE	: February 18th, 2019
SUBJECT	: To change and reroute alternator ground cables
TERMS & CONDITIONS	: Refer to the warranty section further in this Bulletin.

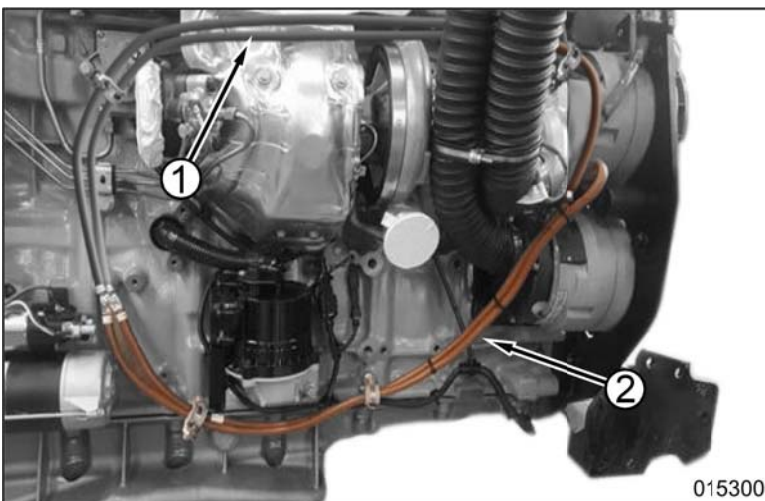
Figure 1: Routing of alternator ground cables

It has been reported that the ground cables of both Prestolite AC172 alternators are too close to the exhaust pipe and turbocharger (refer to 1-Figure 1). The ground cables insulation might suffer damage due to excessive heat.

- 1. Previous routing (= not OK)
- 2. New routing (=OK)

This Service Bulletin gives step-by-step instructions to change the alternator ground cables and reroute them under the crankcase breather unit (refer to routing 2-Figure 1).
