QUARANTINE NOTICE

Reference number:	QN-03-1159	Issued: 26 February, 2019
Subject:	Bonnet-Vent Water Shields	
Model(s):	DB11 V12	
VIN Range:	Refer to the separately published list of affected Vehicle Identification Numbers (VINs)	
Applicable to:	All Dealers	
Distribute to:	After Sales Manager Executive Manager Service Manager Sales Manager	Warranty Staff Technician(s) Parts Staff

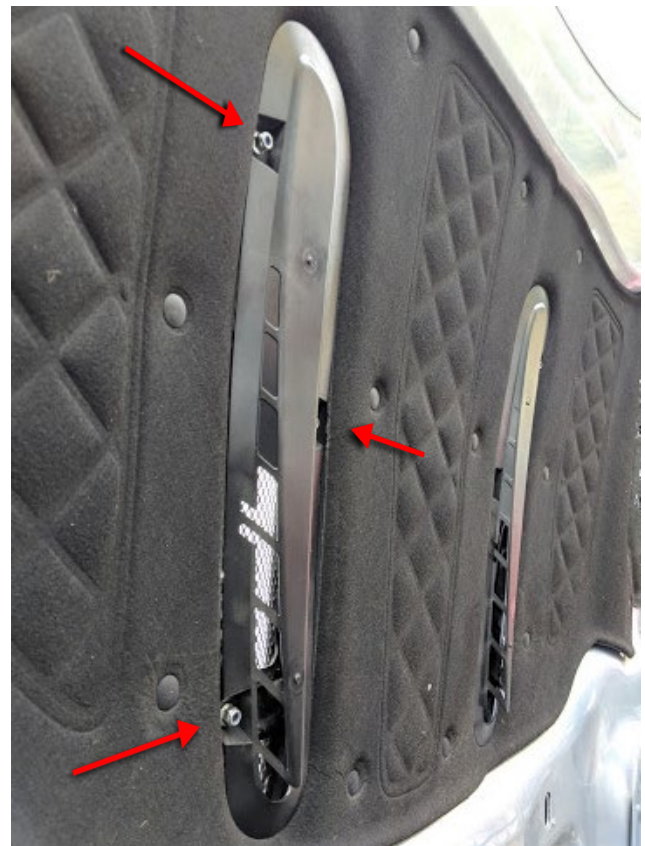
Figure 1

There can be a problem when DB11 V12 is parked in rain. Water can go into the bonnet vents and collect on the coil pack seal. The water can then go into the breather pipe for the spark plug cavity as the engine temperature decreases. When water touches the HT leads it can cause a misfire.

2. Attach the left side water shield to the bonnet with three nuts (refer to Figure 1).
