## SERVICE ACTION

| Reference number: | SA-03-1159 | Issued: 26 February, 2019 |
| Subject: | Bonnet-Vent Water Shields | |
| Model(s): | DB11 V12 | |

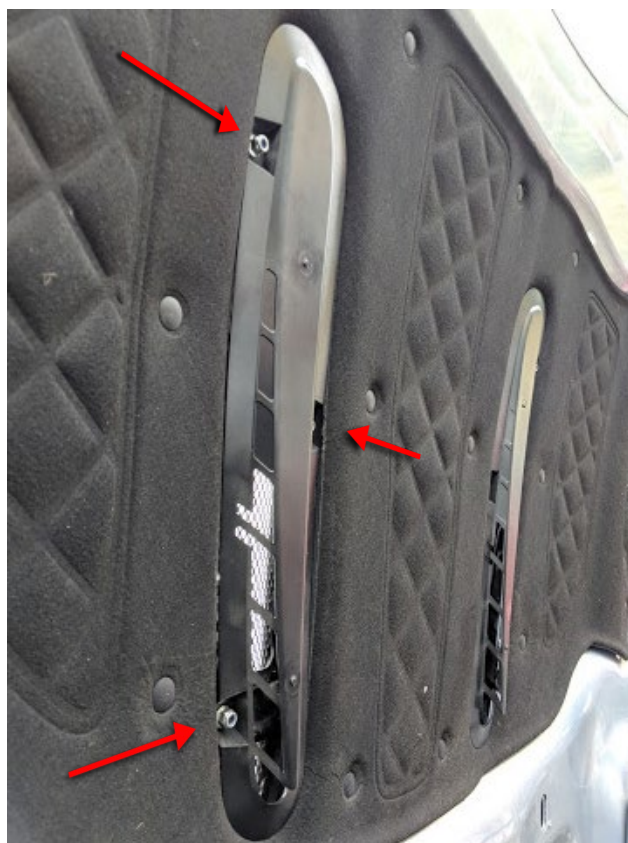
Figure 1

There can be a problem when DB11 V12 is parked in rain. Water can go into the bonnet vents and collect on the coil pack seal. The water can then go into the breather pipe for the spark plug cavity as the engine temperature decreases. When water touches the HT leads it can cause a misfire.

1. Open the bonnet.
2. Attach the left side water shield to the bonnet with three nuts (refer to Figure 1).
