Service Bulletin

Bulletin No.: 18-NA-217

Subject: Cruise Control Inoperative, Malfunction Indicator Lamp (MIL) Illuminated - DTCs P0097, P00F4, P0102 and/or P2199 Set

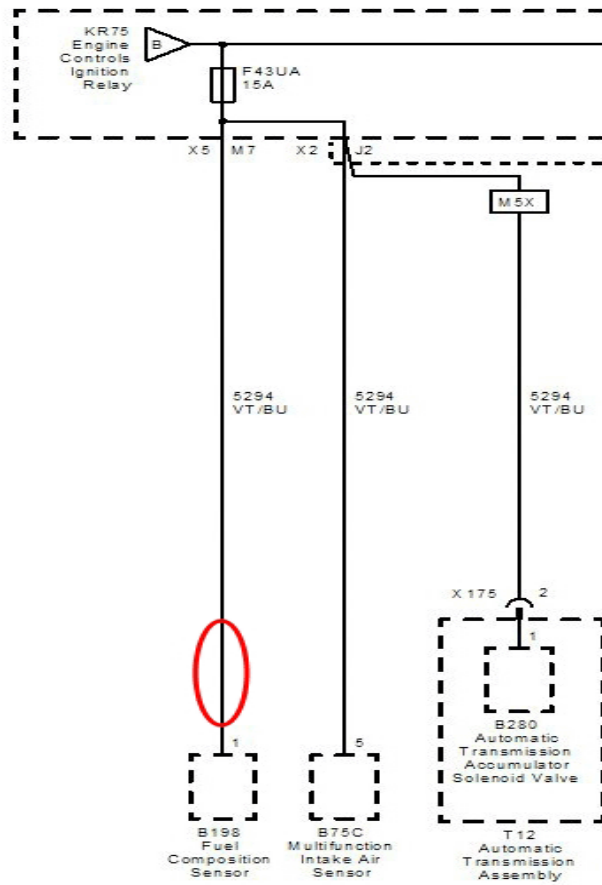
5118293

This condition may be caused by a short in circuit 5294 near the fuel composition sensor electrical connector.

⇒ Refer to Document ID: 4694347 in SI.
