# Service Bulletin

Bulletin No.: 18-NA-376

Date: February, 2019

**Subject: Radio Software Version V509 Over-the-Air Update**

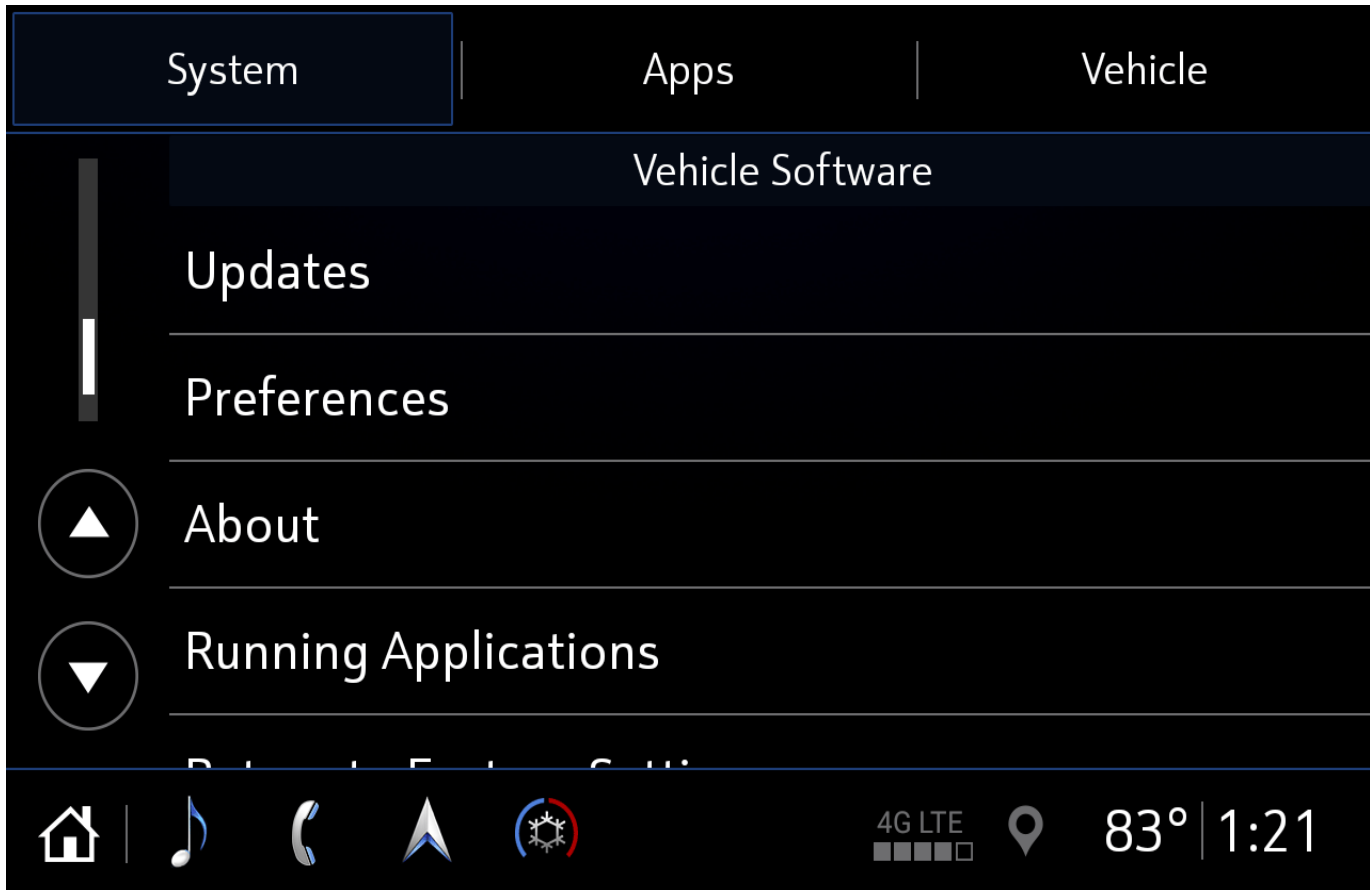
5191512

The process used for this update is dependent on the status of the software on the module and if the module already has a remote install package downloaded. To verify if an update package is already on the vehicle, open “Settings” and then scroll to “Updates” on the radio screen. If an update is shown under the “Updates” screen, proceed to the Update Procedure Using Remote Vehicle Update section of this document.

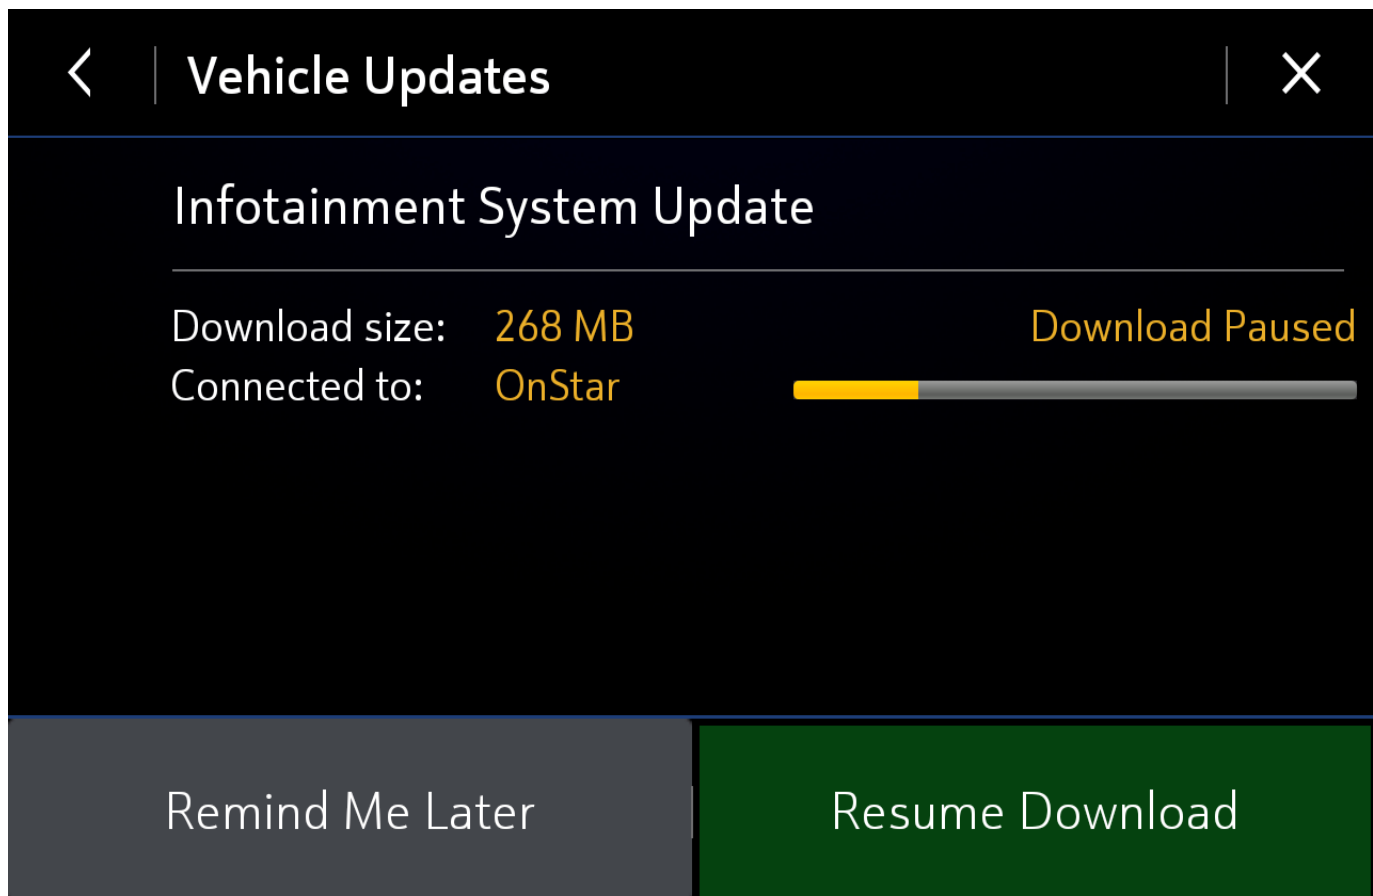
5191499

If no update is shown (see “No Updates Available” image in next section), go to the “About” screen and verify the build number (i.e., L205, L206, V505.3, etc). If the build number is less than V509, proceed with the software update following the **Update Procedure Using TIS2WEB (USB Download)** section of this document.

**Caution:** If Vehicle Update screen shows “Infotainment System Update” (such as the screen above) do not use TIS2WEB or insert a USB stick. Use of the USB stick when the Remote Update has already been downloaded, installed, or paused during installation could result in program failures or module lockup condition. The update should be completed using the Remote Vehicle Update procedure, following prompts on the infotainment screen. Refer to Update Procedure Using Remote Vehicle Update after reading the remaining information in this section if the Remote Update has already been downloaded to the radio.

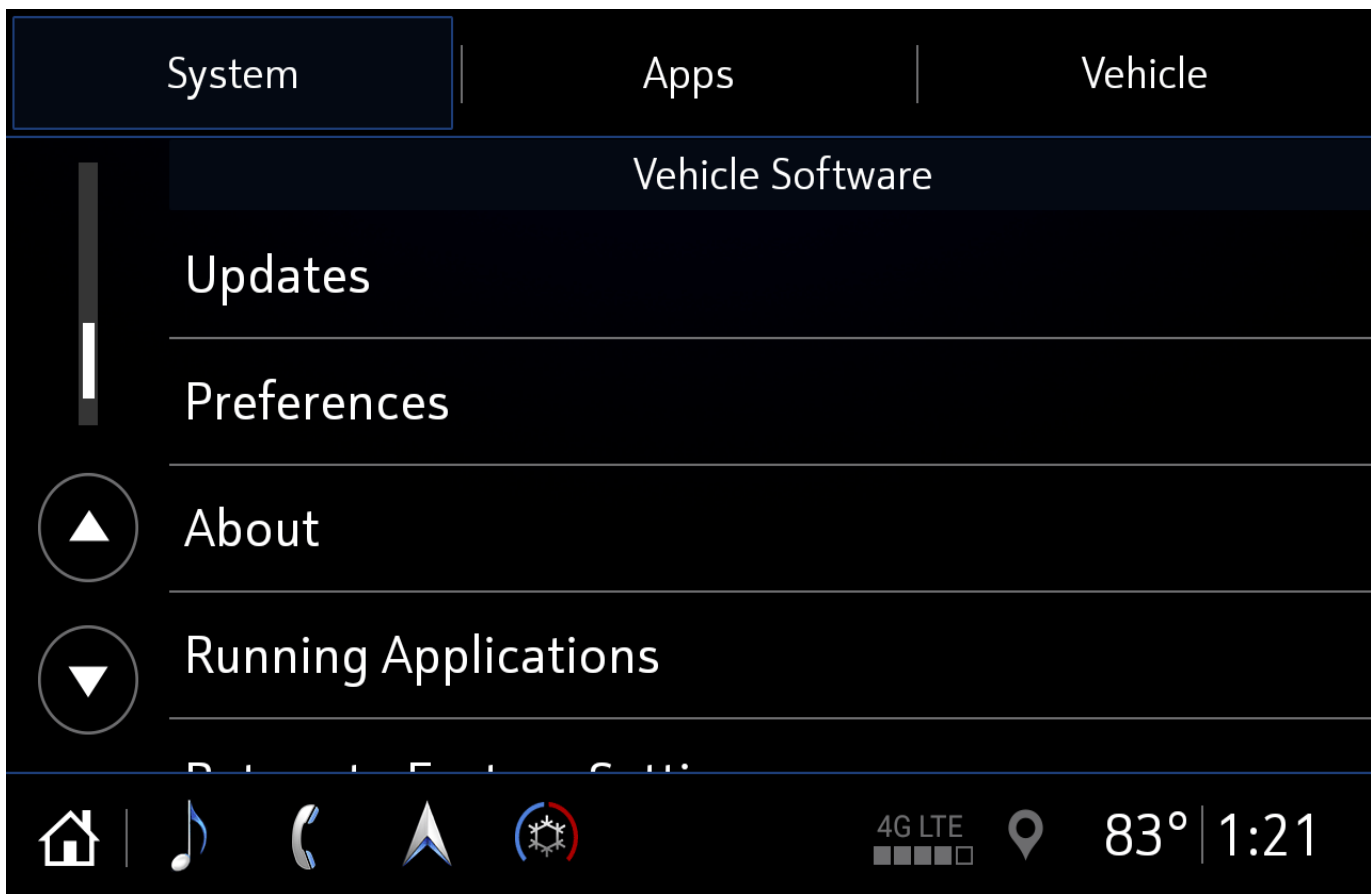
1. Start SPS, select Radio – USB File Transfer and follow the on-screen instructions.
2. Record the SPS Warranty Claim Code on the job card for warranty transaction submission.

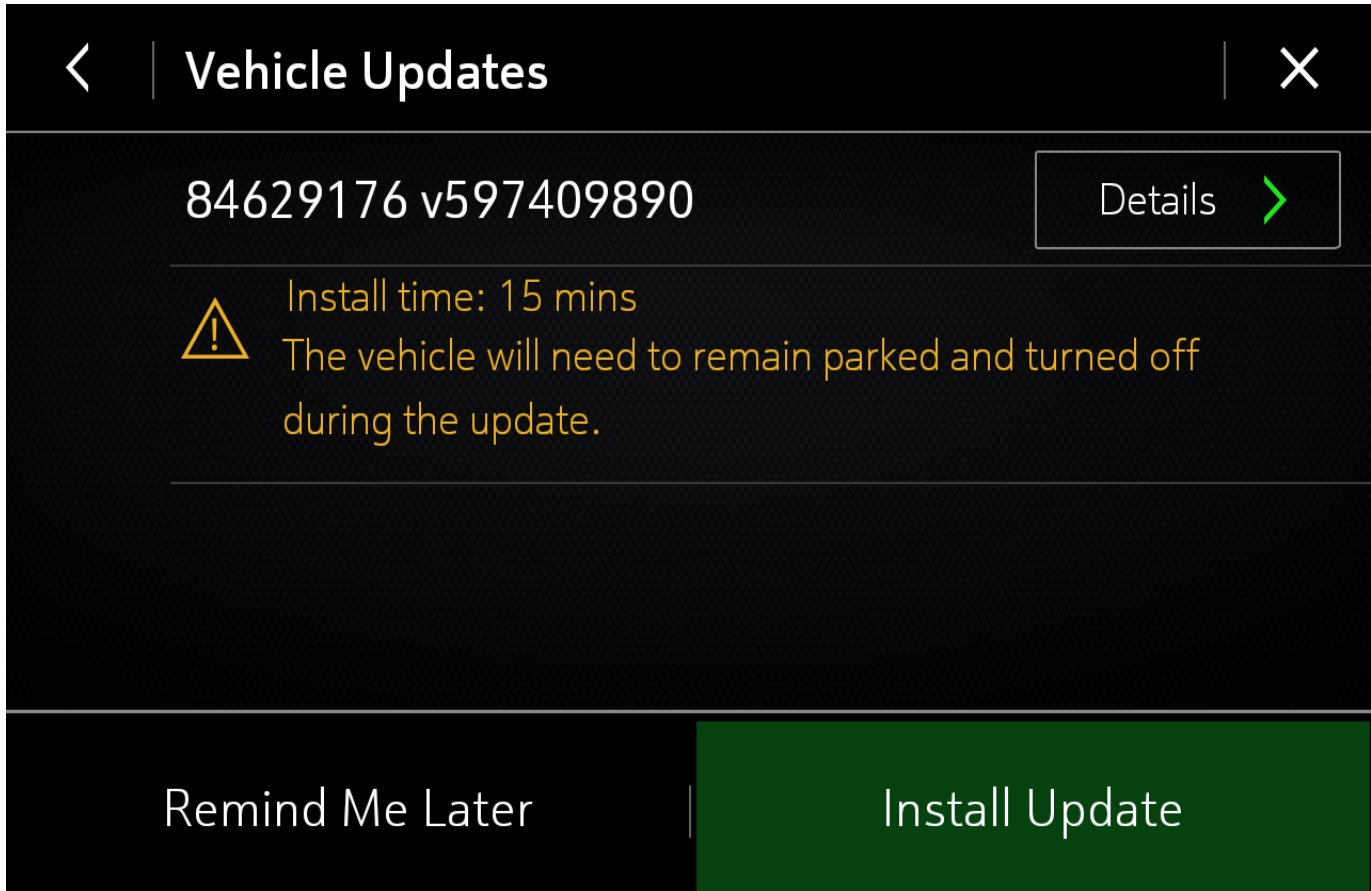
5191507

3. Insert the USB into the vehicle while in Park. On the radio screen, select "Settings, "Updates" or select "Learn More" on pop up after USB insertion.
4. Confirm the part number with image below.
5. Follow on screen prompts to complete the update.

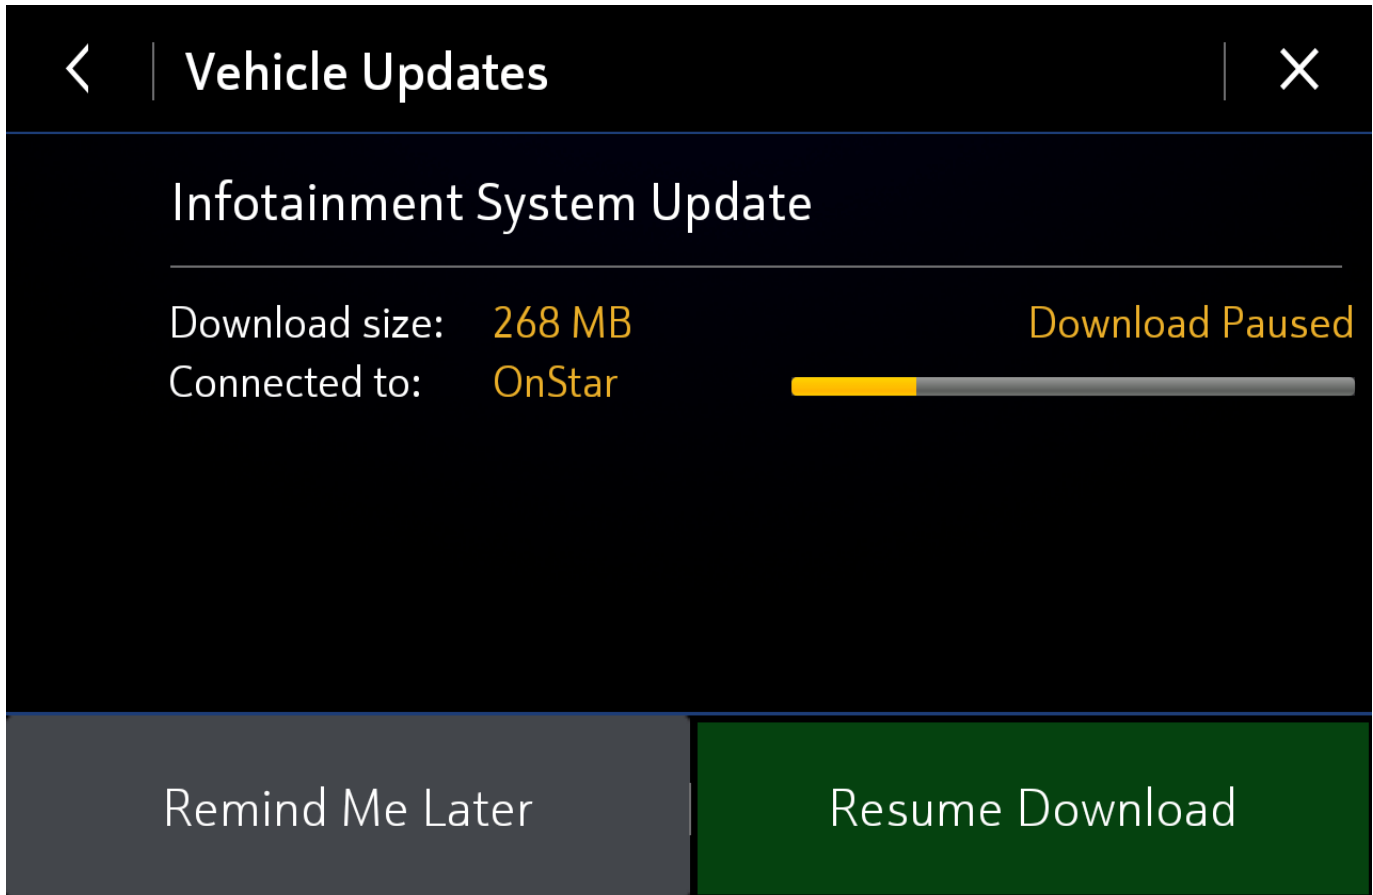
5191499

## Scenario 2: Consistently Paused Download

If the above screen is shown and resuming the download repeatedly fails, a USB update will need to be performed. Turn the vehicle on, return to the home screen, and insert USB stick (see previous section). A pop up should be shown to "Install Now." Click "Install Now", verify the part number is correct and follow on screen prompts.

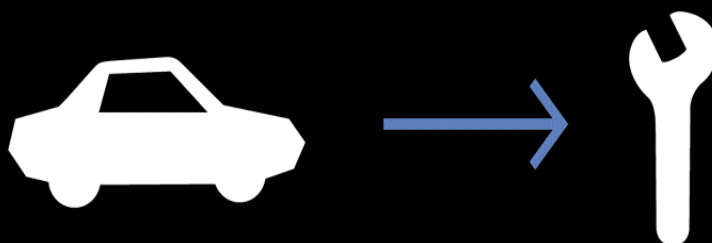
5191519

Scenario 3: Update Failed. Return to dealer screen

Update failed. Return to dealer.

If the above screen is shown, download the update through TIS2Web and insert USB stick into the radio **twice** (USB stick is not recognized on first insertion). A blue progress bar should come on the screen and update will proceed. If this screen above is shown when trying to update the radio through USB, reformat to FAT32 on your PC, and then try to download the update through TIS2WEB again.

If the screen above is shown again, contact the Techline Customer Support Center (TCSC) at 1-800-828-6860 (1-800-503-3222 French) for assistance.
