# Service Bulletin

Bulletin No.: 19-NA-004

**Subject:** Squeak or Creak from Right Rear of Vehicle While Driving

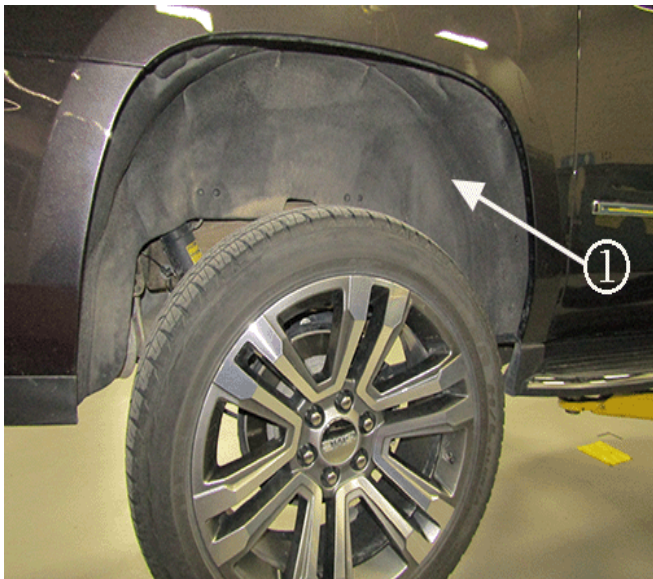
5205840

<b>Involved Region or Country</b>	North America, N.A. Export Regions
<b>Additional Options (RPOs)</b>	
<b>Condition</b>	Customer may comment on hearing a squeak or creak coming from the right rear of vehicle while driving.
<b>Cause</b>	The cause of the condition may be sheet metal interference at a seam in the inner quarter wheel house, cause during the manufacturing process.
<b>Correction</b>	After verifying the customer's condition, gain access to the right quarter panel inner sheet metal and eliminate the interference, following the steps in the Service Procedure below.

1. Remove the right rear wheelhouse liner (1). Refer to the appropriate *Rear Wheelhouse Liner Replacement* procedure, in SI.

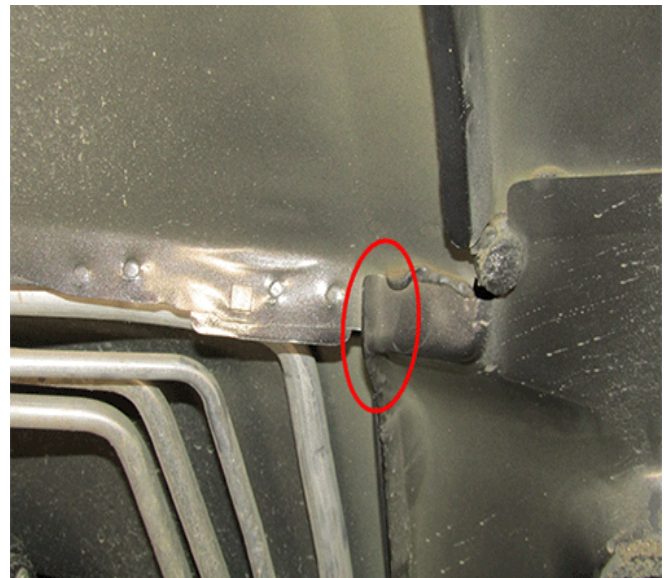
5205844

2. Locate the sheet metal seam/gap shown in the graphic above.
