Service Bulletin

Bulletin No.: 19-NA-008

Subject: Upper Inboard Corner of the Rear Body Structure Stop Lamp Has Sharp Edge

Brand:	Model:	Model Year:		VIN:		Engine:	Transmission:
		from	to	from	to		
GMC	Terrain	2018	2019			All	All

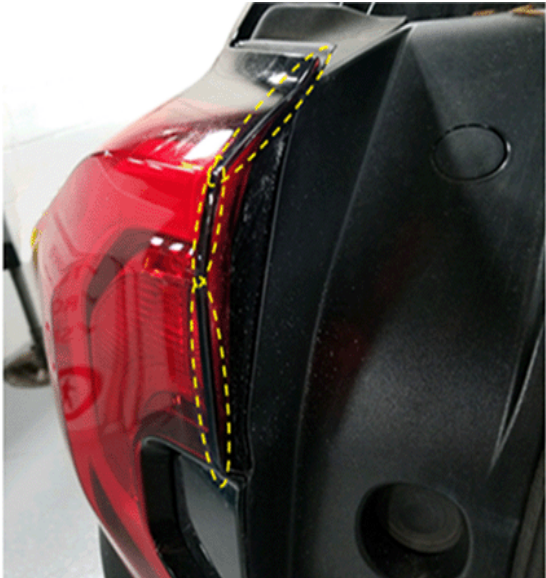
<p style="text-align: right; font-size: small;">5217579</p> <p>Customer may comment on noticing, or feeling, a sharp edge on the upper, inboard corner of one, or both, of the rear body structure stop lamps.</p>
Cause	The cause of the condition may be excess flashing created during the rear body structure stop lamp production process.

<p>Correction</p>	<p>Important: DO NOT replace the lamp for this sharp edge condition. Raise the rear liftgate and inspect both stop lamps for excess material (flash) at the parting line on the existing lamp, at the location shown above.</p> <div style="text-align: right; margin-bottom: 10px;">5217582</div>
