Service Bulletin

Bulletin No.: 16-NA-339

Subject: Vibration Analysis Diagnostic Aids

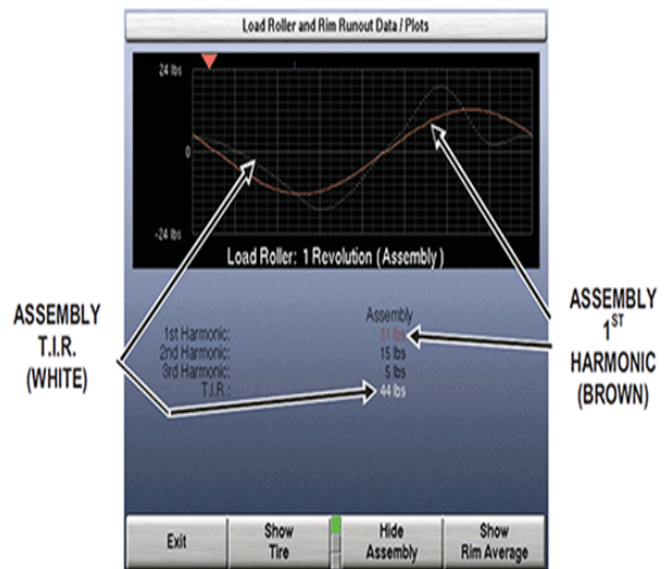
4743978

- Some cases of tire/wheel assemblies have been shown to have acceptable T1 RFV numbers, but with further investigation, have been found to have bent inboard rim flanges with hidden tire damage, visible inside the tire sidewall when dismounted.

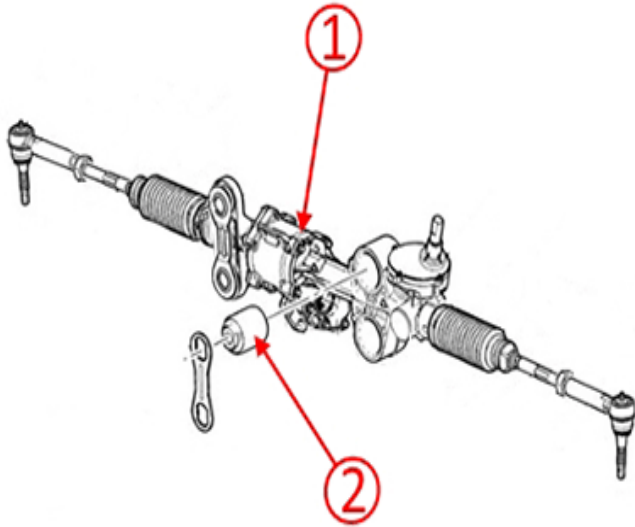
4743660

A revised steering gear/rack (1) mounting bushing (2) has been released to address customer vibration concerns. After various testing and measurement of T1 vibration, a vibration path from the tie rods =>steering rack=>steering bushings=>frame=>body mounts=>cabin floor=>seats has been identified. To help isolate the steering rack, a revised hydraulic mounting bushing has been released and tuned for the T1 frequency. The new steering rack bushing dampens minor T1 vibrations. It has been found that the new bushing also helps dampen minor T2 vibration / disturbance. This is the reason that the causal part (normally the Tire/Wheel Assembly) must be corrected first. If T1 vibration is over 20-25m/g's, the bushings will have little to no effect. Likewise, for T2 vibration / disturbance, the causal part/area must be corrected first to benefit from the bushings.

For vehicles with T1 vibrations under 20-25m/g's, replace steering rack bushings per parts catalogue. Refer to Steering Gear Mount Bushing Replacement in SI.

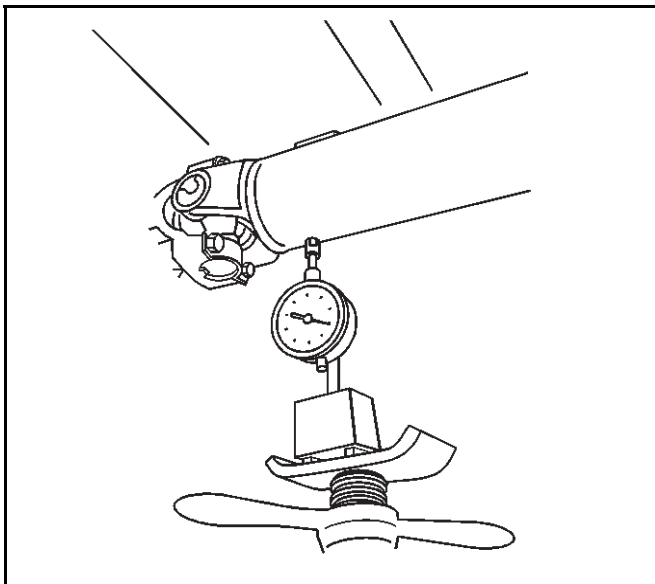
734521

1. Inspect the propeller shaft for dents, damage, and missing weights. There have been many cases of dented propeller shafts. Damaged prop shafts must be replaced.

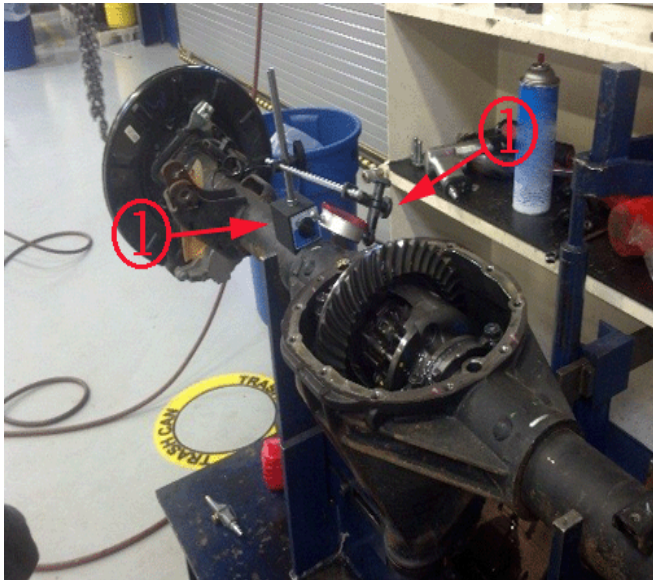
4002895

Pitchline runout / gear set machining, followed by setup issues have been found to be contributors to vibration issues; not just whine noise concerns. Gear set machining issues in these axles seem to most often show up as P1 or higher order P related; with some showing as T1 or higher order of T related; all depending on gear set condition.

1. Perform the Backlash Adjustment procedure, with the following Exception: *Each Tooth* of the ring gear *Must* be measured. The SI procedure mentions 8-points; however to ensure a possible vibration disturbance point is identified, *Each Tooth Must* be measured. Refer to Backlash Adjustment, SI Document ID # 3269088.
2. The above picture is included to help clarify setup of the dial indicator for measurement.
3. Once the backlash and bearing preload is correct, perform a gear tooth contact pattern check in order to ensure proper alignment between the ring and pinion gears. Refer to the Gear Tooth Contact Pattern Inspection in SI, Document ID # 1990157.

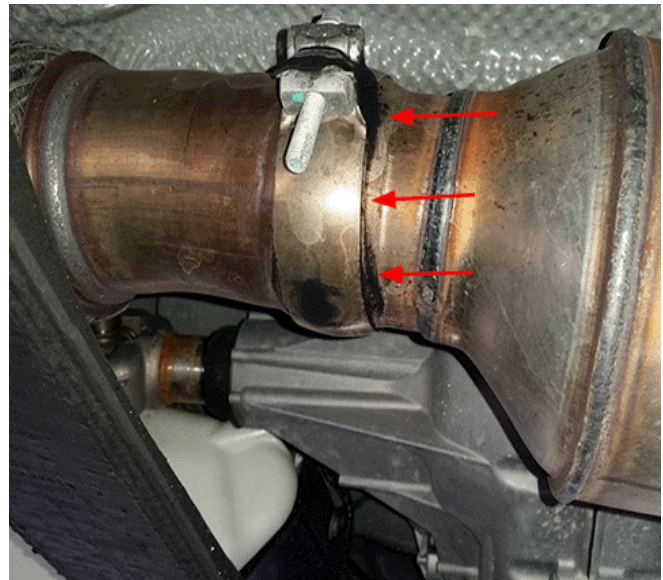
4743980

Note: There have been some cases of excessive V4 drone on 5.3L SUVs with the updated exhaust – a leak at the exhaust Norma clamp joint behind the rear converter may allow E2 V4 drone to manifest. 6.2L engines with a leak at the same exhaust clamp joint may allow excessive drone – more than comparable vehicles. Refer to latest version of PIP5442.

If Pico readings line up as specified, refer to PIT5404 for specific V4 Mode Exhaust Drone diagnostic information.
