Service Bulletin

Bulletin No.: 16-NA-405

Subject: Poor Engine Performance in Extremely Cold Weather Conditions, PCV Bypass Hose and Charge Air Cooler Icing for LUV Engines, Malfunction Indicator Lamp (MIL) Illuminated - DTC P0299, P0236, P2227, P00C7 Set

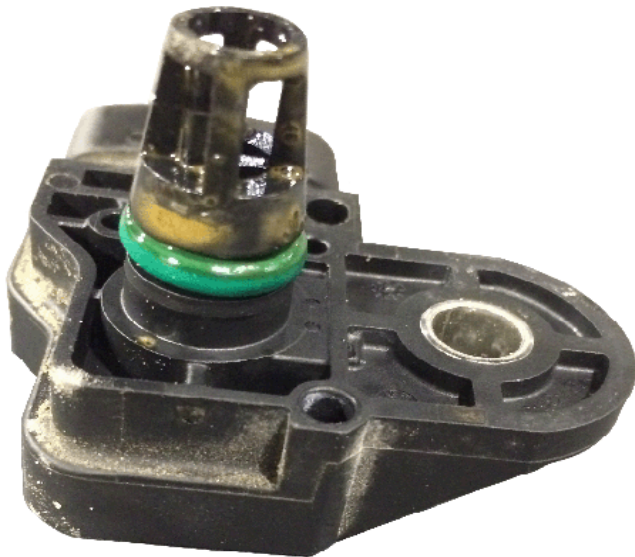
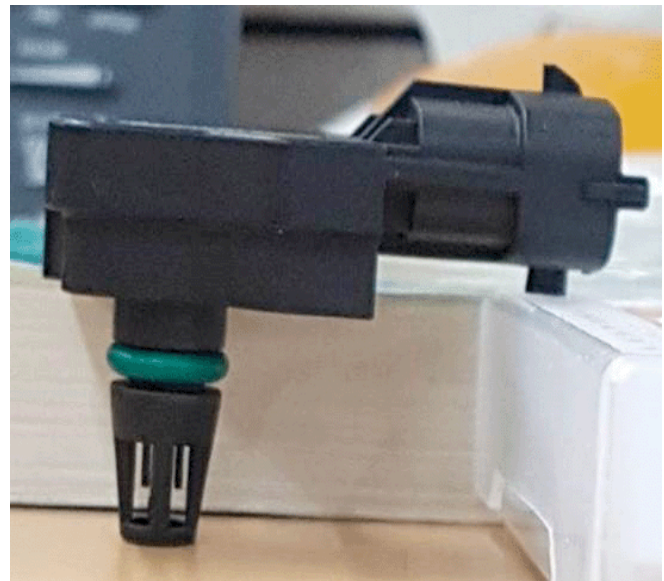
2. Inspect the IAPT sensor for any contaminates.

3. Allow time for any ice build-up to melt by placing the sensor port down.
4. Clean the sensor with a clean towel.
5. Inspect the IAPT sensor for any contaminates.

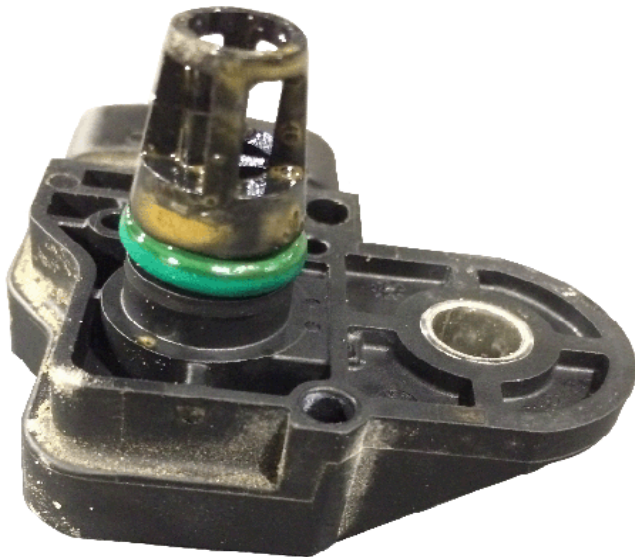
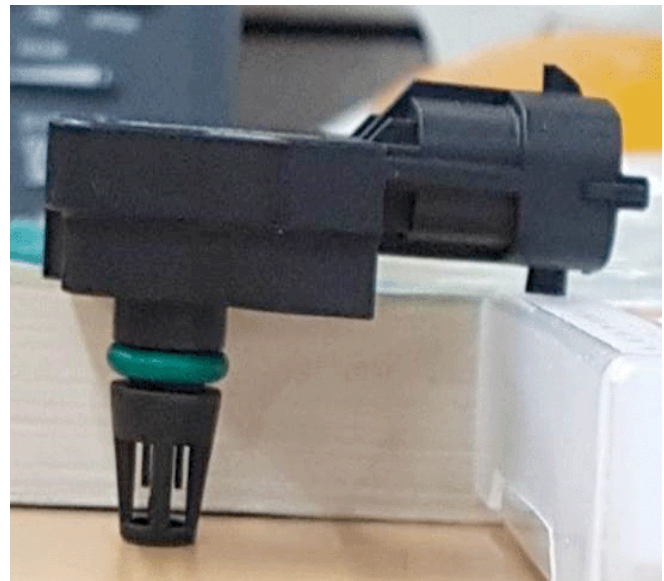
8. Inspect the IAPT sensor for any contaminants.

- 9. Allow time for any ice build-up to melt by placing the sensor port down.
- 10. Clean the sensor with a clean towel.
- 11. Install the IAPT sensor.
