Service Bulletin

Bulletin No.: 17-NA-298

Subject: Headliner Sag

Brand:	Model:	Model Year:		Date Breakpoint:		Engine:	Transmission:
		from	to	from	to		
Chevrolet	Camaro Coupe	2016	2019	2016 SOP	Built Prior to October 8, 2018	All	All

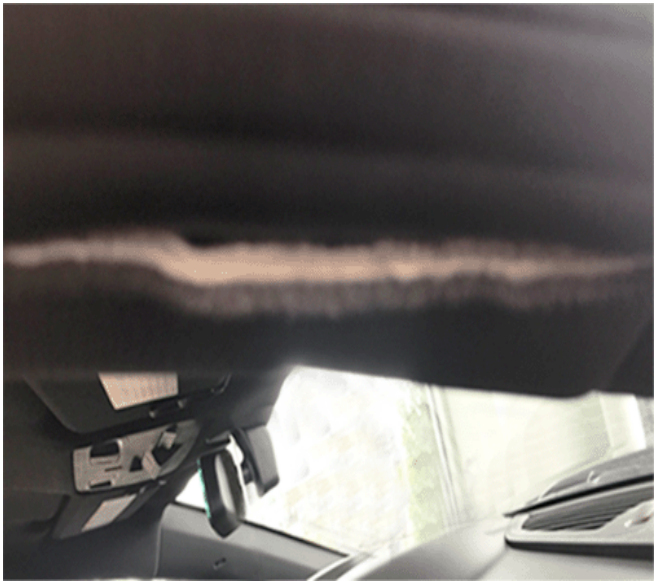
<p>4866356</p> <p>Some customers may comment on seeing the headliner sagging above the passenger door. The graphic above shows a view from outside the passenger door.</p>

The cause of the condition may be mishandling of the headliner during installation.

For vehicles built prior to the breakpoint noted above, if either condition is evident, it will be necessary to replace the headliner AND both the left (1) and right RRABs. Refer to *Front and Rear Row Seat Roof Rail Airbag Replacement* in SI.

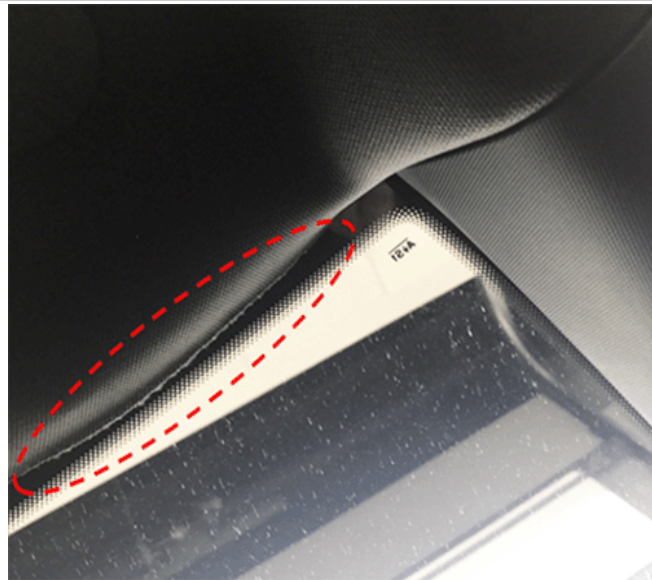
4866358

Some customers may comment on seeing the headliner sagging at the front of the passenger side visor. The graphic above shows a view from inside the vehicle, looking upward at the upper corner of the windshield. Sagging may also be evident at front driver side, rear passenger side or rear driver side due to mishandling.
