# Service Bulletin

Bulletin No.: 17-NA-302

**Subject:** Dust, Snow or Water Around Fuel Filler Area

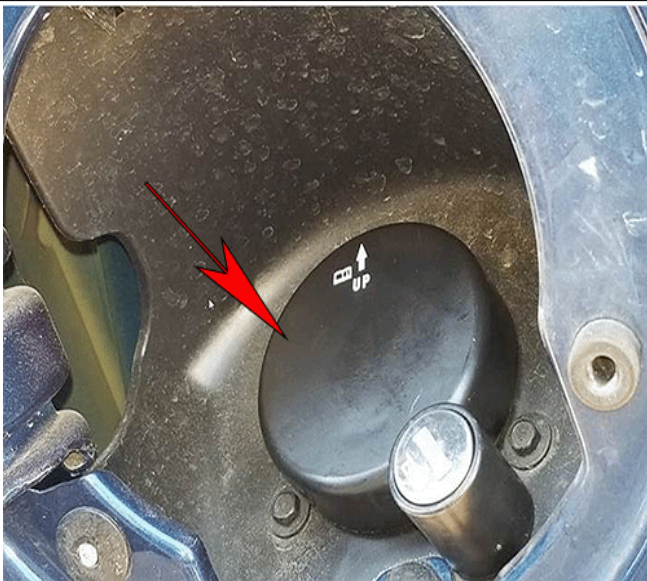
<b>Involved Region or Country</b>	North America and NA Export vehicles
<b>Condition</b>	Some customers may comment on excess amount dirt, snow or water that can build up around the fuel filler neck.
<b>Cause</b>	This condition may be caused when trucks are operated in high amount of dirt, dust or snow which can migrate to the filler cap area.
<b>Correction</b>

<p>4869504</p> <p>Notify the customer that GM has made available a locking gas cap for drivers that operate in these environments. This will help to protect the fill area and the fuel system.</p>
