Service Bulletin

Bulletin No.: PI1354I

Subject: Information on Vibration Analysis and Diagnostic

Models: 2014 Chevrolet Silverado 1500
2015-2018 Chevrolet Silverado 1500
2019 Chevrolet Silverado LD *
2014 GMC Sierra 1500
2015-2018 GMC Sierra 1500
2019 GMC Sierra Limited *
EXCLUDES HD Trucks

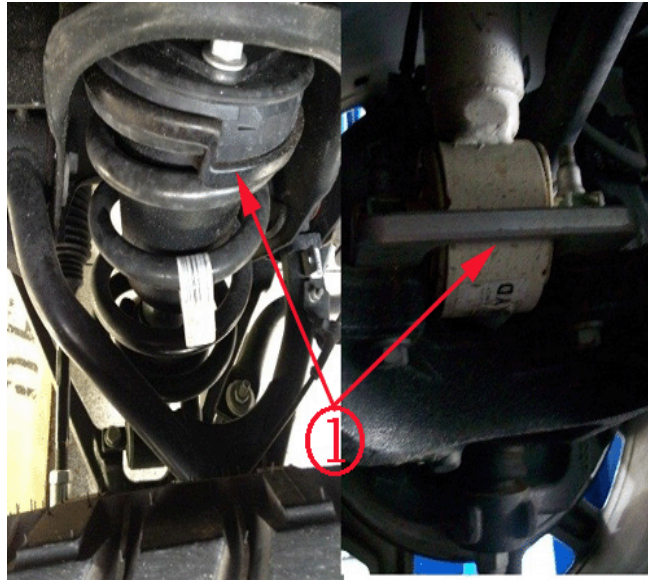
4002193

1. Inspect the truck for any aftermarket equipment installations. For example: non factory tires, wheels and/or lift kits or leveling kits – shims (1) installed as shown above. Aftermarket equipment does include running boards, bug deflectors, and window shades, etc. Remove any aftermarket that might cause vibration transmission paths.
2. Mark each tire valve stems location on the tire. This will be utilized to check for tire slippage on the rim.

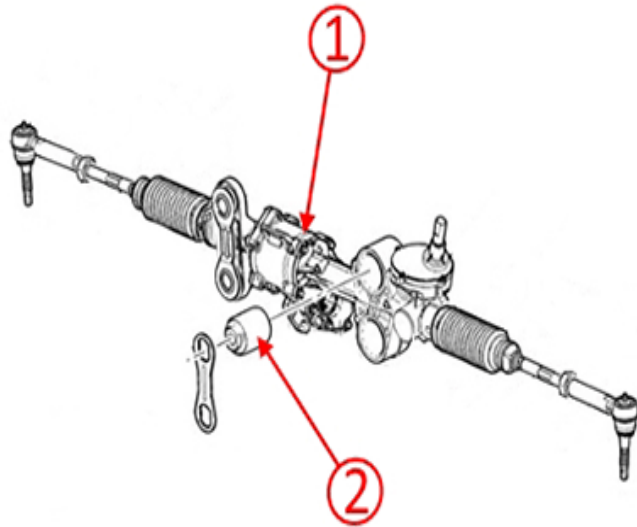
4743660

A revised steering bushing (2) has been released to address customer vibration concerns. After various testing and measurement of the T1 vibration, a vibration path from the tie rods =>steering rack=>steering bushings=>frame=>Body Mount=>Cabin Floor=>Seat has been identified. To help isolate the steering rack (1), a revised hydraulic bushing has been released and tuned to the T1 frequency. The new steering bushing dampens minor T1 vibrations. This is the reason that the causal part (normally the Tire/Wheel Assembly) must be corrected first. If the T1 vibration is over 20-25m/g's, the bushings will have little to no effect.

For vehicles with T1 vibrations under 20-25m/g's, replace steering bushing per parts catalogue. Utilize SI procedure "Steering Gear Mount Bushing Replacement" for replacement of the steering bushings.

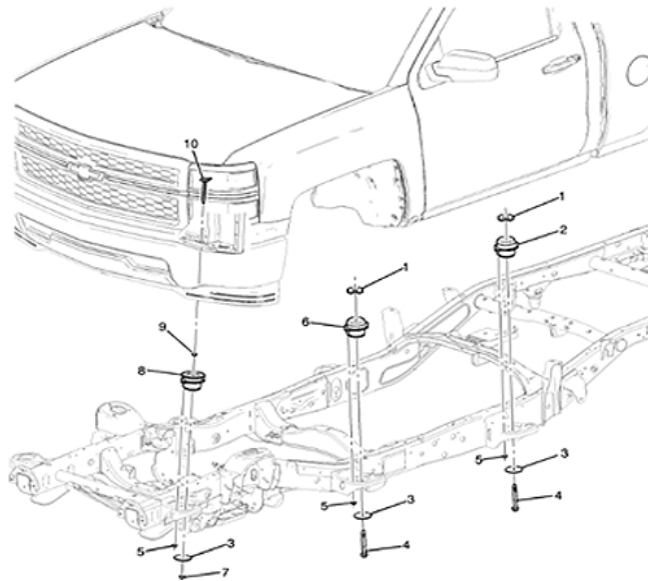
4816998

A revised Rear Cab Mount has been released to address customer vibration concerns. After various testing and measurement of the T1 vibration, a vibration path from the tie rods =>steering rack=>steering bushings=>frame=>Body Mount=>Cabin Floor=>Seat has been identified. To help isolate the cab, a revised Cab Mount has been released and tuned to the T1 frequency. The new cab mount dampens minor T1 vibrations. This is the reason that the causal part (normally the Tire/Wheel Assembly) must be corrected first. If the T1 vibration is over 20-25m/g's, the cab mount will have little to no effect.

Correction: Replace Rear Cab Mount with Revised part number.

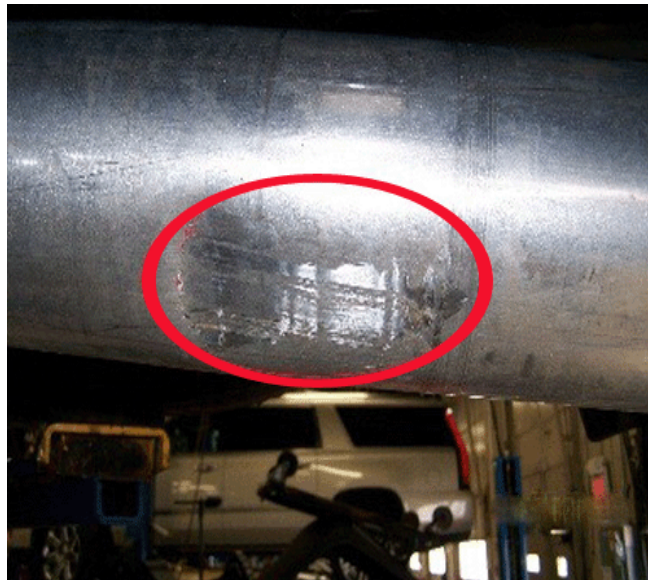
4002784

- Inspect the propeller shaft for dents or damage. There have been many cases of dented propeller shafts.
- For 4WD Trucks, remove the rear propeller shaft, seal output shaft and drive the vehicle in 4WD. If the vibration is gone, the rear prop shaft could be the problem.
- For vehicles with a 3:08 with a one-piece steel shaft, this can be replaced with a one-piece aluminum one that is utilized on all 3:42 and 3:73 ratios (K15543 and K15753 Models only).
- PIP5140: Low Speed Vibration 30-35 mph (48-56 km/h).
- Inspect the transmission output shaft bushing for irregular wear.
