Service Bulletin

Bulletin No.: PIE0505

Subject: Engineering Information – Engine Running Rough and/or Check Engine Light Illuminated, DTCs P0300, P0301, P0302, P0303, P0304 Set

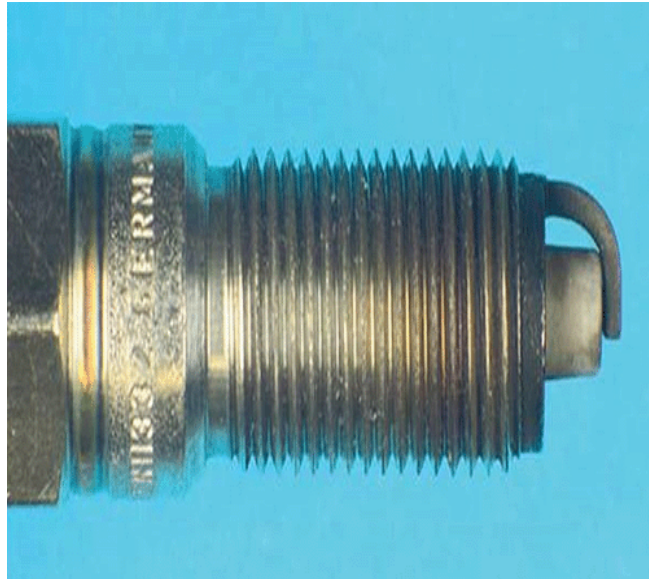
5227620

2. Ceramic at firing end breaks and the loose piece is free to slide up and down (“rattler”) which covers the plug gap and prevents proper sparking (misfire code sets)

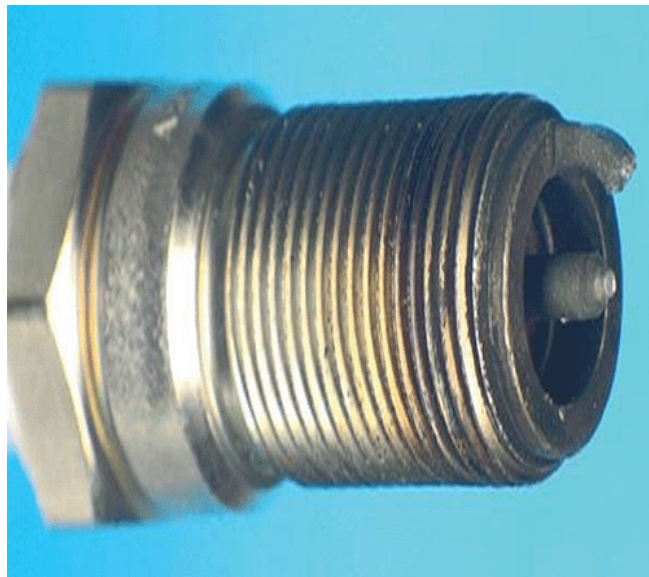
5227626

3. Ceramic at firing end breaks. Combination of misfires and then firing with extra charge from previous misfires causes overheating of combustion gas around the plug and the ground electrode melts and the loose ceramic section slides off
4. If SI directs you to remove the spark plugs, check for a crack on the ceramic at firing end of the plug.
5. If the plug shows signs of cracks on the ceramic, ALL four plugs need to be replaced and returned to the Warranty Parts Center (WPC).
