# Service Bulletin

Bulletin No.: PIE0507

**Subject:** Engineering Information – Rear View Camera Displays Blue Screen with Service Rear Vision System Message, or Surround View Rear Camera Image is Blank

Brand:	Model:	Model Year:		VIN:		Engine:	Transmission:
		from	to	from	to		
Chevrolet	Silverado 1500 (New Model)	2019	2019				
GMC	Sierra 1500 (New Model)

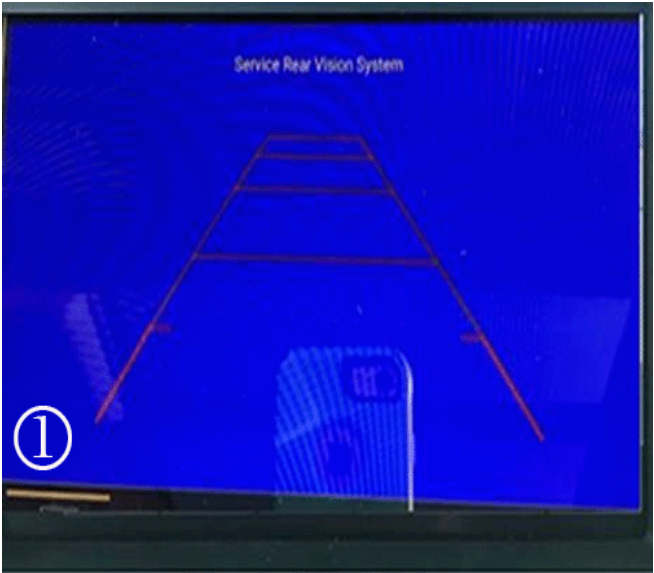
</div> <div data-bbox="1419 785 1484 806">5228133</div> <div data-bbox="683 821 1333 1394">

</div> <div data-bbox="1419 1404 1484 1425">5228134</div> <p>Some customers may report on experiencing a blue screen with “service rear vision system” message on the radio display when shifting into reverse (1) or a black or blank rear camera image when viewing the 270-degree/360-degree Top Down “surround” view (2) as shown in the photos above.</p> <p><b>Note:</b> These conditions may persist over ignition cycles or be intermittent.</p> <p>Technicians may find any of the following DTCs</p> <p><b>A11 Radio</b></p> <ul style="list-style-type: none"> <li>• B395A Symptom 08,72 or 3A</li> </ul> <p><b>K157 Video Processing Module (VPM)</b></p> <ul style="list-style-type: none"> <li>• B395A Symptom 08</li> <li>• B399B Symptom 02, 05</li> <li>• B101D Symptom 3C, 39</li> </ul>
