Service Bulletin

Bulletin No.: PIE0508

Subject: Engineering Information – Burning Smell, Potential Loss of Driveability and/or No Start/Crank

Brand:	Model:	Model Year:		VIN:		Engine:	Transmission:
		from	to	from	to		
Chevrolet	Malibu	2016	2019

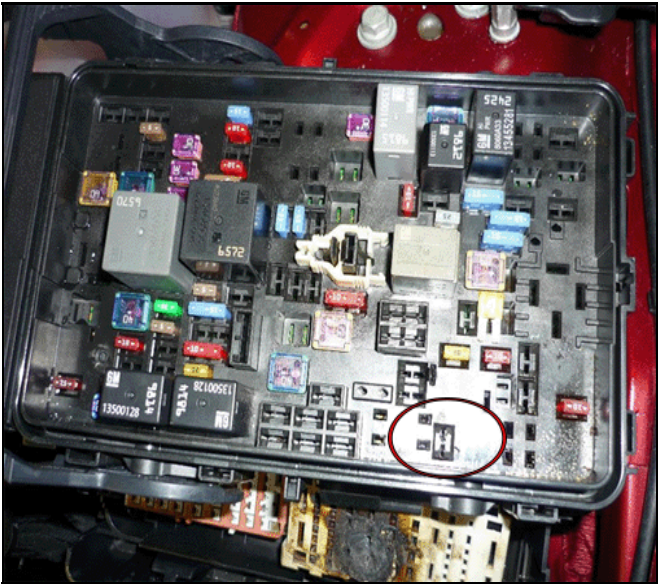
5233353

If you encounter a vehicle with the above concern, visually inspect the wiring harness and X5 connector that is plugged directly into the UBEC for signs of a thermal event, as shown in the photos above, and contact the engineer listed below with your findings.
