Service Bulletin

Bulletin No.: PIE0510

Subject: Engineering Information – Instrument Panel Upper Skin Delaminating Near Passenger Airbag Door

Brand:	Model:	Model Year:		VIN:		Engine:	Transmission:
		from	to	from	to		
Cadillac	XT5	2017	2019

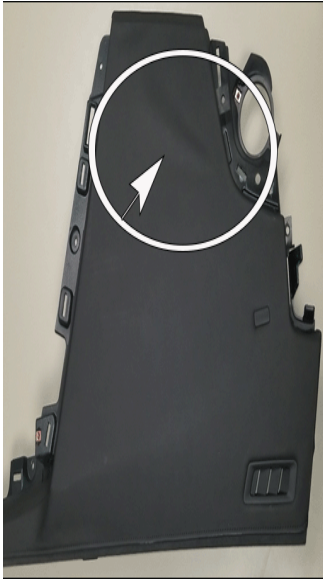
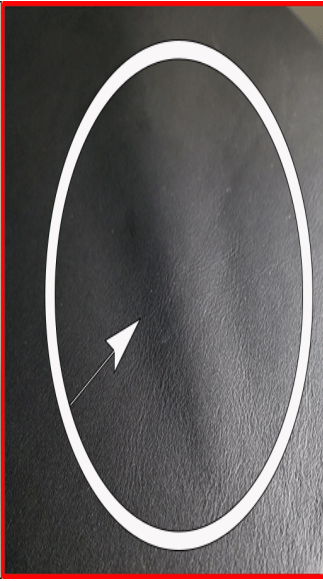
</div> <p style="text-align: right; font-size: small;">5237408</p> <p>Some customers may comment on the instrument panel upper skin is delaminating near the passenger airbag door.</p>
Cause	GM Engineering is attempting to determine the root cause of the above condition. Engineering has a need to gather information on vehicles PRIOR to repair that may exhibit this condition. As a result, this information will be used to "root cause" the customer's concern and develop/validate a field fix.

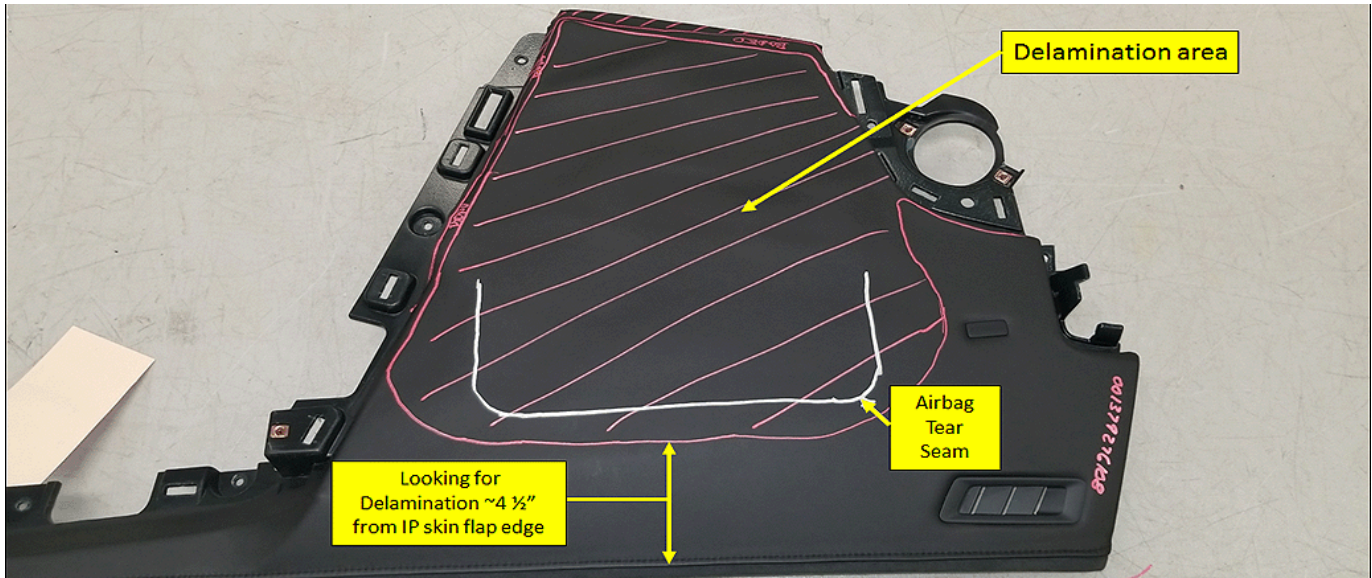
5240437

Important: Measure 7 1/16" to left from front corner of side window defroster grille. Then measure from the IP skin flap edge toward the windshield 4 1/2". Delamination should reach this area, beyond the airbag tear seam, to be considered a part for this investigation. If delamination does not reach this point, replace the IP Upper Trim Panel, there is no need to return it. If it is beyond the tear seam, remove IP Upper Trim Panel and Airbag as an assembly and return it as instructed in the Word document of this EI. Then replace both parts.

2. Analyze the instrument panel for signs of delamination and confirm that it is within the measurements as shown in the photos above.
