EC17-006a

ITB17-017a

MIL ON WITH DTC P0101, P010B, AND/OR P0106

APPLIED VEHICLES: 2016-2018 Q50 (V37)
2017-2018 Q60 (V37)

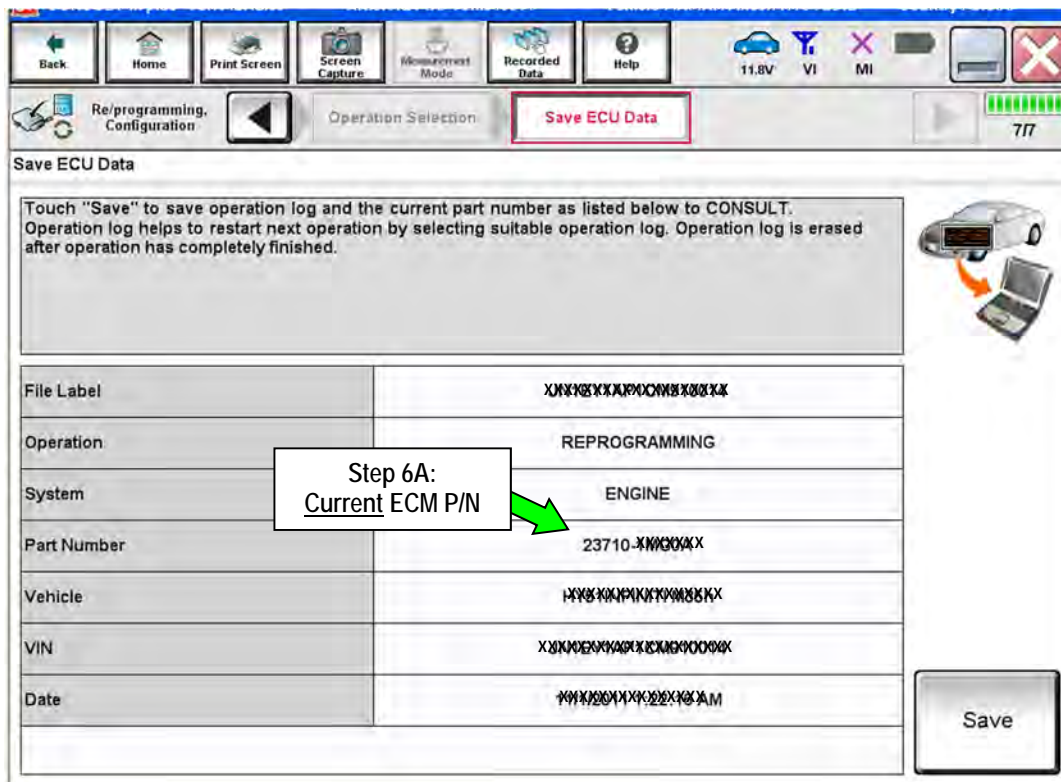
Figure 2

6. When you get to the screen shown in Figure 2, confirm this bulletin applies as follows:
- A. Find the ECM Part Number and write it on the repair order.

- B. Compare the P/N you wrote down to the numbers in the **Current ECM Part Number** column in **Table A** on the next page.
- If there is a match, this bulletin applies. Continue with the reprogramming procedure.
 - If there is not a match, this bulletin does not apply. Close C-III plus and refer to ASIST for further diagnostic information.

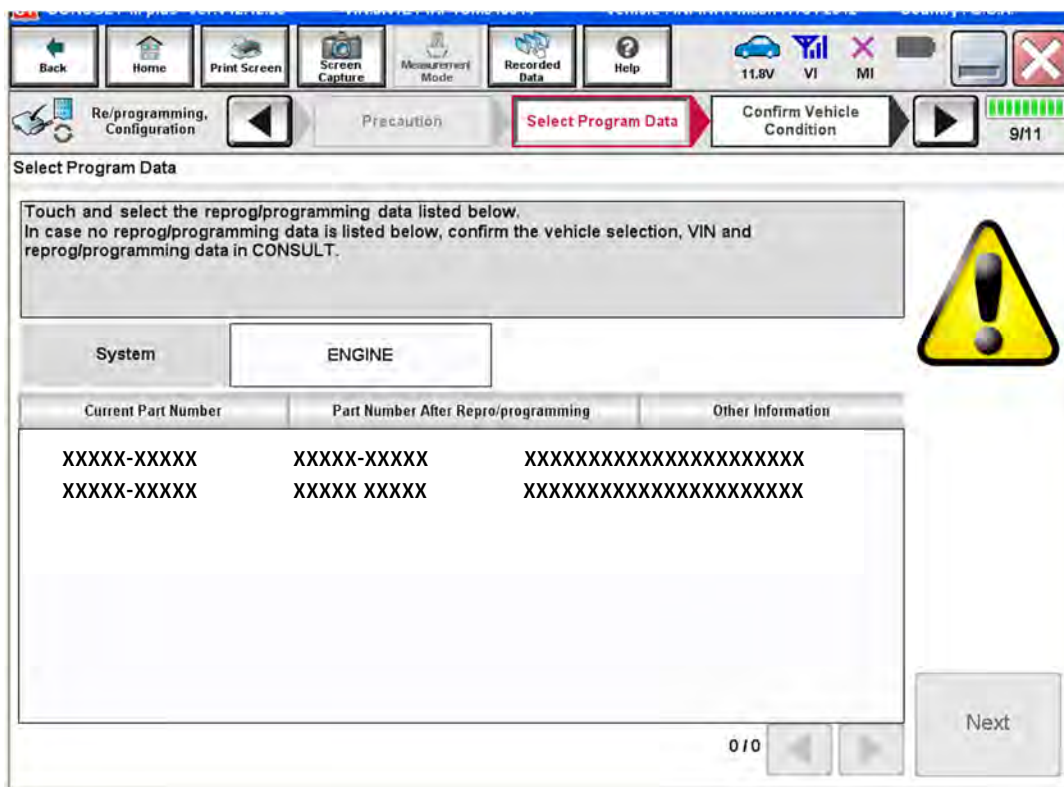
- In some cases, more than one new P/N for reprogramming is available.
 - If more than one new P/N is available, the screen in Figure 3 displays.
 - Select and use the reprogramming option that **does not** have the message “Caution! Use ONLY with ITBXX-XXX”.
- If you get this screen and it is blank (no reprogramming listed), it means there is no reprogramming available for this vehicle. Close C-III plus and refer back to ASIST for further diagnosis.

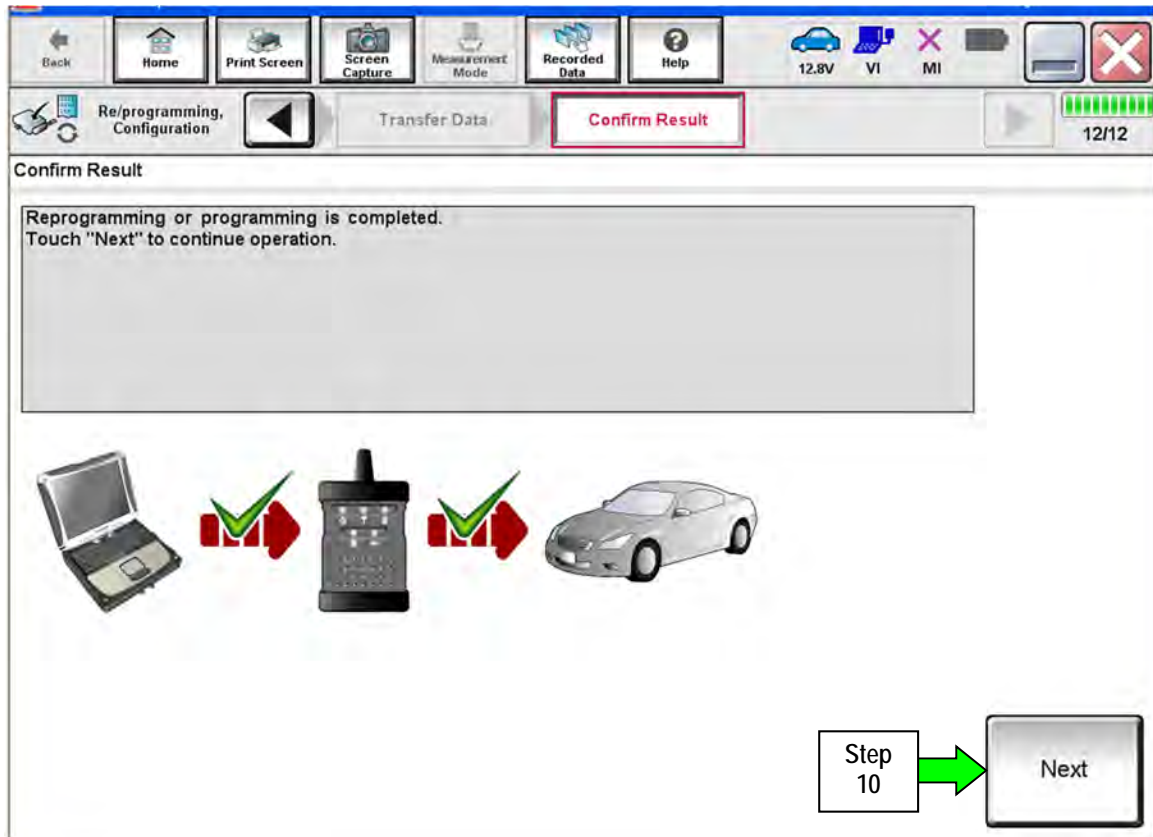
8. When the screen in Figure 4 displays, reprogramming is complete.

NOTE: If the screen in Figure 4 does not display (reprogramming does not complete), refer to ECM recovery on the next page.

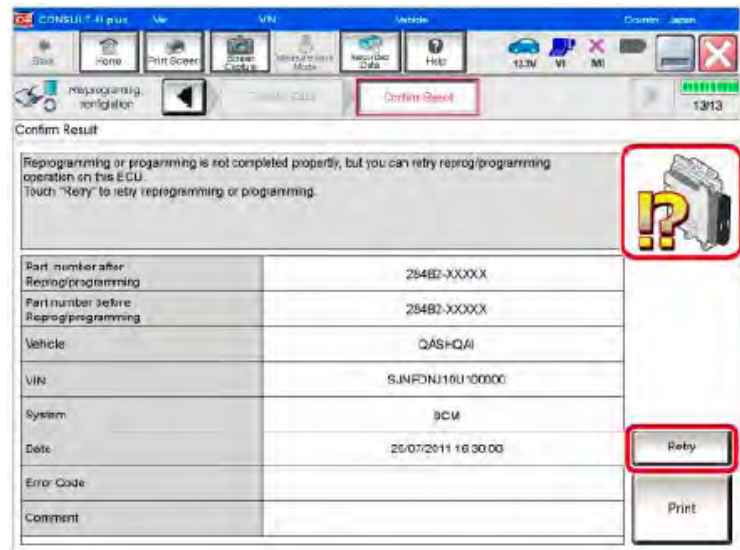
Figure 5

If reprogramming does not complete and the “!?” icon displays as shown in Figure 5:

- Check battery voltage (12.0 - 15.5 V).
- Ignition is ON, engine OFF.
- External Bluetooth® devices are OFF.
- All electrical loads are OFF.
- Select retry and follow the on screen instructions.
- “Retry” may not go through on first attempt and can be selected more than once.

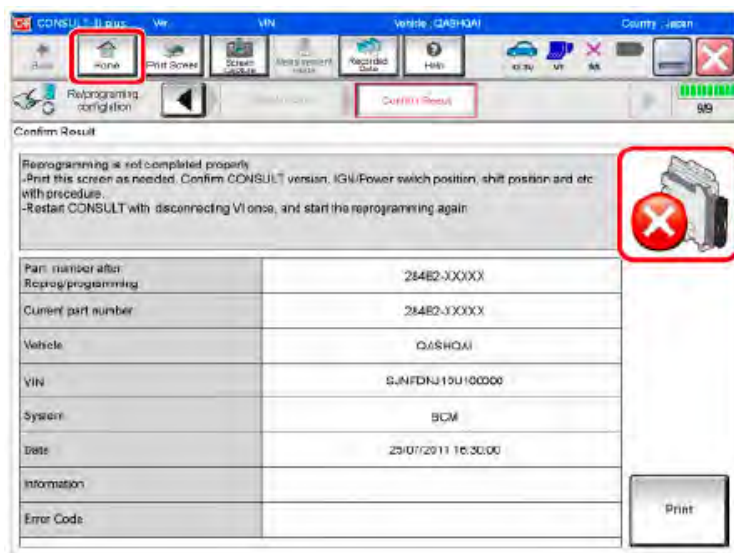
Figure 6

If reprogramming does not complete and the “X” icon displays as shown in Figure 6:

- Check battery voltage (12.0 - 15.5 V).
- CONSULT A/C adapter is plugged in.
- Ignition is ON, engine OFF.
- Transmission is in Park.
- All C-III plus / VI cables are securely connected.
- All C-III plus updates are installed.
- Select Home, and restart the reprogram procedure from the beginning.

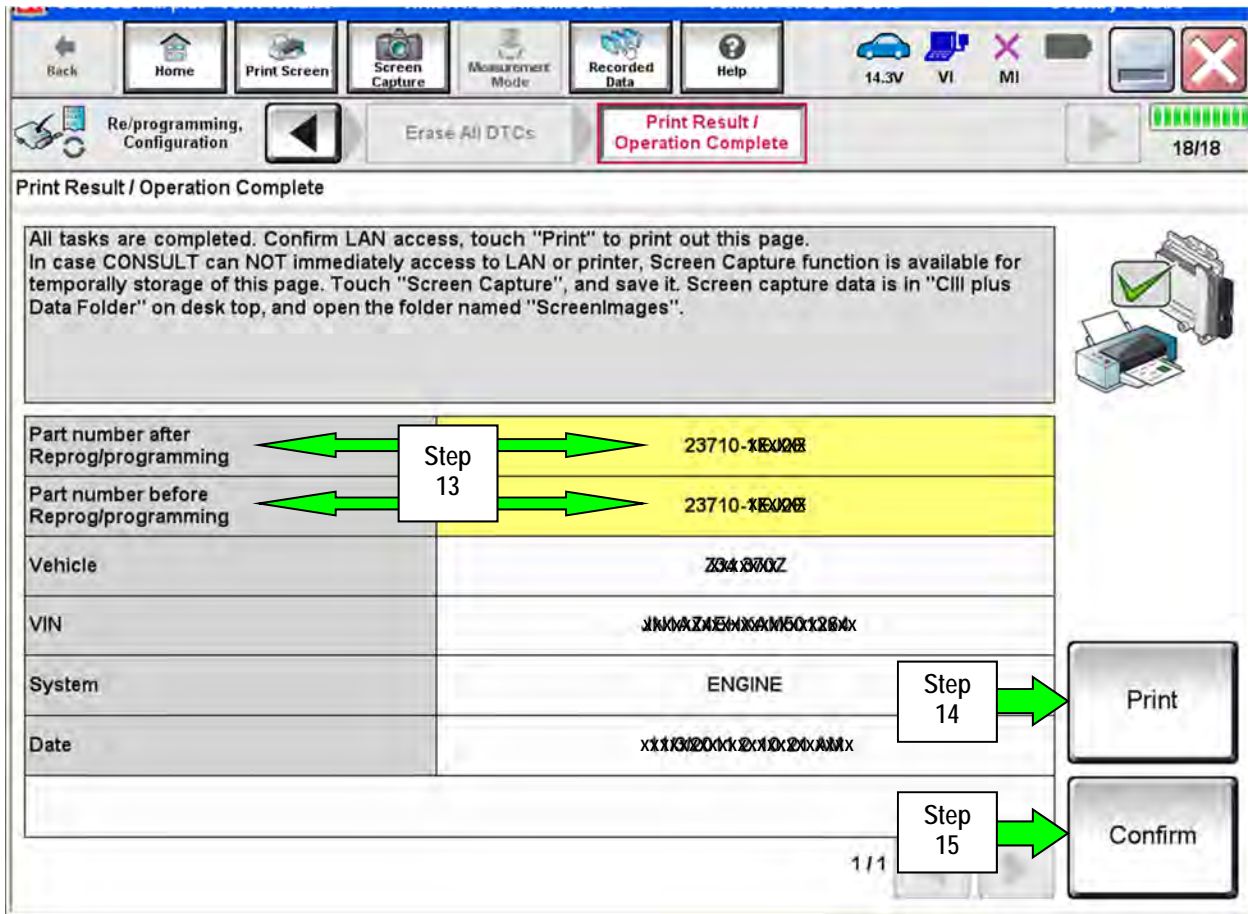
12. When the entire reprogramming process is complete, the screen in Figure 7 will display.
13. Verify the before and after part numbers are different.
14. Print a copy of this screen (Figure 7) and attach it to the repair order for warranty documentation.
15. Select Confirm.
