Rear Lid Strut Diagnosis

Advanced Technical Information

Bulletin #: 1902

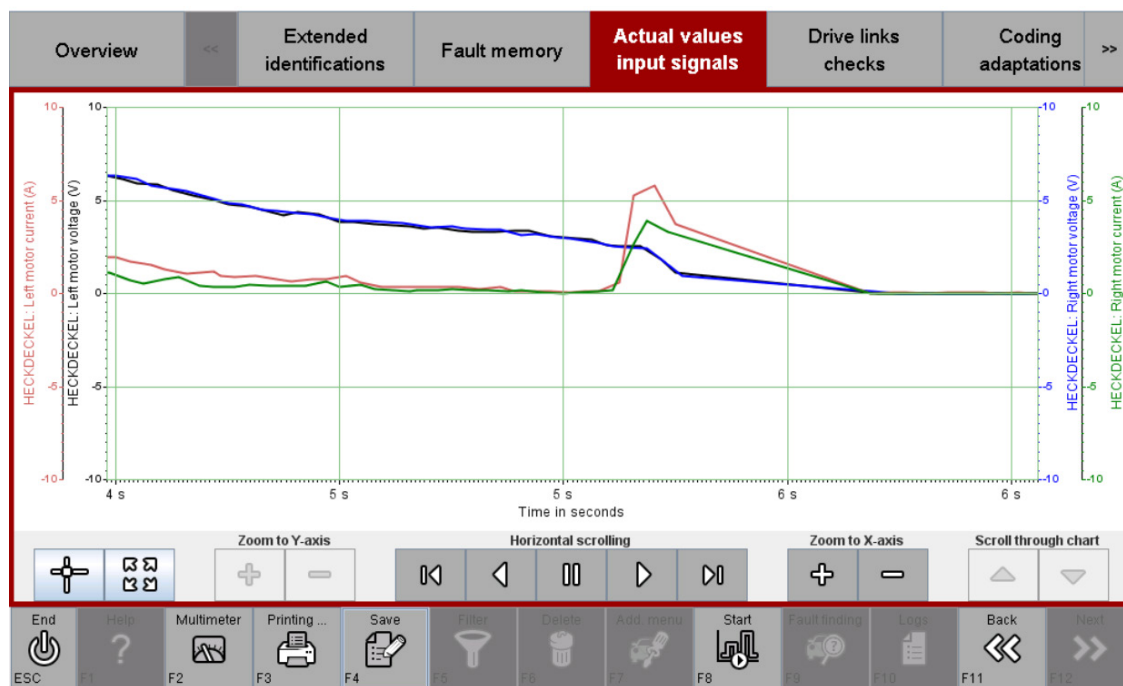
The graph above shows the voltage in the blue and black lines. It is very consistent for both struts.

The current is shown in the green and red lines. The red line has a larger current spike than the green line does. This could be due to some mechanical resistance that is causing that strut to work a bit harder (it needs more energy). The lid adjustment or a binding strut would be good places to check for that.

Note that the green current line could be from an electrical resistance accumulating in a strut. Higher electrical resistance would cause the current flow to decrease (the red line could be the normal one in that case).

The lid adjustment will have an effect on the current required to close or open the lid. Ensure the adjustment is correct in relation to the body opening as a first diagnostic step. Reference WM559015 Adjusting Rear Lid.
