January 18, 2019  
Subject: Recall R89910  
TO: All U.S. and Canadian Volvo Retailers

<h1>Quality Bulletin</h1>				
TITLE: <b>R89910: Tailgate Lift Arms (Drive Units) Model Year 2018 – 2019 XC60</b>				
GROUP:	CAT/NO: <b>R89910</b>	ISSUING DEPARTMENT: <b>Warranty</b>		CAR MARKET: <b>United States and Canada</b>
REFERENCE BULLETINS: <b>PB 83-R89910</b>			ISSUE DATE: <b>2019-01-18</b>	STATUS DATE: <b>2019-01-18</b>
Service Personnel: <b>Read and initial</b>	SERVICE MANAGER	SERVICE WRITER	WARRANTY ADMINISTRATOR	
			<b>Page 1 of 3</b>

<b>Title</b>	Inspection and replacement of "drive units", tailgate lift arms	<b>Page:</b>	1 (5)
<b>Action</b>

**Recall R89910: Tailgate Lift Arms  
Model Year 2018-2019 XC60**

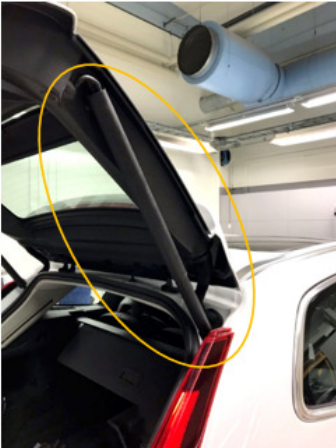
Condition 1, OK

-Condition 1, replace the lifting arms according to VIDA VCC-370949-5.

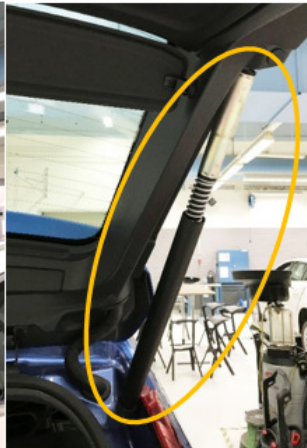
Condition 2, Not OK

-Condition 2, Adjust and fasten the outer tube according to attached document "Instruction". Then replace the lifting arms according to VIDA, VCC-370949-5

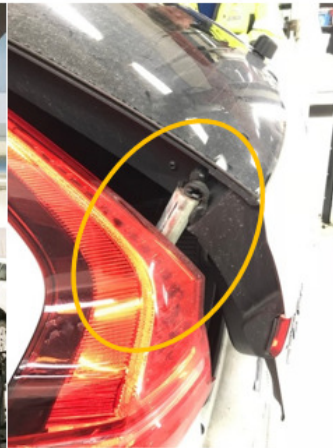
Condition 3, Not OK

-Condition 3, with a bent lifting arm(s) follow the attached "VIDEO". Cover the tailgate, open and close the tailgate until the bent lifting arm(s) is broken. Replace the lifting arms according to VIDA, VCC-370949-5.

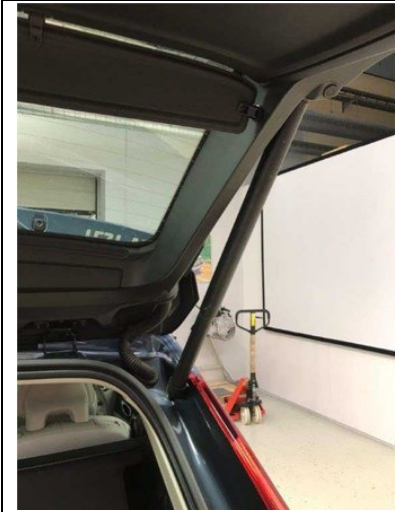
1.

### Condition 1

If motor, power operated tailgate looks according to image, both dampers are to be replaced according to Vida:

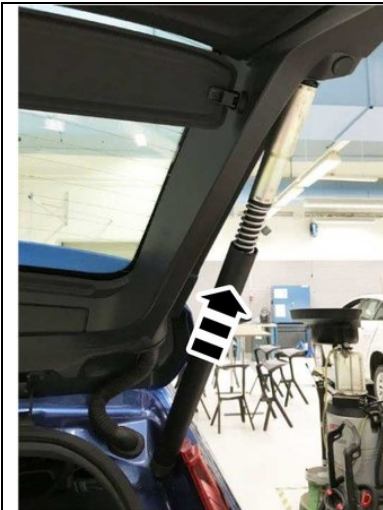
2.

### Condition 2

If motor, power operated tailgate looks according to image, the tailgate must not be closed.

Lift up the outer tube and secure it so that the outer tube does not slide down.

Both lift arms are to be replaced according to Vida:

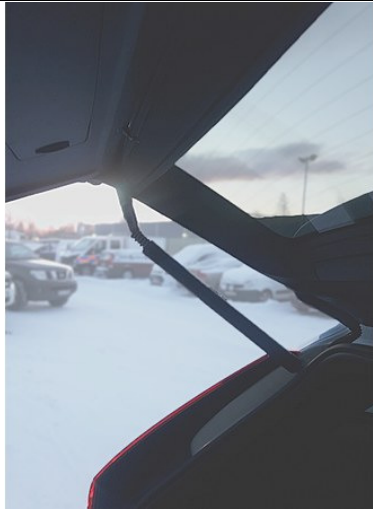
3.

**Condition 3**

If motor, power operated tailgate looks according to image, the tailgate must not be closed.

When dismantling the broken lift arms see attached instruction video in QB-R89910 in TIE. **Note: Use tape on the metal eyelets in the tarp to prevent paint damage.**

Then both lift arms are to be replaced according to Vida:

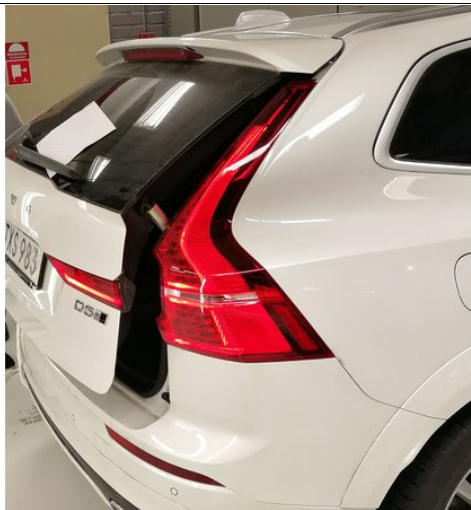
4.

**Condition 3**

If motor, power operated tailgate looks according to image, do not operate tailgate.

When dismantling the broken lift arms see attached instruction video in QB-R89910 in TIE. **Note: Use tape on the metal eyelets in the tarp to prevent paint damage.**

Then both lift arms are to be replaced according to Vida:
