Technical Journal

Rear tow hook cover, comes loose

REF NO: TJ 33542.1.0	ISSUING DEPARTMENT: Technical Service	CAR MARKET: United States and Canada		
3 US 7	PARTNER: '510 Volvo Car USA	ISSUE DATE: 2019-01-15	STATUS DATE: 2019-01-21	
FUNC GROUP: 8619	FUNC DESC: Miscellaneous	Page	1 of 3

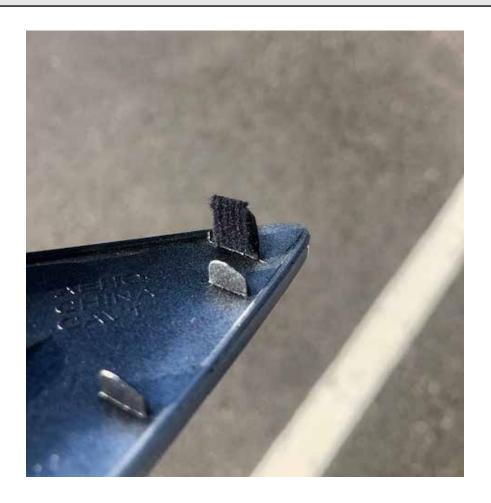
If the rear tow hook cover comes loose, follow the advice under service.

Use tape P/N 30643492 (50x25x0.6) and cut a small piece 8x11 mm.

Apply the tape on the locking tab in order to increase the thickness of the tab on the loose cover or the new cover, see attachment TJ33542.jpg.
