Technical Journal

TITLE:
Upper front suspension, knocking noise

REF NO: TJ 34391.2.0	ISSUING DEPARTMENT: Technical Service	CAR MARKET: United States and Canada	
PARTNER: 3 US 7510 Volvo Car USA		ISSUE DATE: 2019-01-18	STATUS DATE: 2019-01-23
FUNC GROUP: 7230	FUNC DESC: Spring front, helical spring and torsion	Page 1 of 4

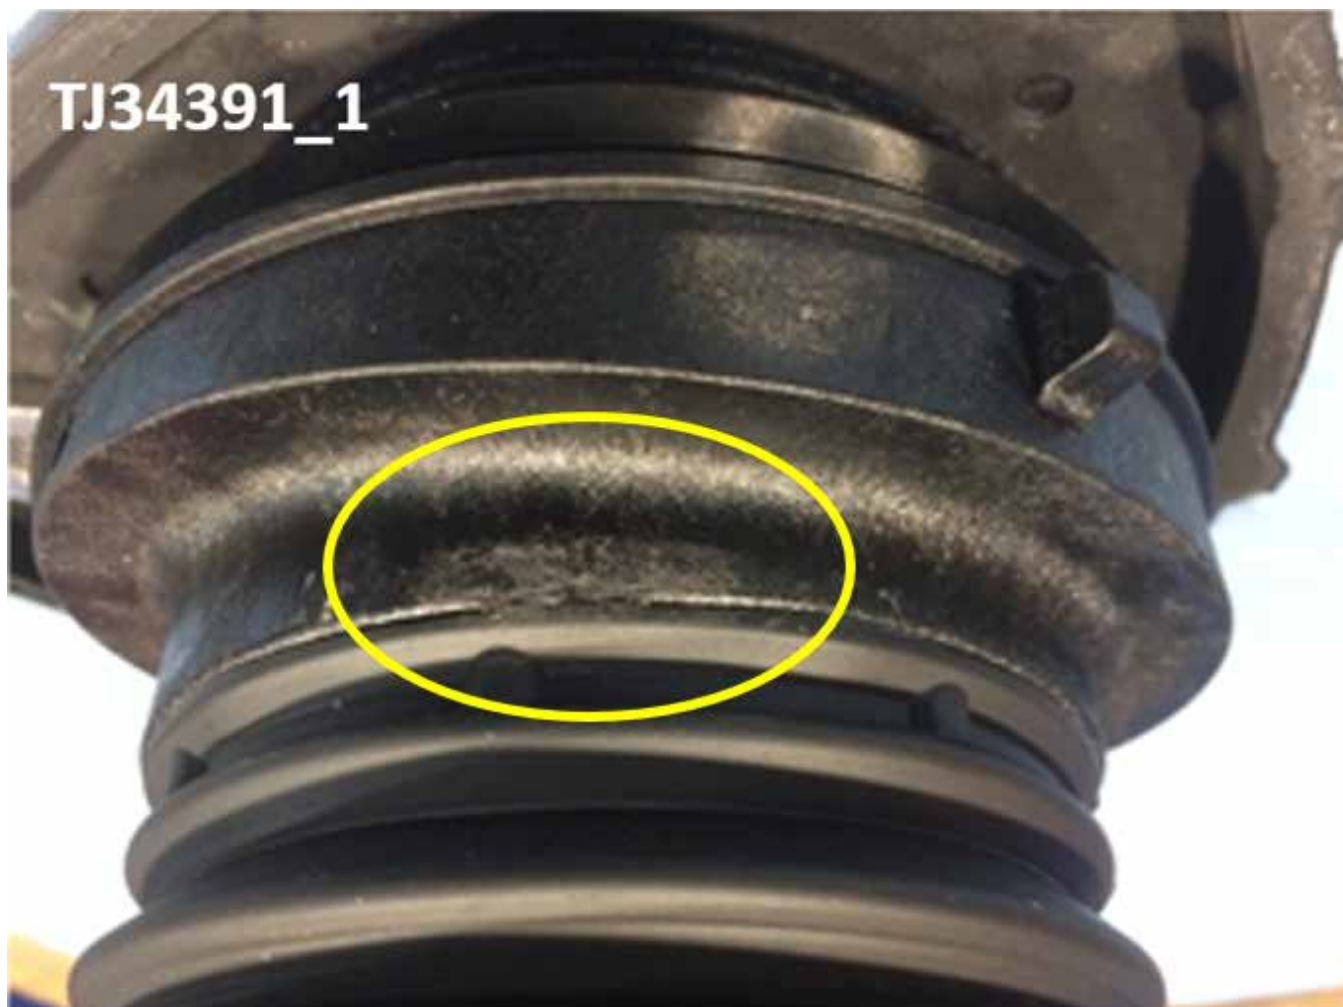
If the front spring is rubbing with the upper bearing according to the attached photo **TJ34391_1.png**.

If the problem is confirmed, replace both front spring coils according to VIDA.

Valid for **MY19**, chassis range **0088993-9999999** and structure week **201840-999952**.
