SERVICE PROGRAM BULLETIN

APPLICABILITY: 2018 MY Legacy
 2018 MY Outback
 2017-2018 MY Impreza
 2018 MY Crosstrek

NUMBER: WUA-86R

SUBJECT: Harman Kardon Head Unit Reprogramming

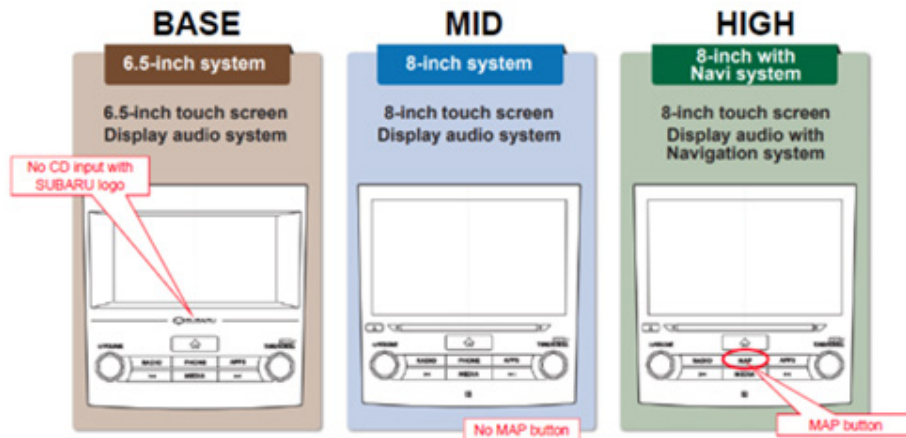
2017-18MY Impreza and 2018MY Crosstrek:

Multimedia System Type	Descriptive Features
6.5 Inch Display Audio System (Base)	No CD slot / Eject Button
8.0 Inch Display Audio System (Mid)	Phone Button in Top Row Center
8.0 Inch Audio / Navigation System (High)	Map Button in Top Row Center

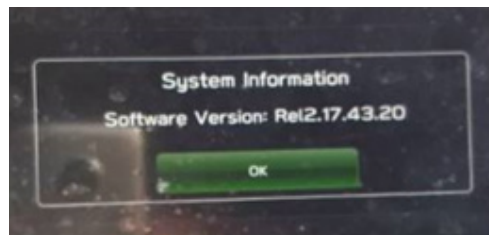
(EXAMPLE photo)

- Confirm the current Software Version ID. If the Current Version is **Rel_UO.18.43.20**, **STOP** as this latest update has already been installed. Otherwise, proceed to **Step 2** below.

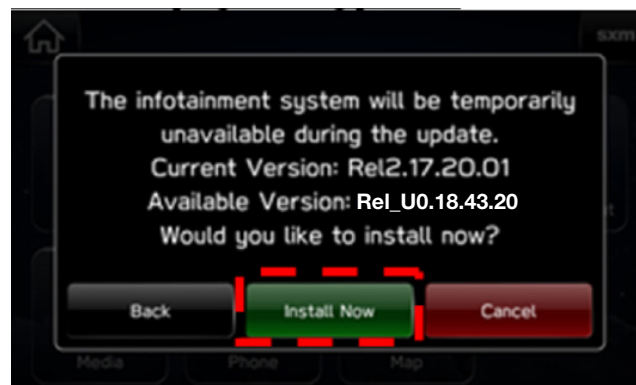
- The current and available software version information will be displayed. The Available Version I.D should be **Rel_UO.18.43.20**.

- After confirming the Available Version, press “Install Now” to start the reprogramming process.

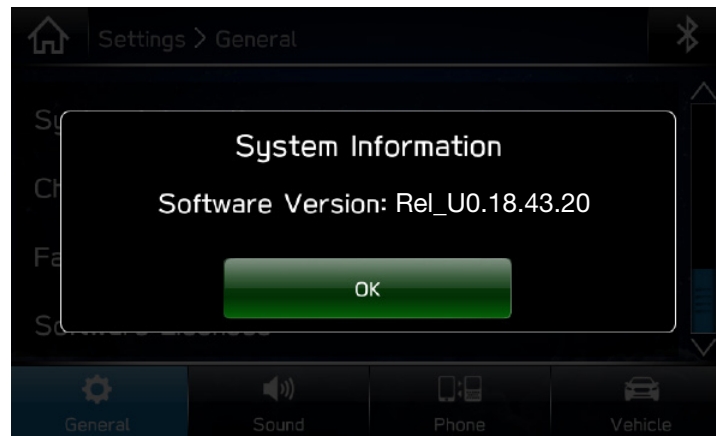
- Confirm Software Version is now “Rel_UO.18.43.20”.
