SERVICE BULLETIN

APPLICABILITY: 2019MY Ascent

NUMBER: 12-258-19

SUBJECT: Rear Combination Lamp Access Panel Retaining Clips

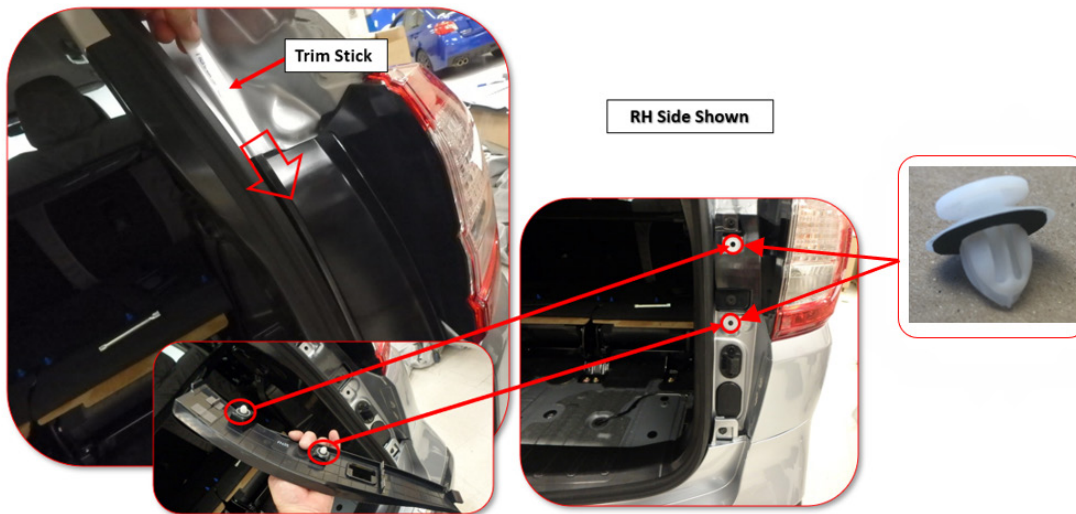
This bulletin announces a service procedure requirement to follow whenever removing the rear tail lamp access covers. The change involves the two retaining clips which are now ONE-TIME USE items and **MUST** always be replaced before reinstalling the covers.

The part number for the access cover retaining clip is **909130241** (qty. 2 per side).

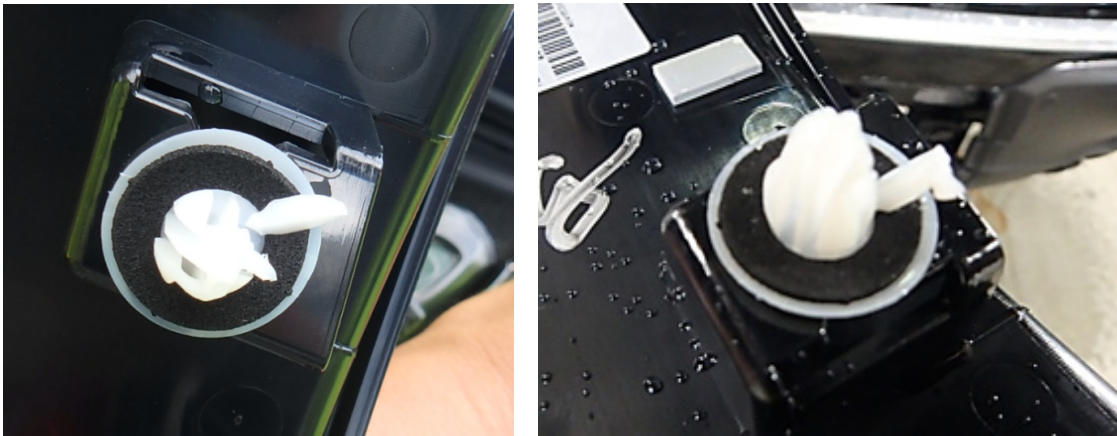
The photos below show damaged clips identified during inspection for a concern of water accumulating in the spare tire well area. Damaged portions of the clip have compromised the sealing portion and caused the leak.

REMINDER: Customer satisfaction and retention starts with performing quality repairs. The basic service procedures for removing and installing the tail lamp access covers have been changed. **This change involves the two retaining clips which are now ONE-TIME USE items and MUST always be replaced before reinstalling the tail lamp access covers.** Always refer to the applicable Service Manual and review the full requirements of the repair being performed. This includes SAFETY precautions, proper inspection criteria, special tools, required processes and related one-time-use parts needed for a complete and lasting repair.
