Center Stop Lamp Rattle Noise

Service Category Vehicle Exterior

Section Lighting (ext)

YEAR(S)	MODEL(S)	ADDITIONAL INFORMATION
2018	LC500, LC500H

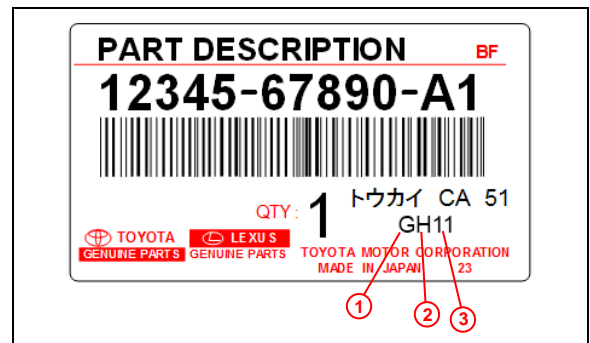
Figure 1. Identification Method

Confirm that the service part has a date code of GH11 or later on the part description.

In the example shown, "GH11" means August 11, 2017.

The second letter represents the month.

1	Year (E = 2015, F = 2016, G = 2017, etc.)
2	Month (See Note)
3	Day

If the date code is BEFORE August 11, 2017, please return or scrap the part and reorder.
