Lack of A/C Performance at Idle in High Ambient Temperature

Service Category Vehicle Interior

Section Heating/Air Conditioning

Some 2016 – 2019 model year Tacoma vehicles may exhibit a condition where the air conditioning system shuts down and stops blowing cool air during periods of extended engine idle with ambient temperatures greater than 100°F. Follow the Repair Procedure in the bulletin to address this condition.

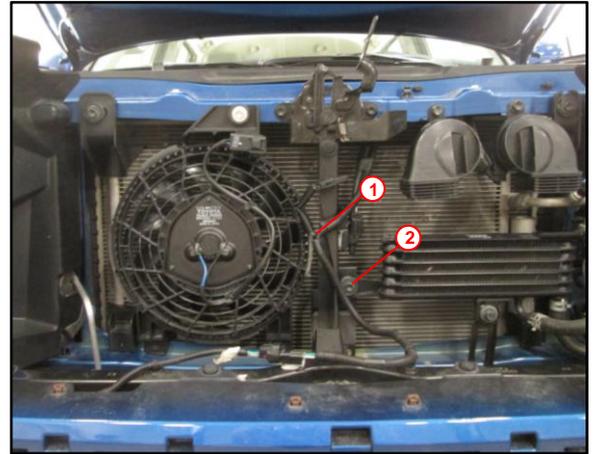
Figure 5.

6. Modify the NEW condenser fan so there is no interference with the automatic transmission oil cooler mounting point.

1	Cut Condenser Fan Bracket
2	Automatic Transmission Cooler Mount

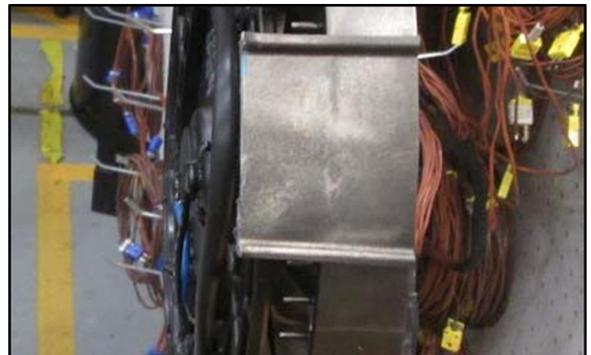
Figure 9. Finished Mount Modification

- D. Clean off ALL remaining plastic burrs from the cut surface.

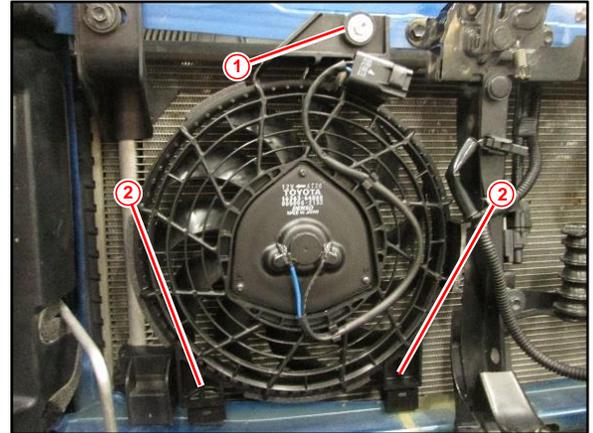
Figure 10.

7. Install the NEW condenser fan.
 - A. Slide the two bottom mounts of the condenser fan over the sheet metal lip of the radiator core support.
 - B. Install the bolt into the top mount.

1	Bolt
2	Bottom Mount

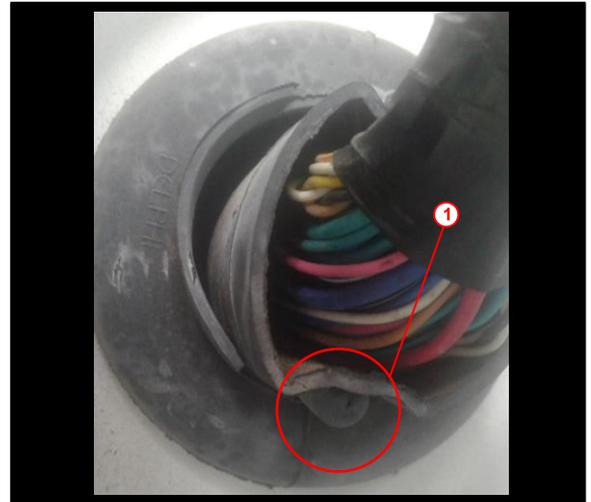
Figure 40.

23. The A/C ECU pigtail and driver J/B sub-wire harnesses will be routed into the passenger compartment through the bottom of the grommet that will require modification.

1	Sub-wire Harness Grommet Passage
----------	---

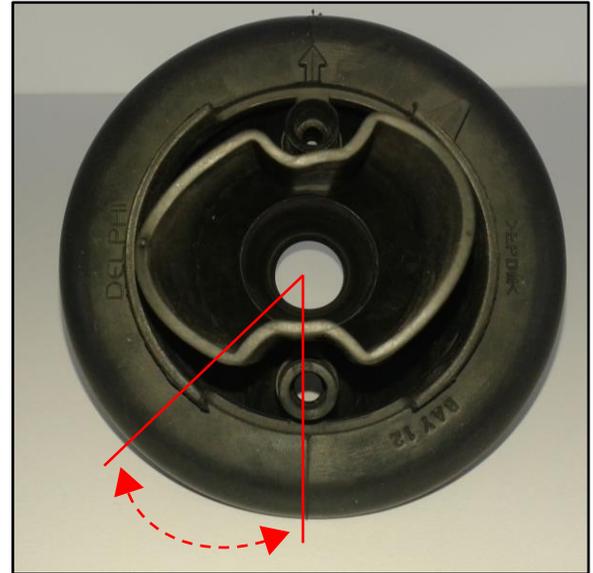
Figure 43.

25. Confirm the orientation of the grommet passage is between the 6 and 8 o'clock positions, viewing it from the engine compartment side.

If the grommet is NOT in this orientation, rotate the bulk head grommet so the passage is in the proper orientation.

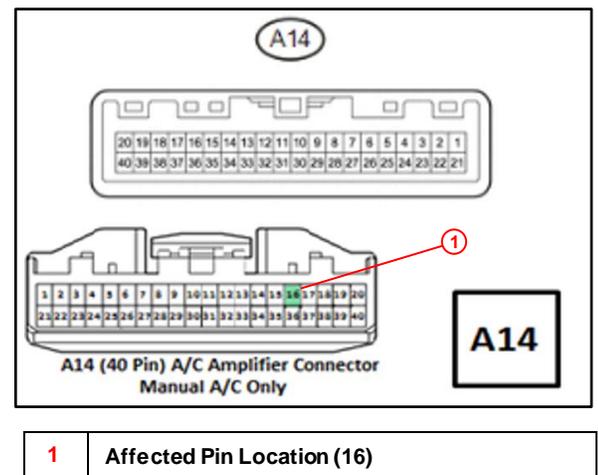
Figure 122. Manual A/C Connect A14

- A. Manual A/C vehicles will ONLY have one connector (A14) at the A/C ECU.
- (1) If connector A14, pin 16 has a pin/wire, the connection of the NEW A/C ECU sub-wire harness to connector A14 will be made by a wire splice process.
 - (2) If connector A14, pin 16 does NOT have a pin/wire, the connection of the NEW A/C ECU sub-wire harness to connector A14 will be made by a pin insertion process.

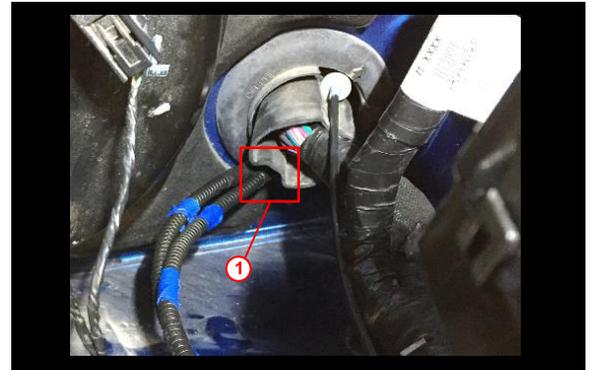
Figure 161.

1	Silicone Sealer Application
----------	------------------------------------
