To: All Canadian Volvo Retailers Subject: Service Action S19850

Service Action S19850: Securing Wiring Harness (V60) Model Year 2019 V60

Volvo Car Customer Service QB Instruction VCC-485523-2

Title	Cable harness, securing	Page	1 (3)
Action	Installation	Operation number:	99921-2

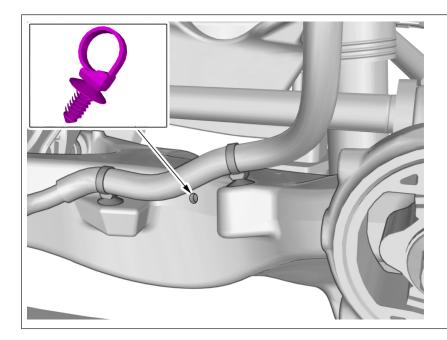
Installation

Volvo has identified that the wire tie is missing that retains the wiring harness on the left and right rear lower control arms.

Install the marked component. On both sides.
