# Technical Journal

**Tailgate opening by foot movement detection**

<b>REF NO:</b> TJ 34502.1.0	<b>ISSUING DEPARTMENT:</b> Technical Service	<b>CAR MARKET:</b> United States and Canada	
<b>PARTNER:</b> 3 US 7510 Volvo Car USA		<b>ISSUE DATE:</b> 2019-02-21	<b>STATUS DATE:</b> 2019-02-26
<b>FUNC GROUP:</b> 8321	<b>FUNC DESC:</b> Boot lid; tailgate	Page 1 of 3

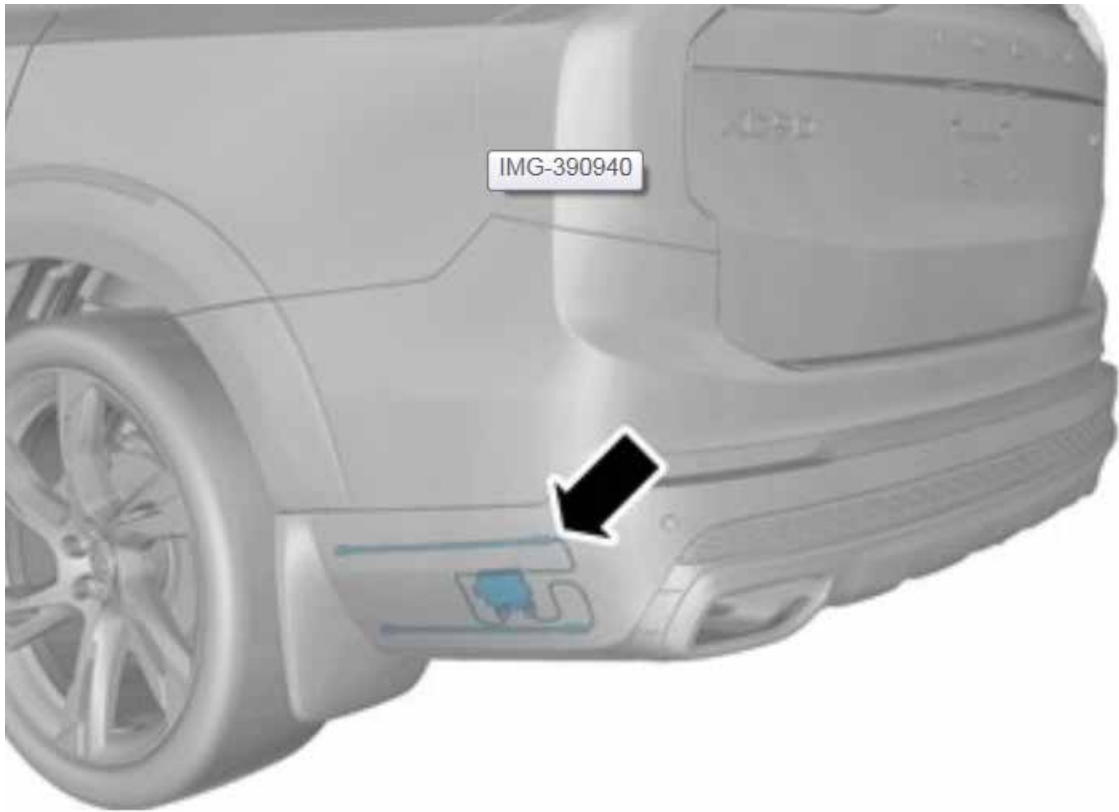
File Name	File Size
XC90 Skid plate.PNG	0.2106 MB

Note: This is applicable to all vehicles equipped with a Power operated tailgate/trunk. XC90 with skid plate, the sensor is located on the left side of the rear bumper (see attached photo).
