## **T8 P0EA773 Auxiliary Cooling System Performance**

REF NO:	ISSUING DEPARTMENT:	CAR MARKET:		
TJ 34123.1.6	Technical Service	United States and Canada		
3 US 7	PARTNER:	ISSUE DATE: 2019-02-12	STATUS DATE: 2019-02-18	
	010101000	2019-02-12	2019-02-10	
FUNC GROUP:	FUNC DESC:			
2647	Heater, thermostat	Page	1 of 4

## **Technical Journal 34123.1.6**

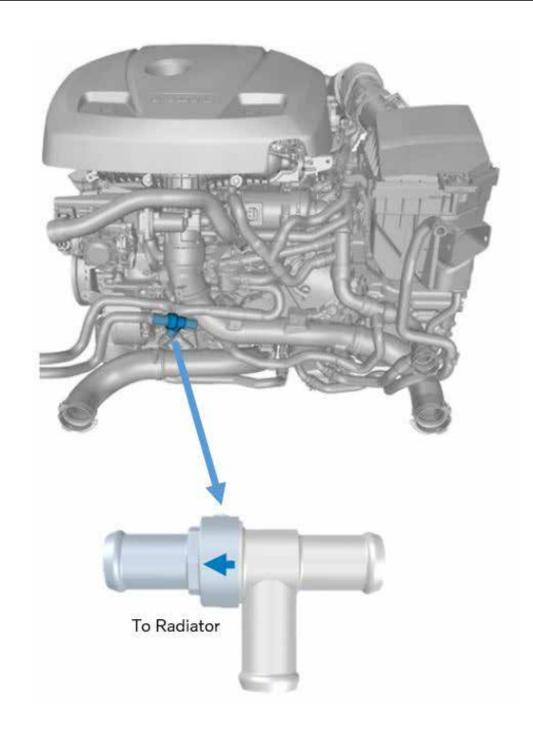
Note: Orientation of the component is critical to correct operation. See attached photo US34123\_ Orientation Illustration.jpg

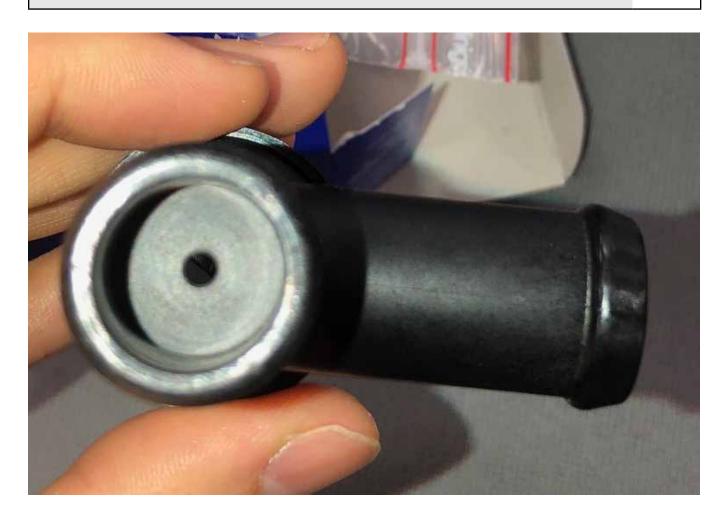
Before installing component, please verify that the correct component is installed. The new components can be recognized by the orifice visible from one side. See attached photo as example.

A new component is now available for replacement and the old thermostat part number has been blocked. Do not install old component.

Please order and install component 32139082. In the coming weeks, this may be superceded by 32263957 & 32263958. These components are identical in function.
