# Technical Journal

**No steering assistance during workshop visit**

<b>REF NO:</b> TJ 34507.1.0	<b>ISSUING DEPARTMENT:</b> Technical Service	<b>CAR MARKET:</b> United States and Canada	
<b>PARTNER:</b> 3 US 7510 Volvo Car USA		<b>ISSUE DATE:</b> 2019-02-15	<b>STATUS DATE:</b> 2019-02-20
<b>FUNC GROUP:</b> 6422	<b>FUNC DESC:</b> Steering gear, servo complete	Page 1 of 3

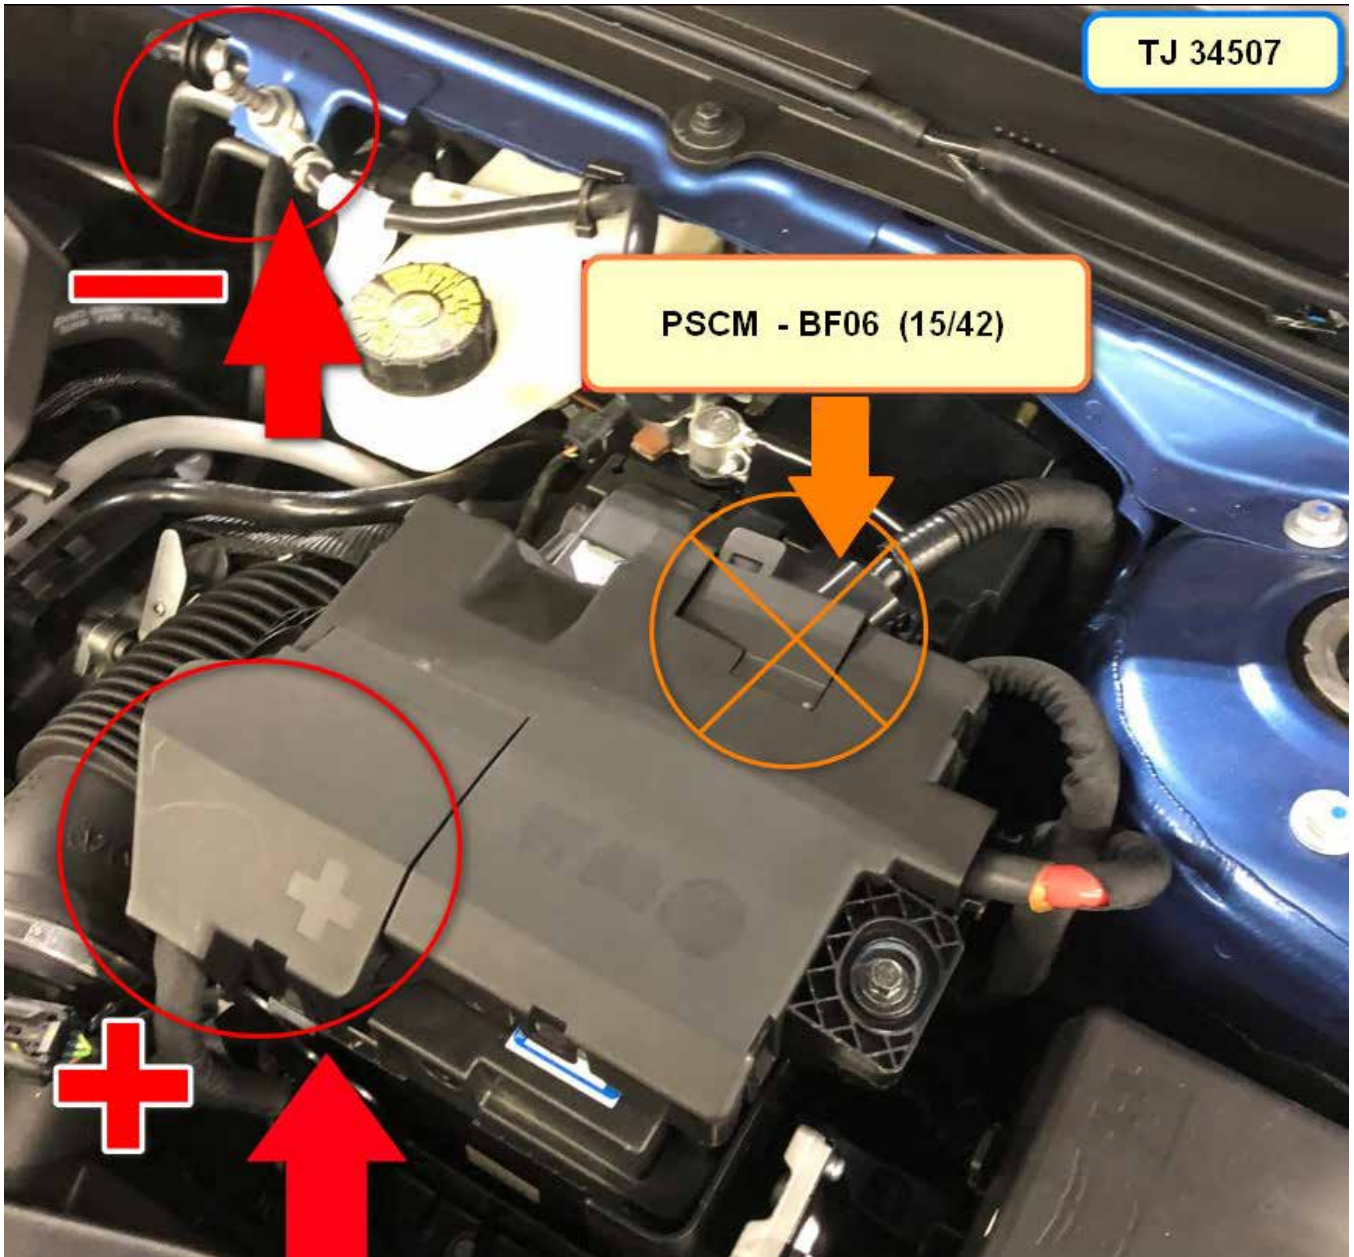
TJ 34507

The failure could occur in the workshop if the technician applied the battery charger clamp directly on the stud for the steering fuse instead of the normal battery charging post, please see attachment. Red arrows in the photos show the correct B+ and B- positions for charging / jumpstarting.

If the power steering system is not responding, or if there is an error message in VIDA that it is not possible to download software to the power steering control module (PSCM), then check the fuse for the power steering system, Volvo electrical component BF06 (15/42 in wiring diagram).

In case the 100A fuse is defective, then replace only the fuse, there is **no** need to replace the steering gear or any other steering equipment.

Parts: 100A Fuse P/N 31654002. Note: do not use any other 100A fuses since these have different dimensions.
