Technical Journal

Tail light assembly, replacement or adjustment

REF NO: TJ 34506.1.0	ISSUING DEPARTMENT: Technical Service	CAR MARKET: United States and Canada	
PARTNER: 3 US 7510 Volvo Car USA		ISSUE DATE: 2019-02-15	STATUS DATE: 2019-02-19
FUNC GROUP: 3531	FUNC DESC: Stop lamp; tail lamp; direction lamp	Page 1 of 3

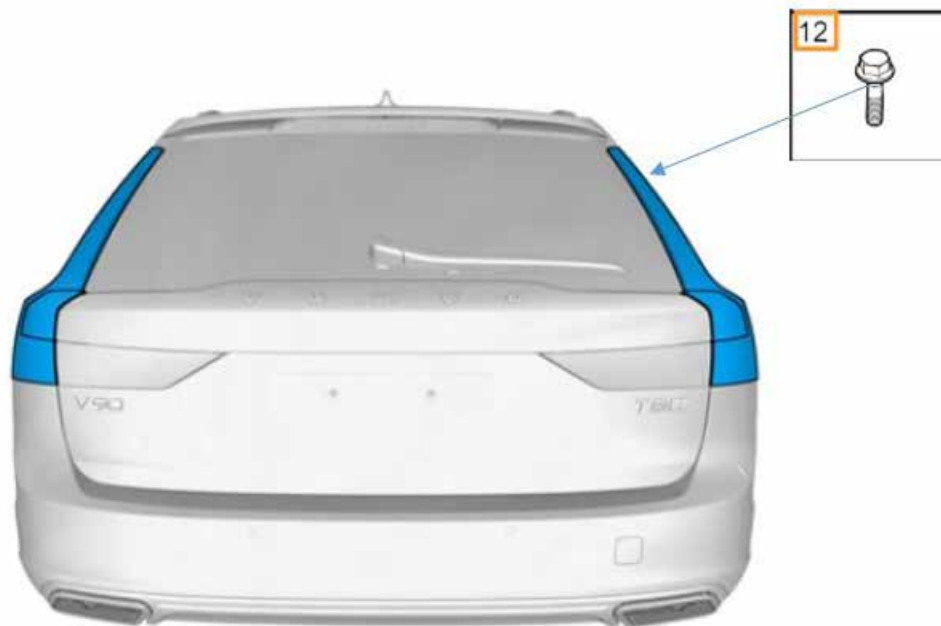
File Name	File Size
TJ34506.jpg	0.0370 MB

When replacing or adjusting the tail light assembly, the upper screw (see attachment) needs to be secured with thread-locker, follow advise under service.

Apply thread locker P/N: Wurth 0893243050 on the screw threads P/N: 30624359.
