| DOC # | PROCESS NAME | PAGE | REVISION | STATION | BY | DATE |
|---|---|---|---|---|---|---|
| AR865 | Rear Coolant Line Clamp Inspection | 1 of 1 | - | SER-E | C.Ward | 3/15/2019 |

**Complaint:** Metrolinx Contractual concerns with inconsistent coolant line connections

**Cause:** Incorrect/inconsistent coolant lines connections located on Sarnia units

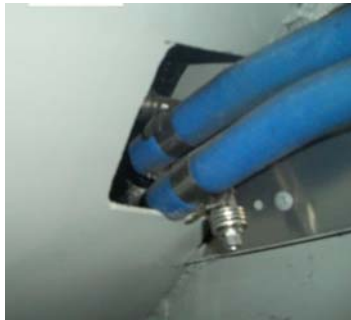
Method #1

1. Hoses connected to a continuous metal coolant line. In this application, there should only be two constant torque clamps to review - one on each hose connection.
2. Hoses connected with the usage of a 90 degree elbow fitting. In this application, there should be four constant torque clamps to review.

Once the cover is removed, you can do a visual check of the constant torque clamps. Using a 5/16" wrench or ratchet with socket, check the constant torque clamps to ensure they are tight. Do not overtighten.
