Technical Service Bulletin

37 Transmission malfunction, DTC P17F600, U008000, and/or U010100 stored in TCM or ECM

37 19 85 2053878/2 March 12, 2019. Supersedes Technical Service Bulletin Group 37 number 19-84 dated February 26, 2019 for reasons listed below.

Model(s)	Year	VIN Range	Vehicle-Specific Equipment
A6, A7	2019	000001 - 050600	3.0TFSI

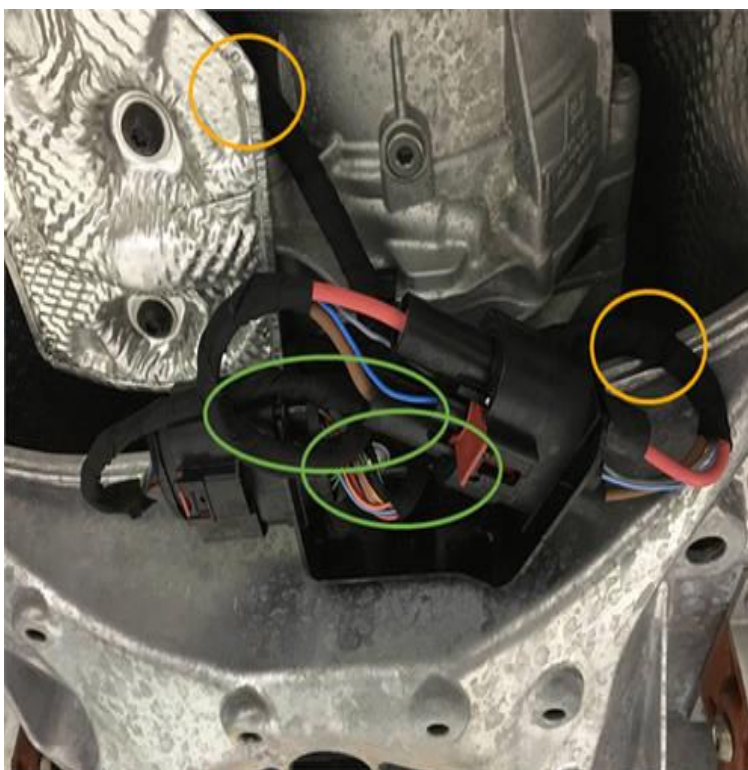
The transmission harness can come in contact with the crossmember and could be damaged.

Figure 1. Common areas for harness damage.

2. Replace the transmission harness with a new part and reroute the transmission harness. The transmission harness should not be repaired.

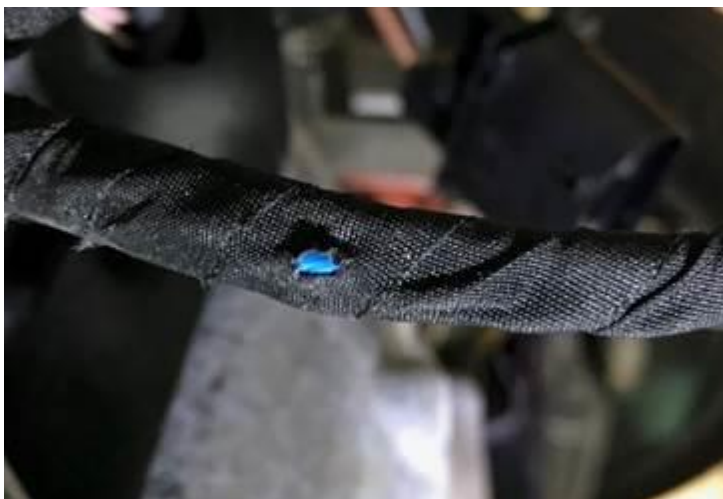
Figure 2. Example of a small rip in the protective tape.

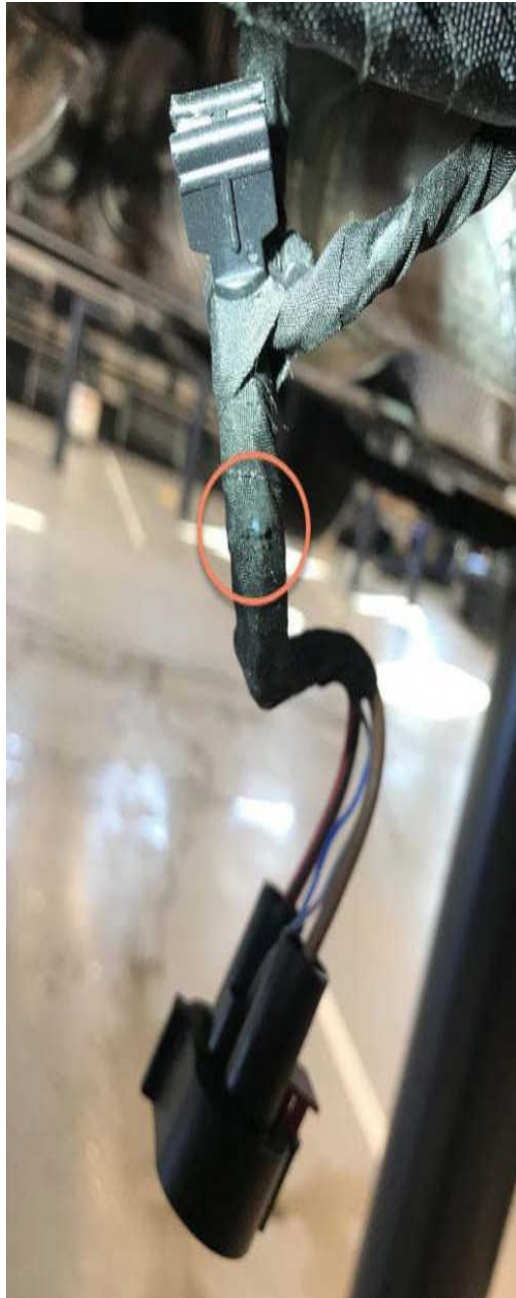
Figure 3. The damage on the harness might be difficult to spot.

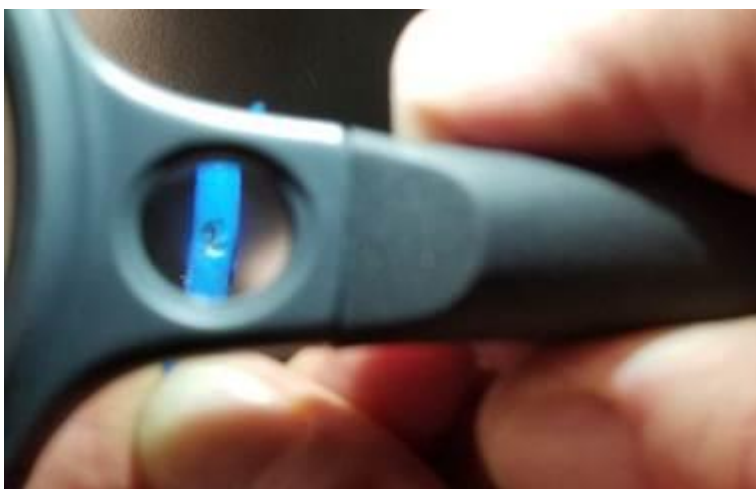
Figure 4. The cause of the DTC may be as small as a pinhole.
