Technical Service Bulletin

91 MIB2 High Scale: rearview camera/overhead view camera does not turn on

91 19 42 2053532/1 March 4, 2019.

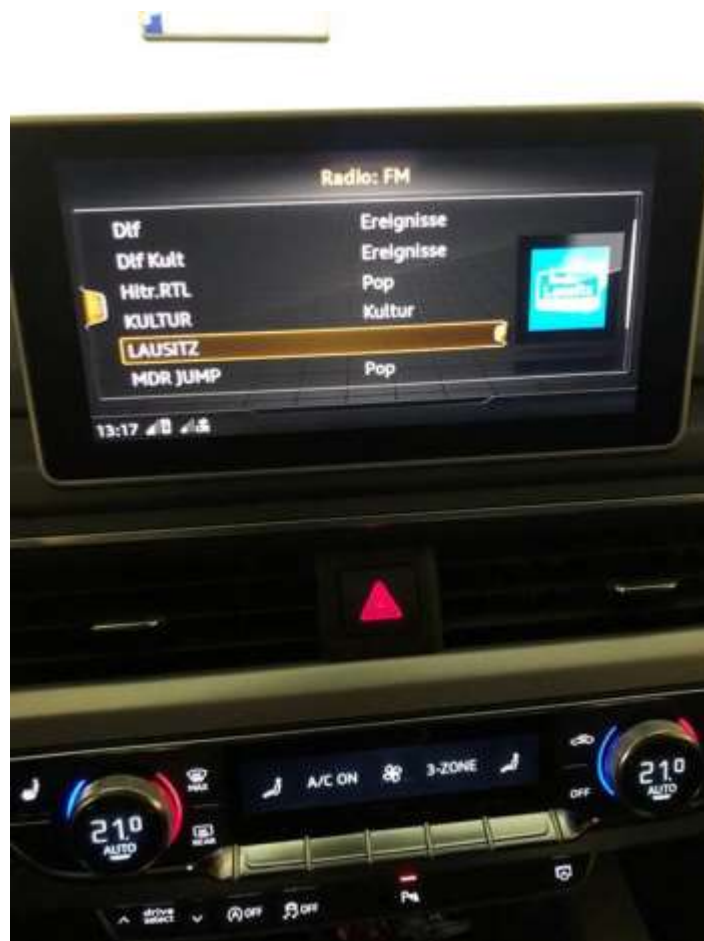
- The rearview/overhead view camera and the optical parking aid are sporadically not switched on when moving into reverse. The previously adjusted menu (radio, navigation etc.) stays the same (Figure 1).
- The parking aid button in the center console lights up and an acoustic obstacle warning is given.

Figure 1. Previously adjusted menu stays the same.

The MIB2 High Scale software needs to be updated.

Update the MIB2 Scale infotainment system using either Method 1 or Method 2 according to TSB 2050565: *91 MIB2 High Scale Software Update Instructions (PR Code 7UH)* and use SVM code indicated below:
