Subject: SQUEAK NOISE FROM RIGHT FRONT DRIVESHAFT (SKYACTIV 6AT ONLY)	Bulletin No.: 03-001/19
	Last Issued: 03/22/2019

2012-2013 Mazda3 (SKYACTIV A/T only)

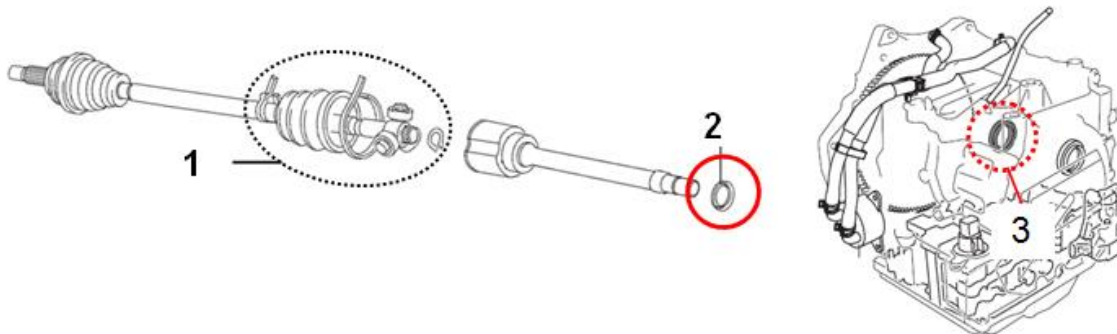
1	Inner joint boot set
2	Dust cover
3	Oil Seal

Some vehicles may exhibit a squeak noise from the right front driveshaft at the automatic transaxle when driving. This concern is likely to occur when driving at speeds between 37-50 mph (60-80 km/h) with the ATF at normal operating temperature. The noise is caused by stick/slip between the oil seal at the transaxle and the dust cover of the driveshaft. To correct this issue, the thickness of the dust cover has been increased.

1. Verify concern
2. Replace the dust cover and the converter housing side oil seal with modified ones according to the instructions on MGSS (FRONT DRIVE SHAFT REMOVAL/INSTALLATION), FRONT DRIVE SHAFT (TRIPOD JOINT) DISASSEMBLY/ASSEMBLY and (OIL SEAL (DIFFERENTIAL) REPLACEMENT Converter Housing Side).

NOTE: When installing the dust cover on the inner joint shaft, it is important to have the hydraulic press in good working order. If the dust cover is not perfectly installed and true, any runout from the dust cap may possibly create a noise concern. It is recommended to check the work once the joint shaft is installed.
