Technical Service Bulletin

Subject: REAR DOOR SEAMING WELT COMES OFF WHEN STEPPING IN AND OUT OF VEHICLE	Bulletin No.: 09-015/19
	Last Issued: 03/27/2019

2014-2018 Mazda3
2013-~~2018~~ CX-5

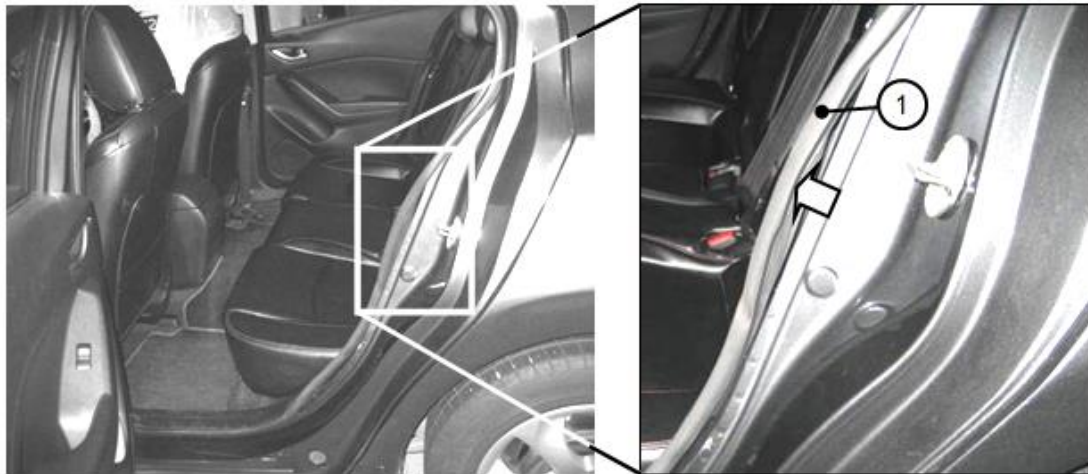
Some customers may complain that the rear door seaming welt (1) comes off when stepping in and/or out of the vehicle. This is caused by the gripping force of the seaming welt being insufficient for frequent usage of the rear seat (vehicle used for ride sharing). No mass production change is planned.

Customers having this concern should have their vehicle repaired using the following repair procedure.

1. Verify concern
2. Re-install the affected side seaming welt(s) with a double-sided adhesive tape (new service part).
